MARINE ACCIDENT  
INVESTIGATION BRANCH

# **SAFETY DIGEST**

**Lessons from Marine  
Accident Reports  
1/2019**

April 2019

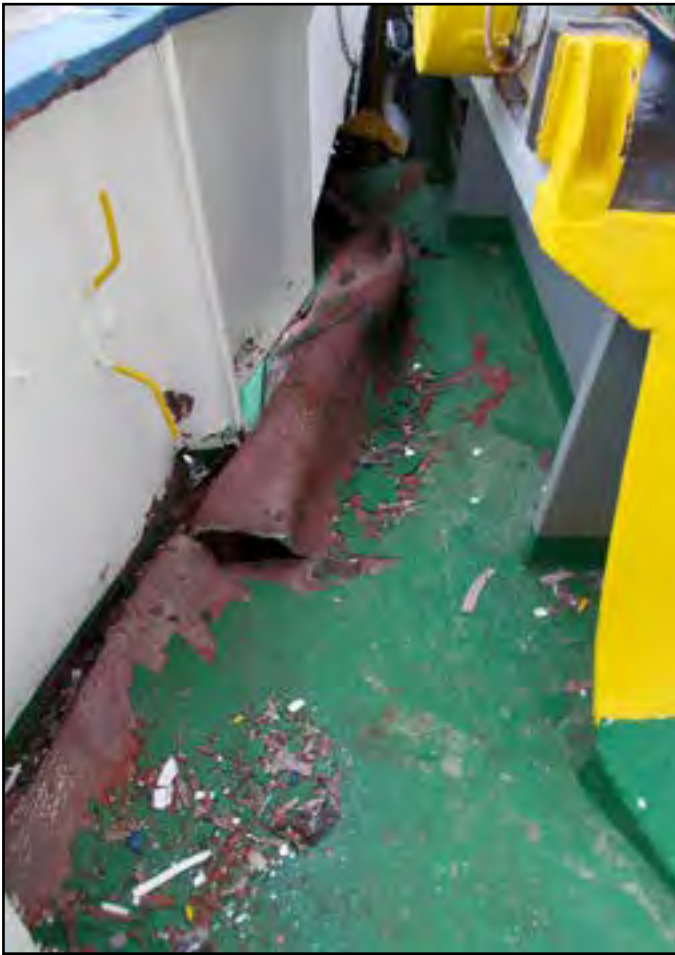
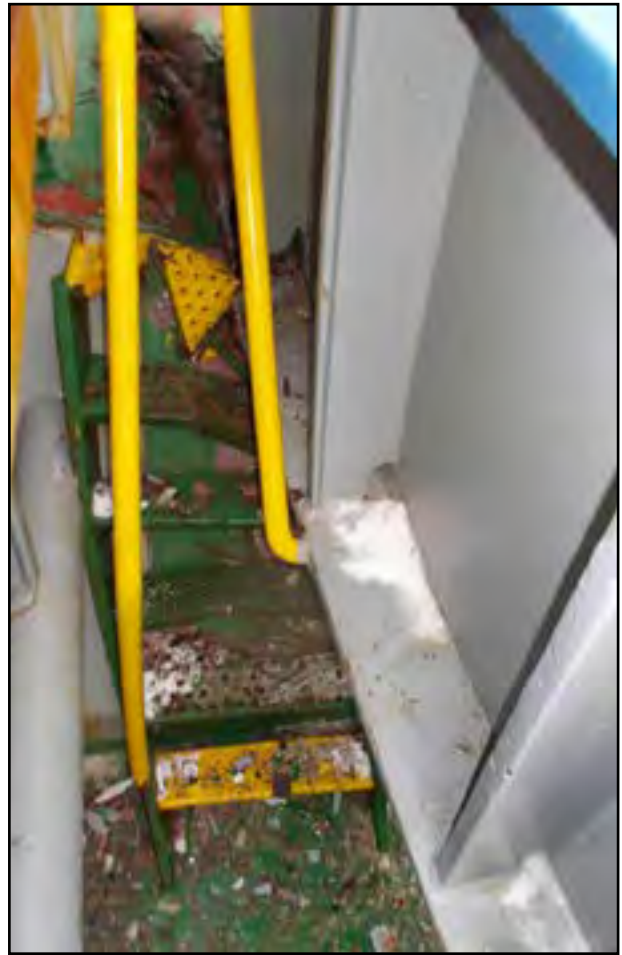
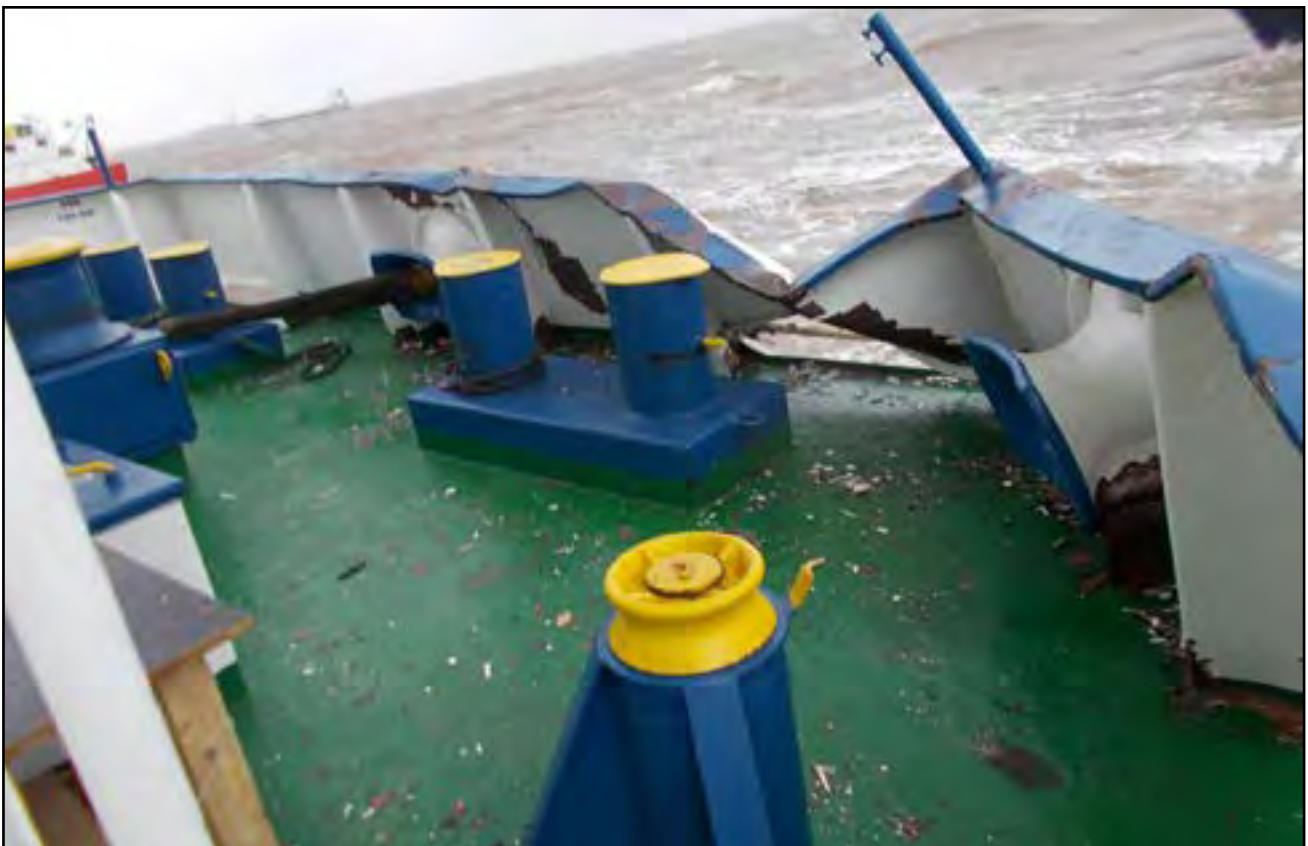
By the time the cargo vessel's engineer had dressed and started the main engine it was too late to avoid a collision. The cargo vessel struck the other vessel at anchor, which then also started to drag. Both vessels then collided with a third vessel, which was also at anchor. Nobody was injured but all the vessels sustained damage (see figure).

Figure: Damage to the small cargo vessel

4. The options available when a ship drags its anchor are extremely limited if its propulsion is not available. Occasionally, when conditions dictate, this means having engines at immediate readiness.

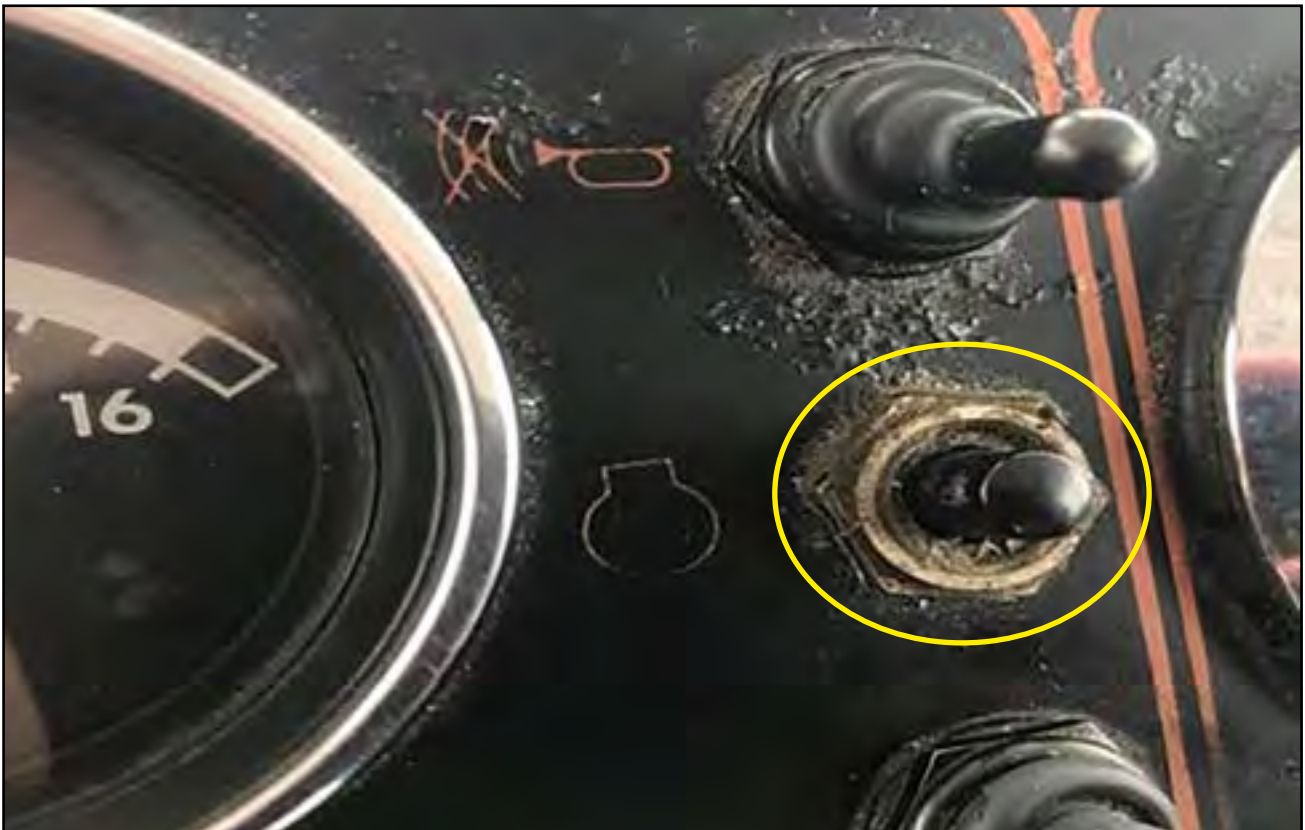
Post-fire examination of the port main engine and its electrical starting system identified an intermittent fault on the wheelhouse engine starter button (Figure 1). This allowed the engine starter motor solenoid to remain energised, and to overload and ignite the electrical cabling (Figure 2).

Figure 1: Main engine starter button

2. To avoid complacency, always err on the side of caution. Machinery alarms are provided for a reason, so positive action should be taken immediately to investigate their cause.

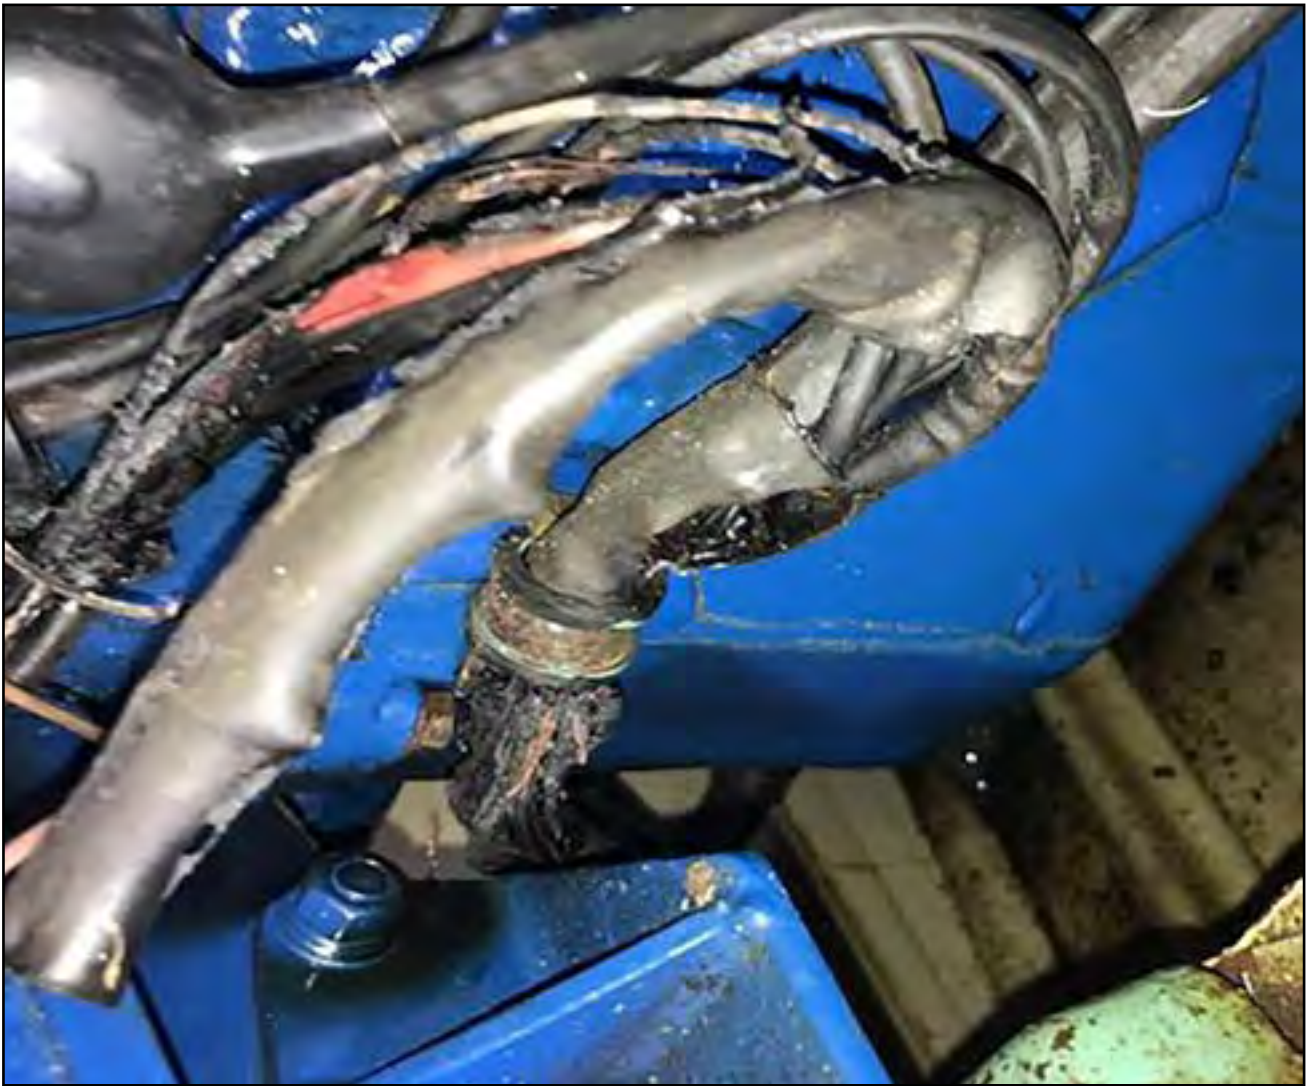
Figure 2: Heat damage to electrical cabling

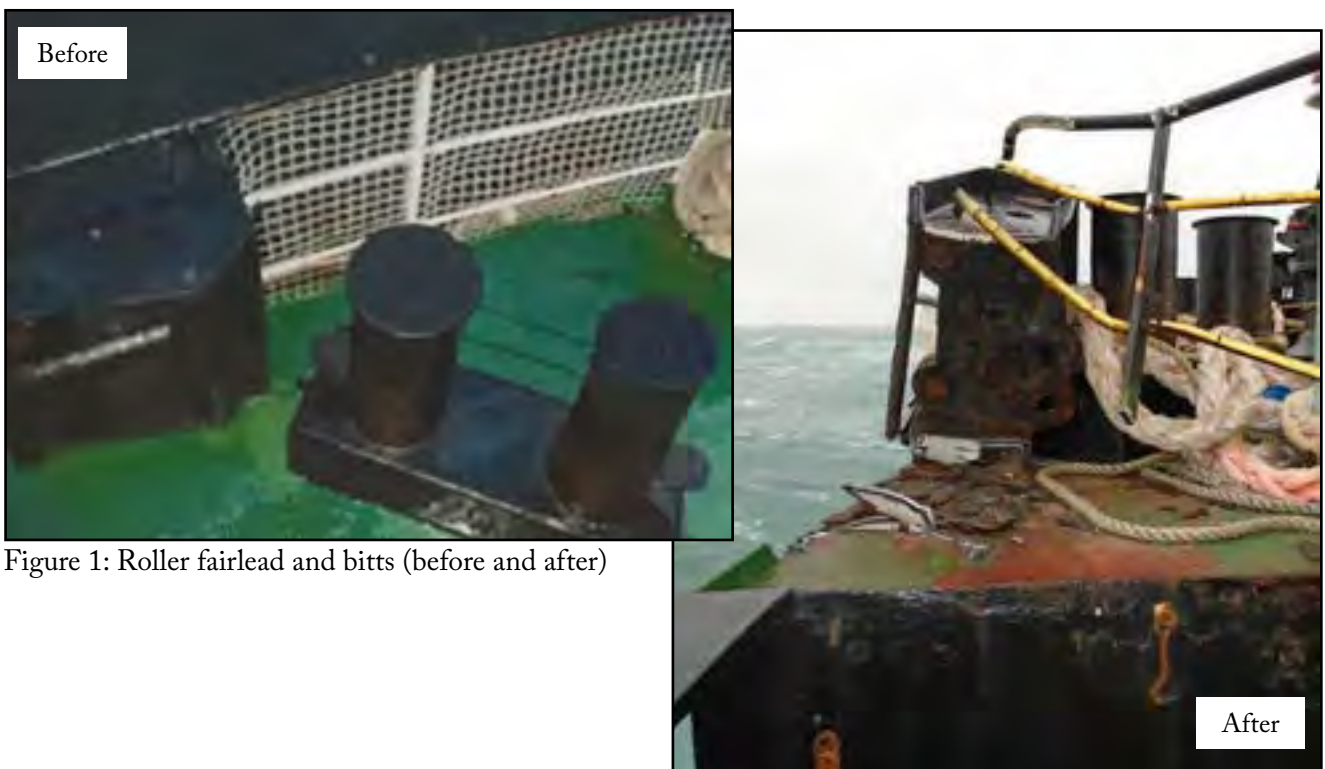
A passenger ferry was attempting to moor on a berth with a strong groundswell in strong winds when, without warning, one of its mooring line bollards was ripped from the deck. The ferry had to be taken out of service for several days to facilitate repairs to its deck plating and a roller fairlead (Figure 1). Fortunately, nobody was injured.

eye spliced at each end. The minimum breaking load (MBL) for the 48mm, 64mm and 80mm ropes was 43t, 75t and 116t respectively. The safe working load (SWL) of the damaged bollard and roller fairlead was 20t and 12t respectively.

It was evident that the forces acting on the mooring line - because of the combined effects of the wind and groundswell - did not reach its MBL but significantly exceeded the SWL of the vessel's deck fittings. This happened because the SWL of the deck fittings had not been properly considered when the size of the mooring line was increased.

Figure 1: Roller fairlead and bitts (before and after)

3. Vessel operators and crew should ensure that mooring line strength does not exceed that of the load limitation of installed mooring equipment such as deck bitts/ bollards, rollers, fairleads and winches. It is recommended that ships' staff make themselves aware of load limitations of equipment and mooring ropes used before using a rope that deviates from that included in the design of the vessel.

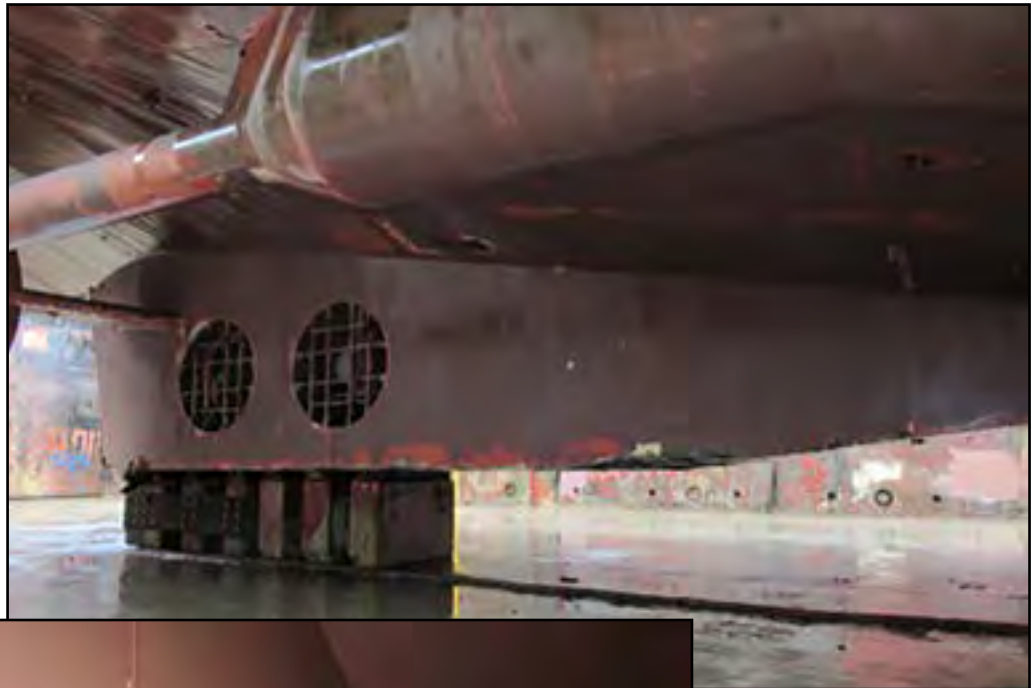
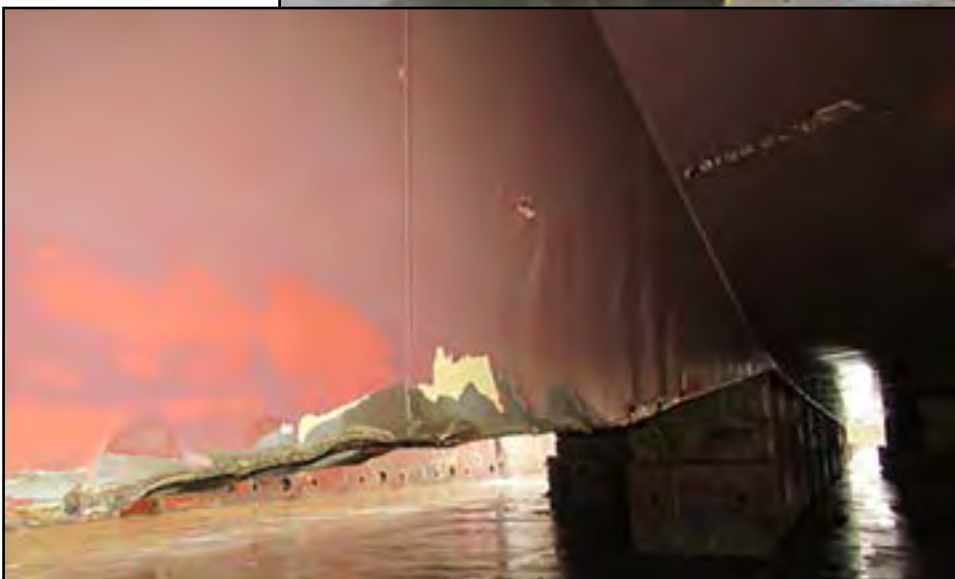
Later, the divers conducting the planned underwater hull inspection saw that the vessel's skeg was damaged. The master was uncertain how this had occurred, and reported to the VTS the vibration felt during the inbound passage. Review of the vessel's position during entry, along with the height of tide, identified that the vessel had been on its intended track. However, it also identified that, because the inbound passage was 1 hour later than intended, and the height of tide was 0.4m less than predicted, insufficient water had been available. The vibration felt during the starboard turn resulted from the vessel taking the ground towards its stern. The damage to the skeg (see figure) required the AHTS to be dry docked for repairs.

Figure: Damage to skag

3. Tides are not always as predicted, but most port authorities generally have real-time tidal information to hand. If this information is not provided as a matter of course through routine VHF broadcasts or exchanges, it is in everyone's interest to ask for it when meeting the required under keel clearance is marginal or in doubt.

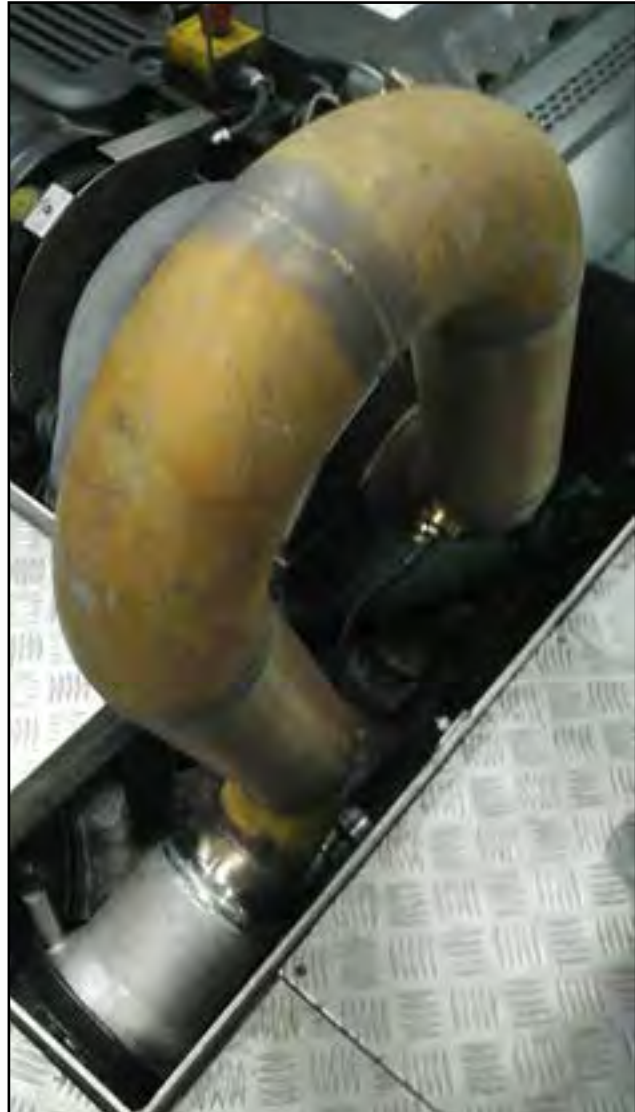
The engines had a history of exhaust pipe cracking and the starboard engine exhaust pipe had been replaced 20 days before the accident, but its lagging had not been refitted. The vessel had a wet exhaust system and the exhaust pipe was raised above the sea level as a precaution against water flowing into a stopped engine.

Figure: Starboard engine exposed exhaust pipe

1. Exposed surfaces with temperatures above 220°C are prohibited by SOLAS regulations as they are fire hazards.
2. If it is necessary to remove exhaust lagging for access, always ensure it is refitted as soon as the work has been completed.

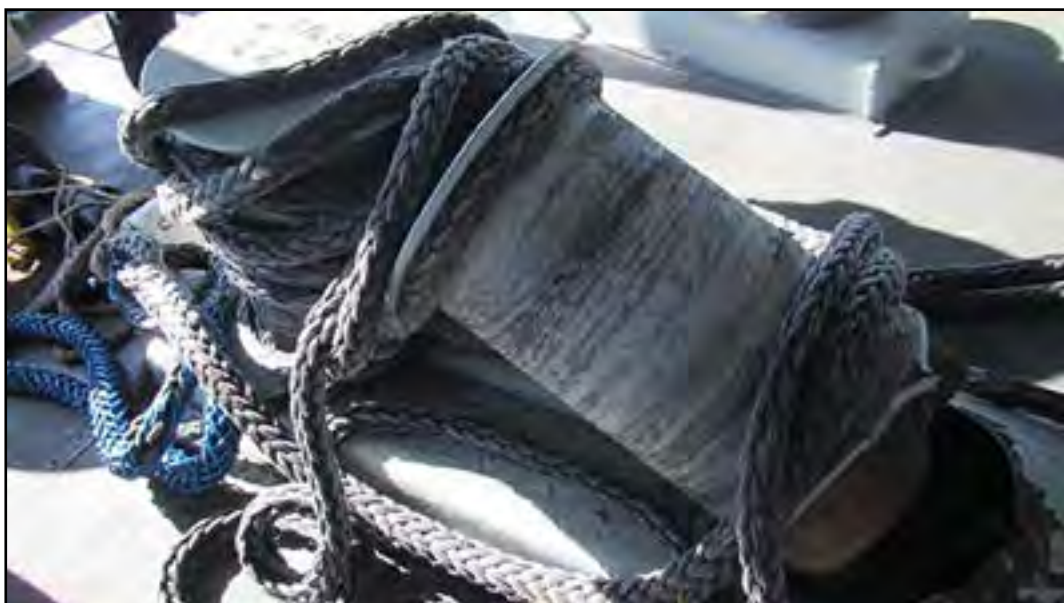
As one of the tugs began to increase its pull, the applied load exceeded the SWL of the ship's structural mooring equipment. As a result, the mooring bitts failed along with the supporting structure for the panama fairlead. Consequential damage included buckled ship-side guardrails and bulwark.

The ship's crew noted that the SWL of the fairlead was 8 tonnes (t). They therefore took local action to highlight all mooring equipment rated at 8t, and instructed that this equipment was not to be used for towing, and included this information in pre-departure/arrival toolbox talks.

Figure 1: Mooring bitts' failure during tug operation

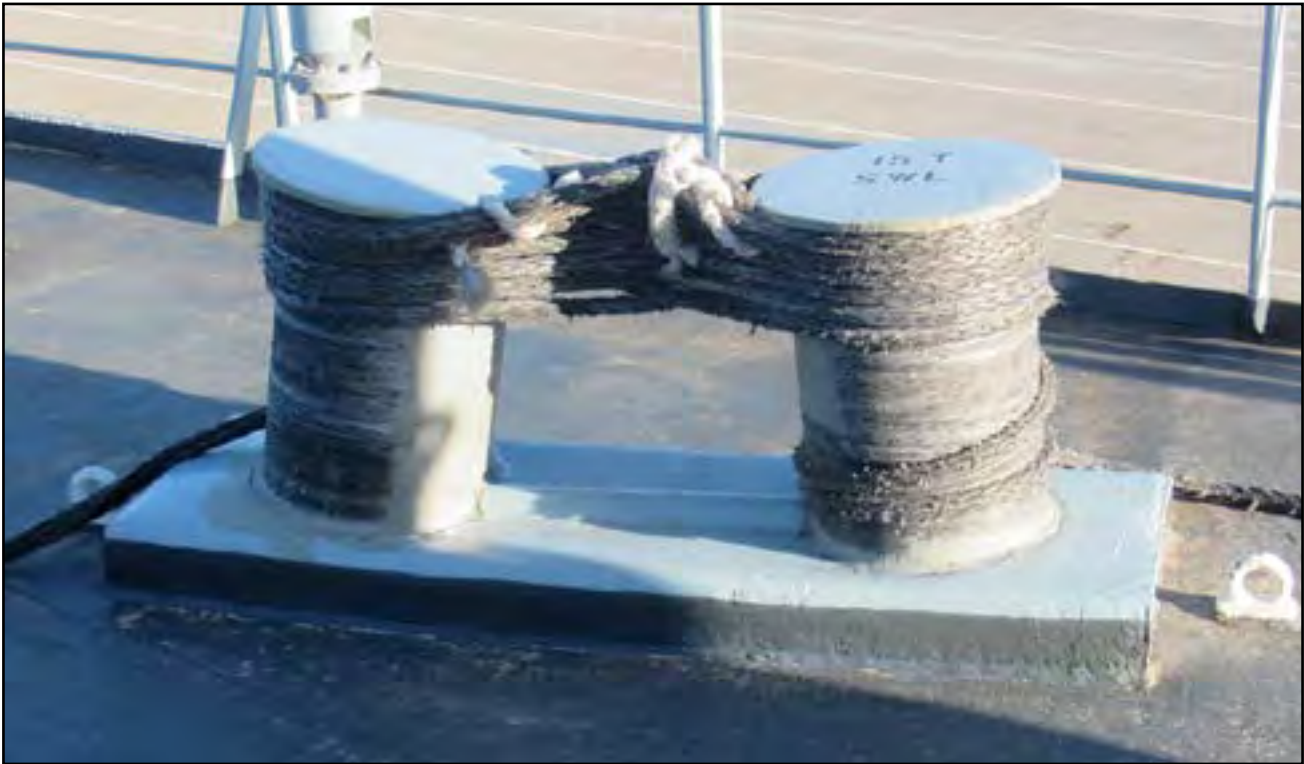
Figure 2: Damage to mooring bitts following surging alongside berth

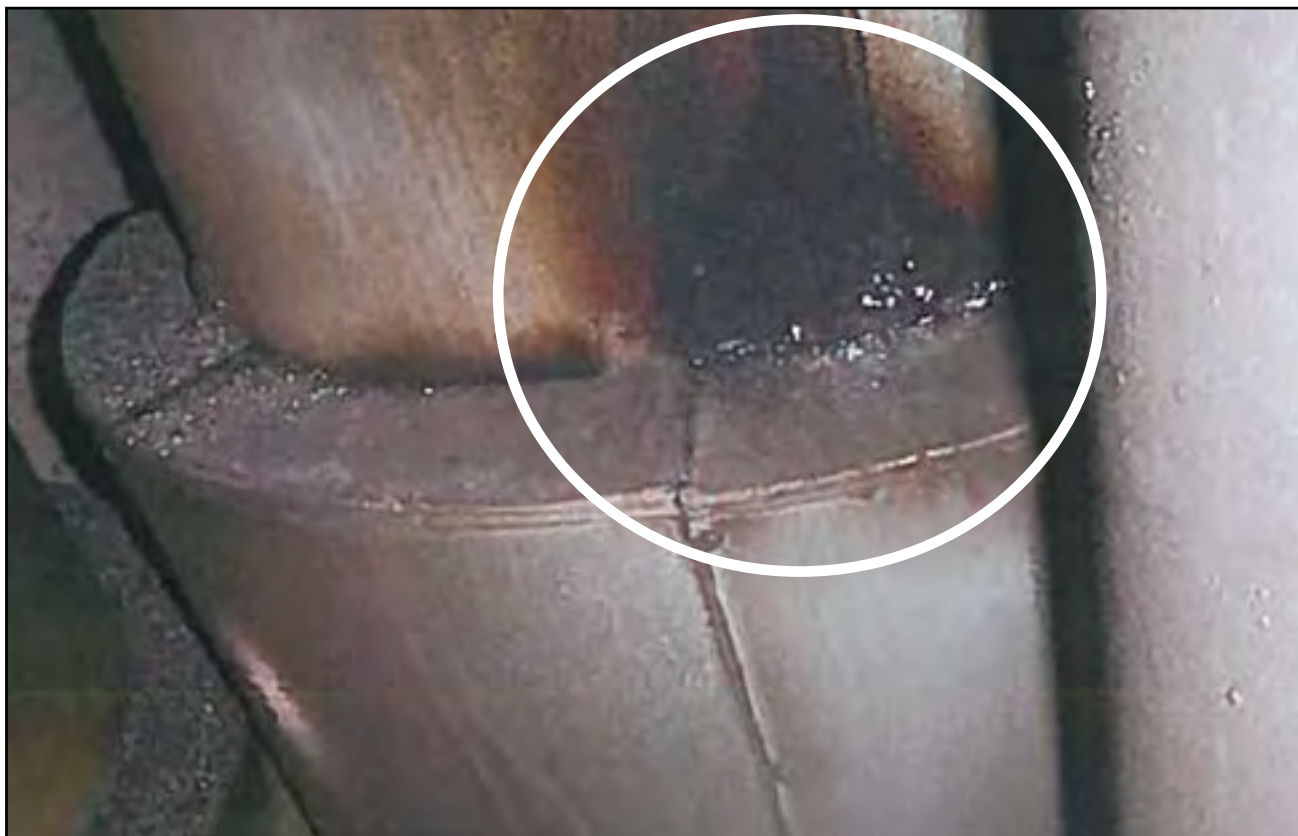
The ship immediately went to emergency stations and diverted to anchor to allow the propulsion system to be shut down. When the ship's teams, wearing fire suits and breathing apparatus, entered the funnel, they found that the source of the smoke was an exhaust gas leak from a loose flange. The sparks had been caused by the hot exhaust gas charring the funnel insulation material (Figure 2).

Figure 2: Damaged area of exhaust lagging

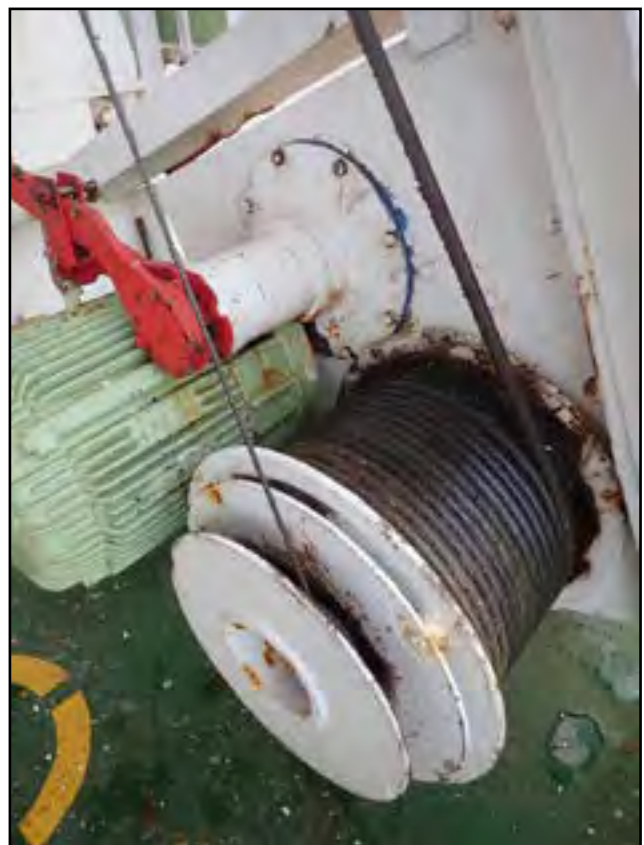
Once the lifeboat was ready, the chief officer gave the order and the bosun started to hoist the lifeboat using the electric motor. Unnoticed by the bosun, the cadet stepped forward to grease the fall wire by letting it run through his hand close to the winch drum (Figure 1) as the boat was being heaved up. Without warning the cadet's hand became stuck to the wire and his fingers became trapped under it as it was being wound onto the drum. Because his hand was so close to the drum, his warning shouts did not give the bosun enough time to stop the hoist motor before his fingers were trapped and traumatically amputated (Figure 2) between the wire and the drum.

Figure 1: Winch drum

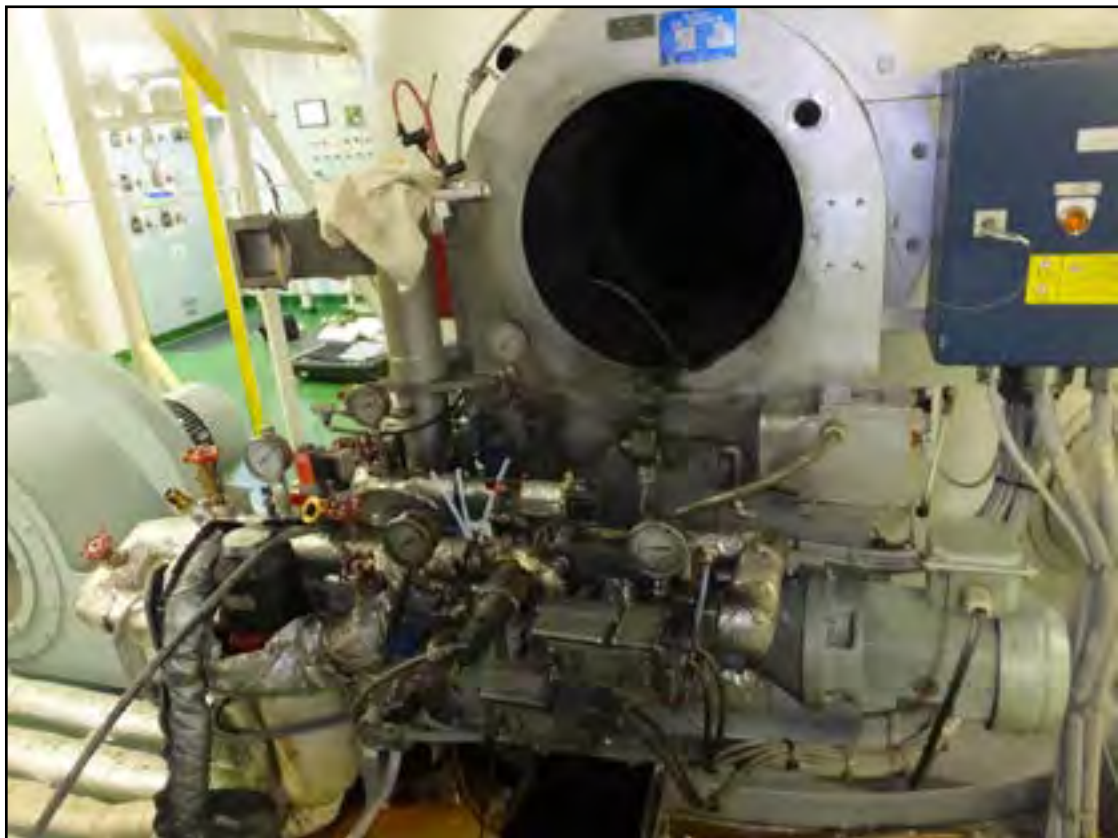
The force of the explosion blew the burner unit off the front of the boiler (Figure 1) and released a fire ball. The motorman was standing directly in front of the burner unit and took the brunt of the explosion. The second engineer was caught in the fire ball, but was able to raise the alarm and attempted to revive the motorman. As the vessel was alongside, shoreside medical teams were quickly on the scene, but they were unable to save the motorman.

Figure 1: The damaged boiler

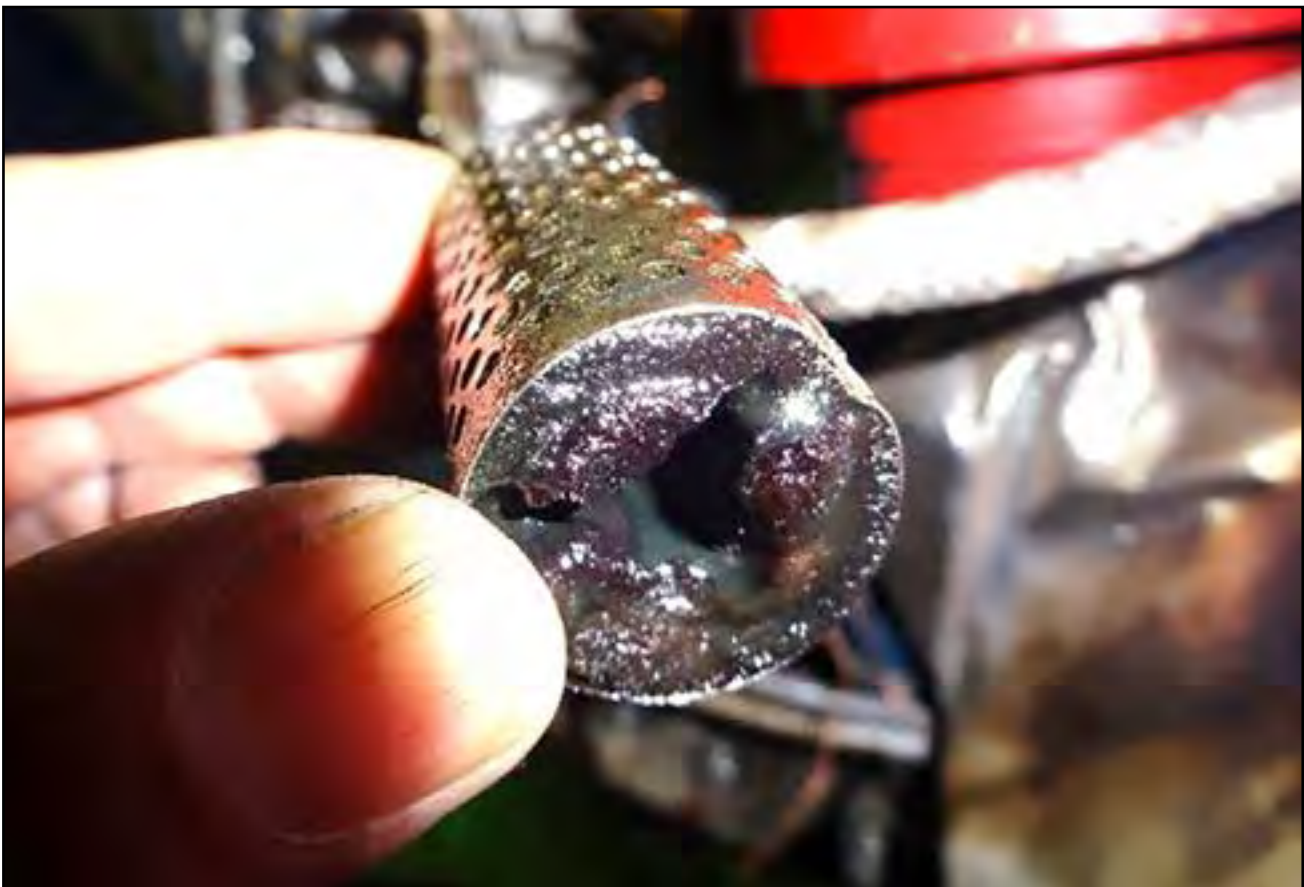
3. Analysis of the low sulphur fuel in use identified it as a summer grade MGO with a Cold Filter Plugging Point (CFPP) temperature of 14°C, indicating that the fuel could become waxy and block filters at 14°C and below. The external ambient air temperature was 4°C, and 9°C in the vicinity of the boiler. Although the fuel had met the international standard test criteria at the time of bunkering, its CFPP was not assessed. Ensuring fuel is suitable for all expected operating conditions in which the vessel may operate is critical to its safe use.

Figure 2: Waxy deposits in fuel line filter

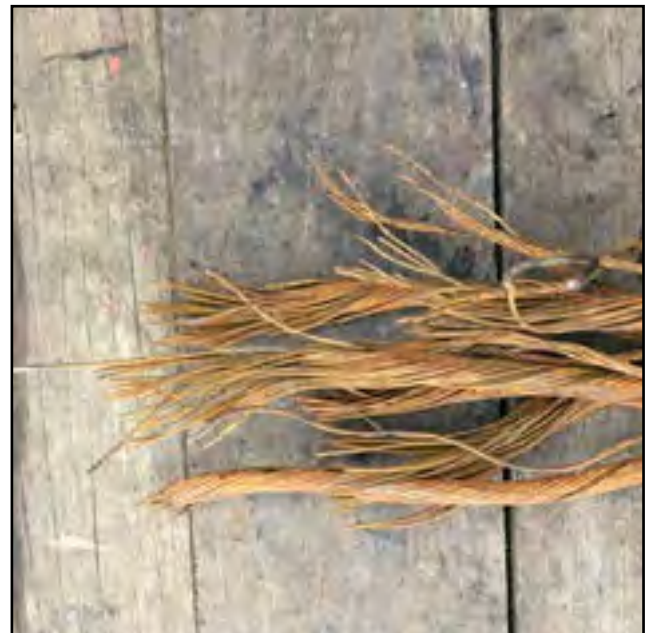
Figure 1: The broken towing wire

1. The towing wire failed as the tug's anchor was being heaved. The tow line failed in the vicinity of the hard socket on the eye of the towing wire. Subsequent destructive testing of the towing wire showed that it parted at a significantly lower load than expected. The towing wire had a certified minimum breaking load of 102.95t; during testing it began to fail at 64t and parted at 87.74t.
2. An inspection of the towing wire identified that the wire was rusty, and flat spots and areas of wear were identified. However, the towing wire was 7 years old and had been inspected regularly by the ship's master as required by the company safety management system. No defects or damage had been recorded.

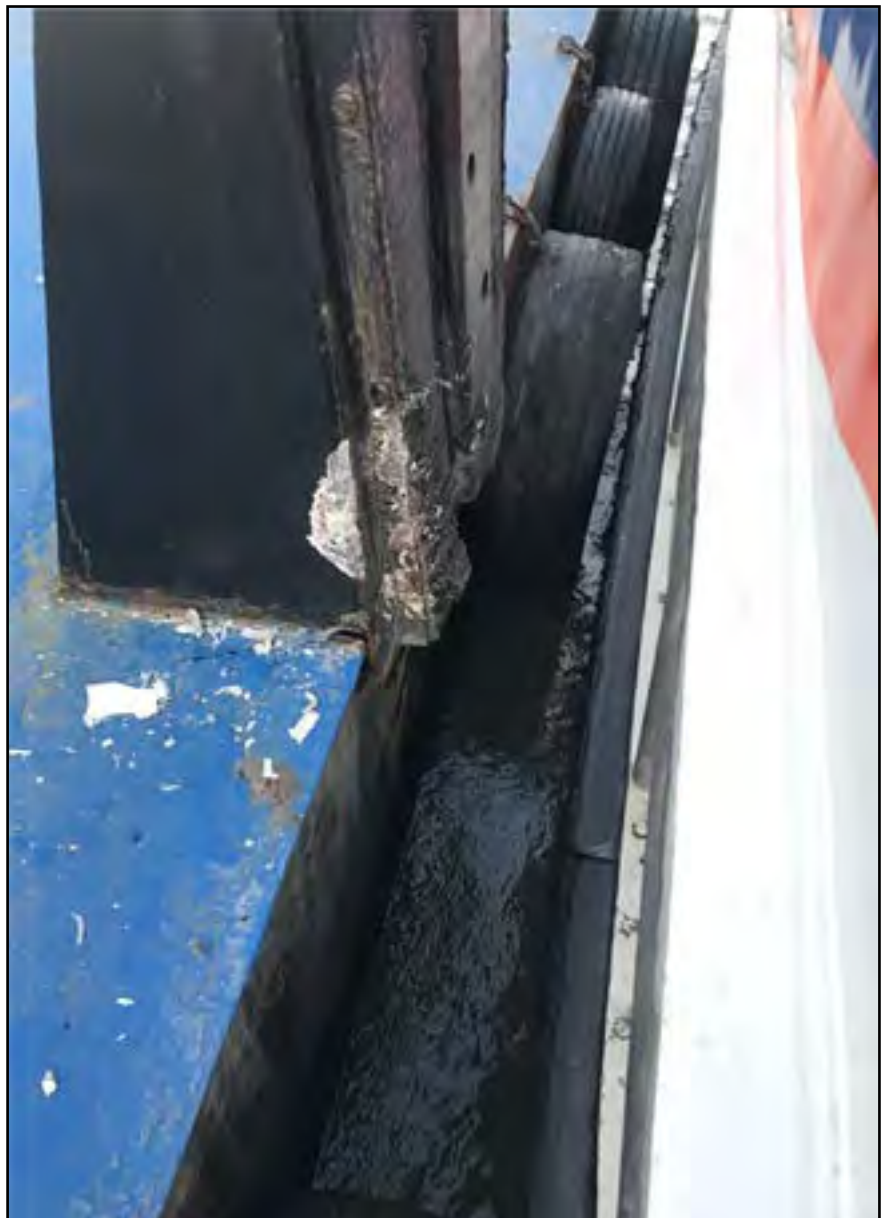
The ferry struck the pontoon (Figure 1). Most of the passengers and crew were seated at the time of the impact, but those who were standing were thrown forward, with two passengers and two crew suffering minor injuries. Damage to the ferry's port bow above the waterline (Figure 2) required it to be taken out of service for repair.

Figure 1: Damage to pontoon

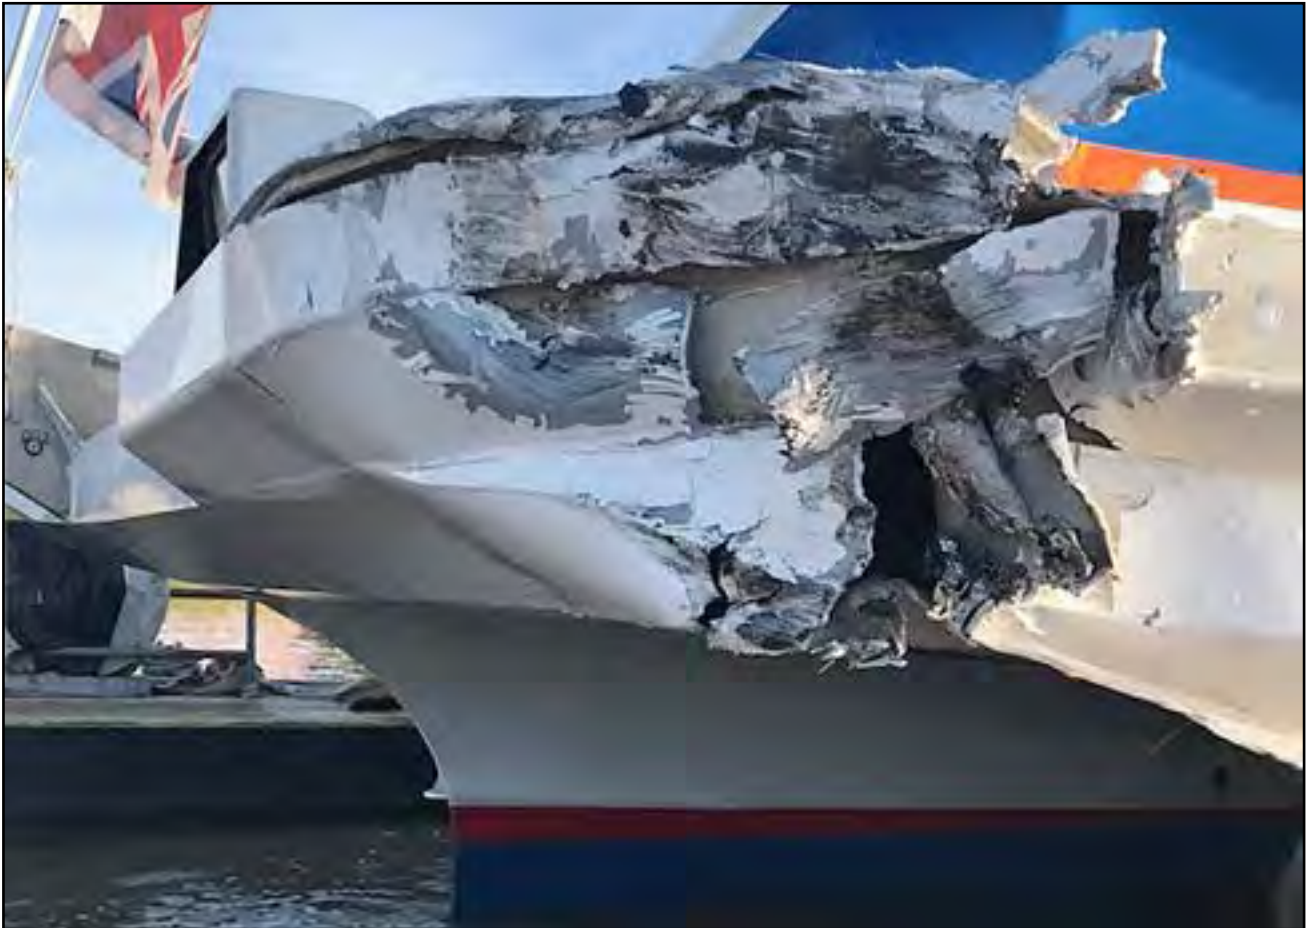
Figure 2: Damage to bow of ferry

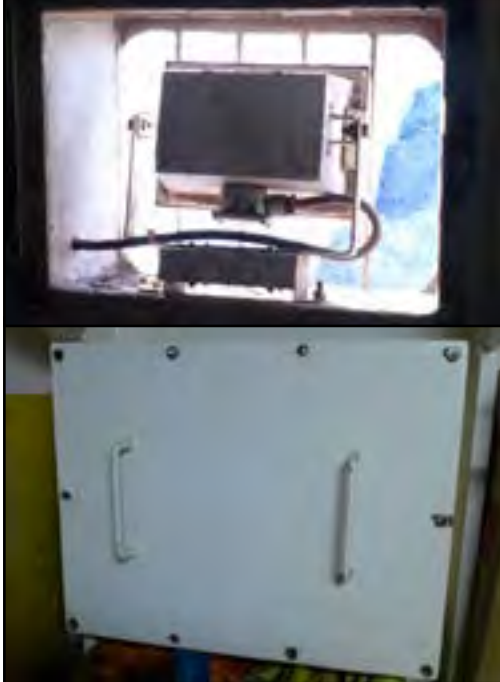
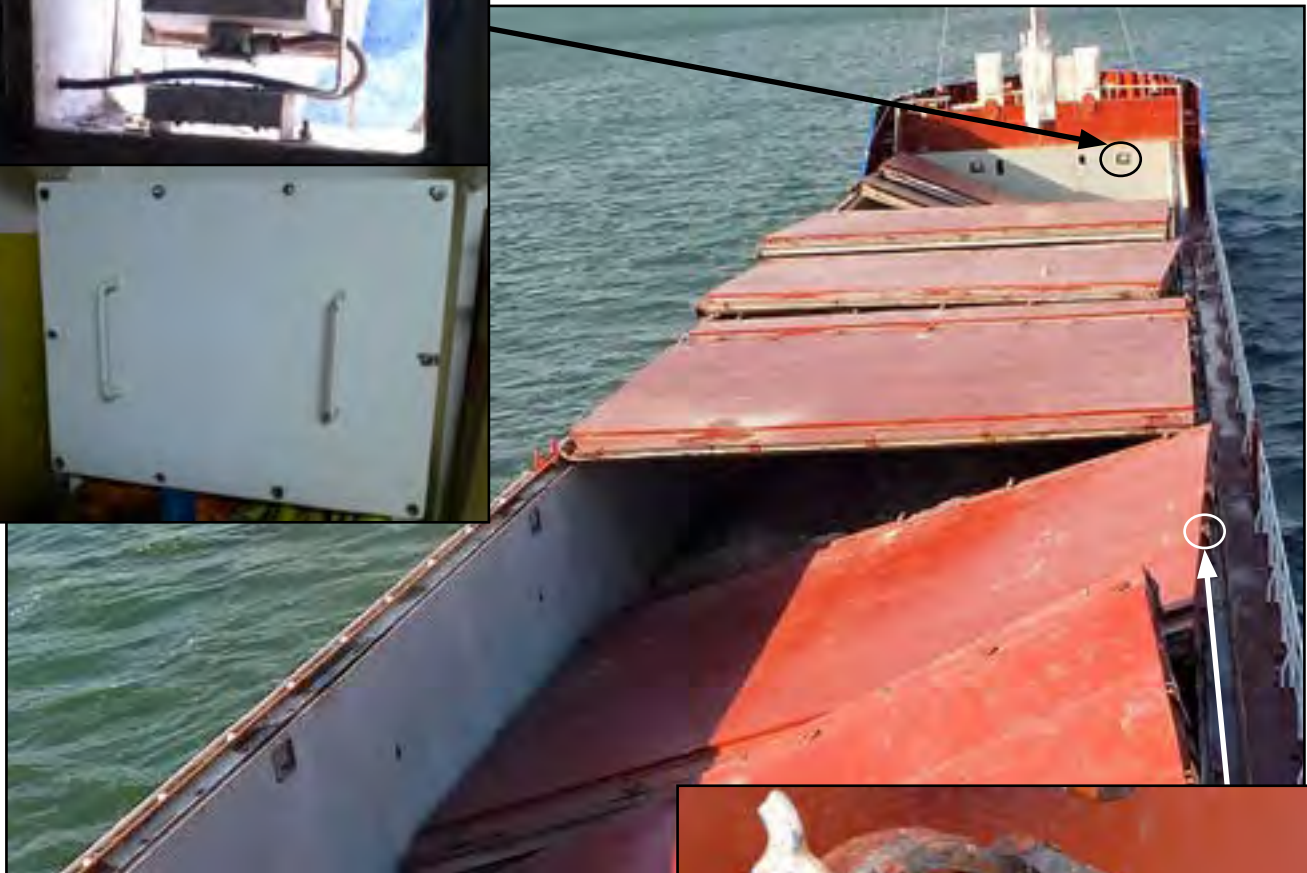
Cargo lamp access plate (removed and closed)

Figure 3: Damage caused by the explosion and the location of the cargo lamp access plate

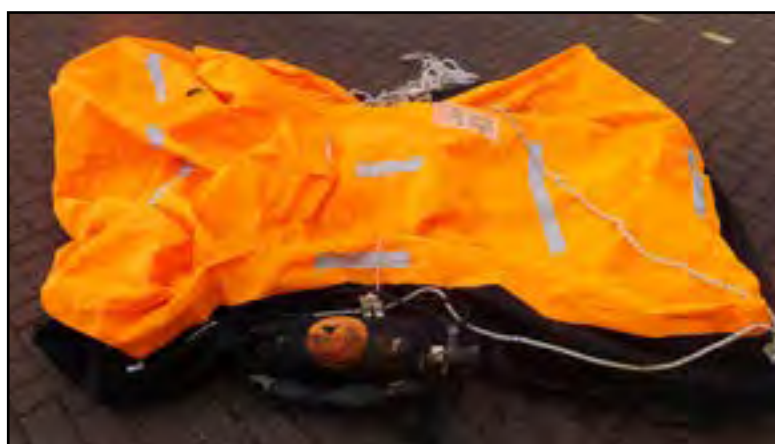
A fishing vessel skipper decided to anchor overnight as the crew were exhausted after several long days of fishing. The skipper anchored the boat in a sheltered bay close to a beach. Once at anchor, the crew hosed down the working deck and ate a meal before going to bed. In the early hours of the morning, all four fishermen were woken as the boat was sinking rapidly by the bow.

Figure: The uninflated liferaft

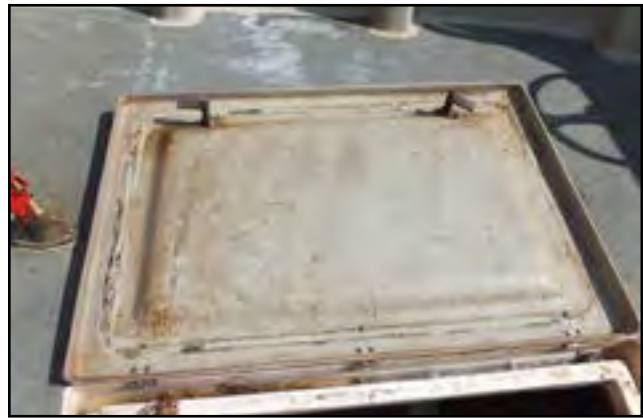
When the boat was recovered and beached a few days later, the deck hatch seals were found to be either missing or damaged (Figures 2 and 3). It is almost certain that while the deck had been awash, water had seeped down into compartments below and, although automatic bilge pumps were fitted in these, they failed to operate.

Figure 2: Missing hatch seal

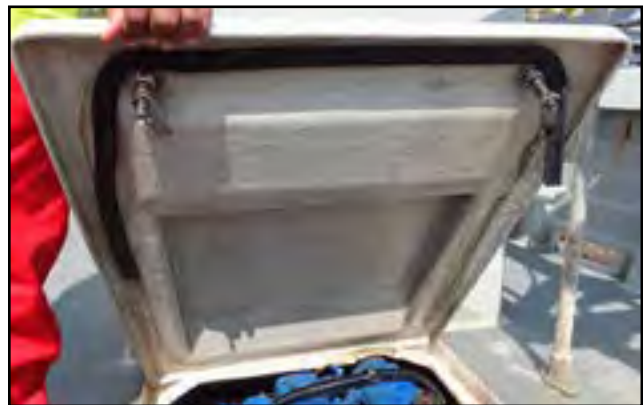
Figure 3: Damaged hatch seal

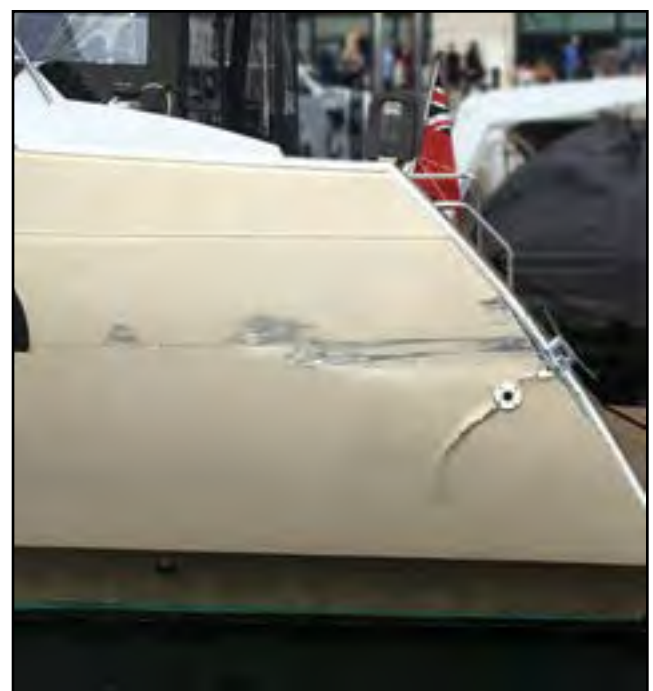
The skipper made a "Pan Pan" emergency radio call and checked that all the guests were safe. Soon afterwards, a harbour patrol boat and the inshore lifeboat were on hand to help the catamaran safely alongside. There were no injuries but the catamaran was damaged by the collision (Figure 2).

Figure 2: Collision damage to the catamaran's port quarter

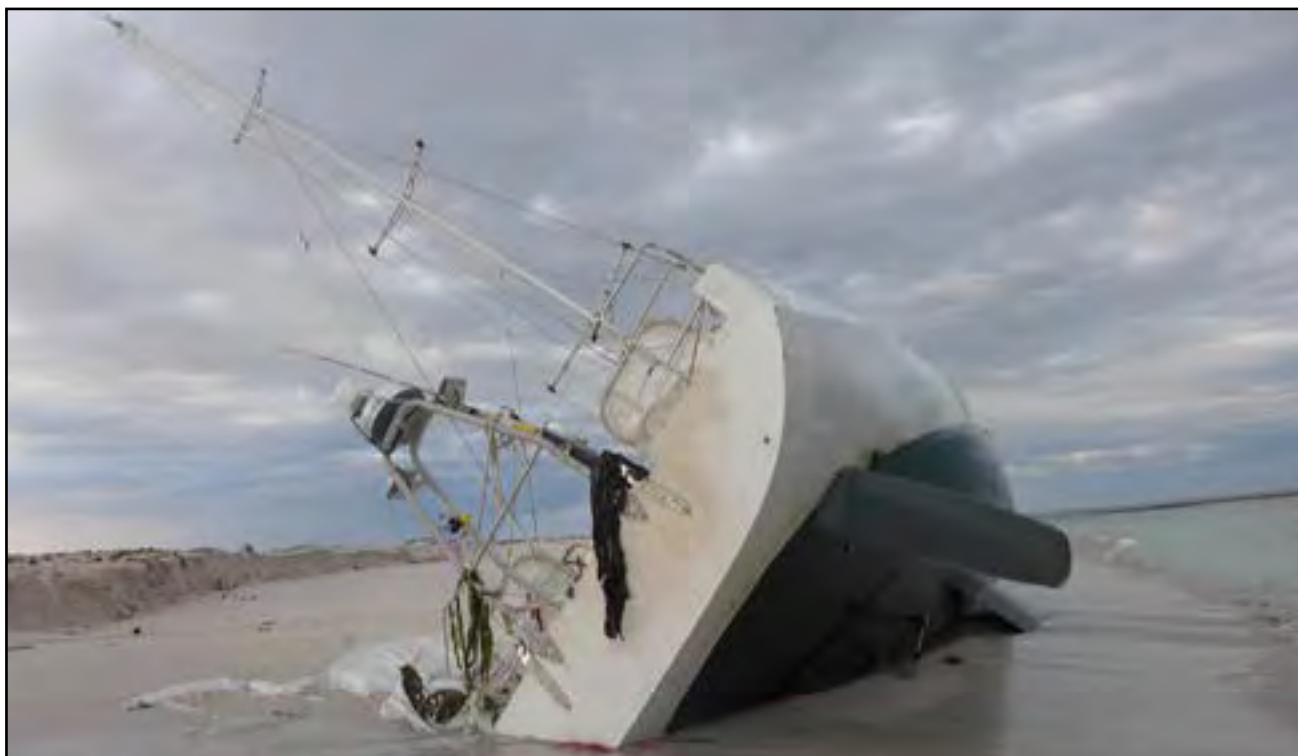
The skipper had been monitoring the situation and realised that the yacht needed to be turned away from danger. However, soon after this turn was made, the yacht grounded and could not be freed. There was a delay of nearly an hour in alerting the coastguard; however, once they had been alerted, all the yacht's crew were rescued into lifeboats. The yacht could not be salvaged and was cut up on the beach where it had grounded (Figure 2).

Figure 2: The stranded yacht on the beach
