MARINE ACCIDENT  
INVESTIGATION BRANCH

# **SAFETY DIGEST**

**Lessons from Marine  
Accident Reports  
1/2019**

April 2019

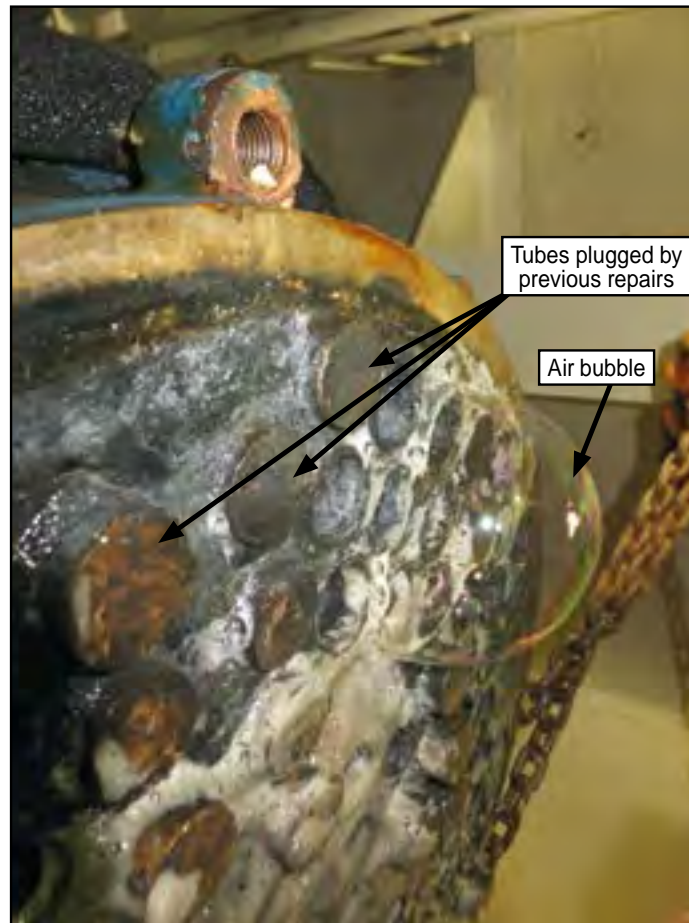
**Figure 3:** Starboard evaporator tube leak
