**IN-DEPTH SURVEY REPORT OF CARBON MONOXIDE EMISSIONS
AND EXPOSURES ON EXPRESS CRUISERS UNDER VARIOUS
OPERATING CONDITIONS**

January 2006

EPHB 289-11a

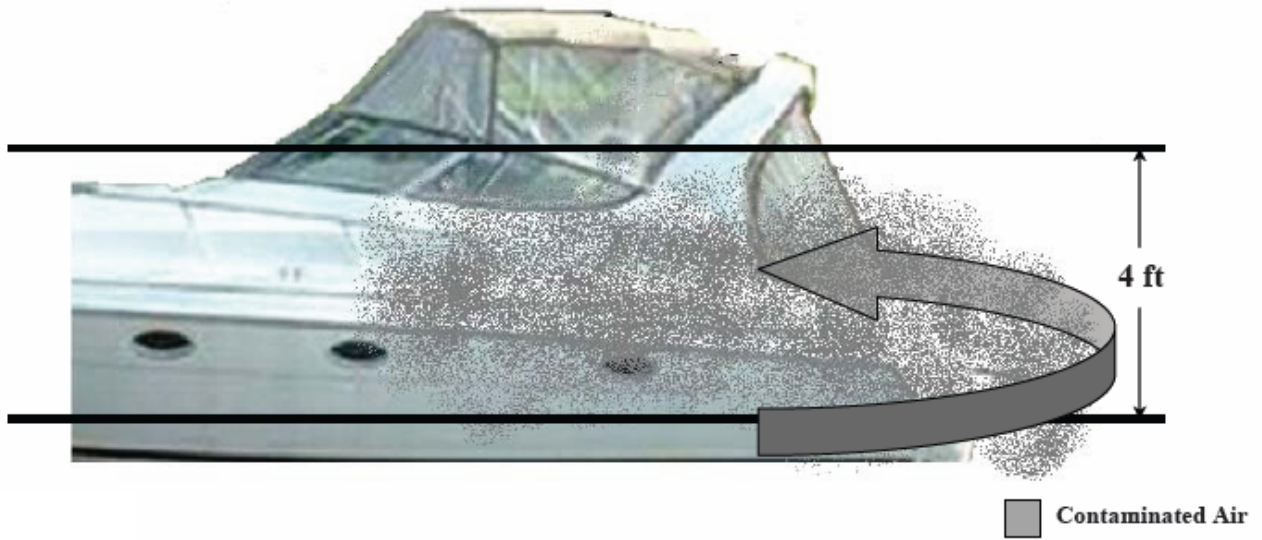
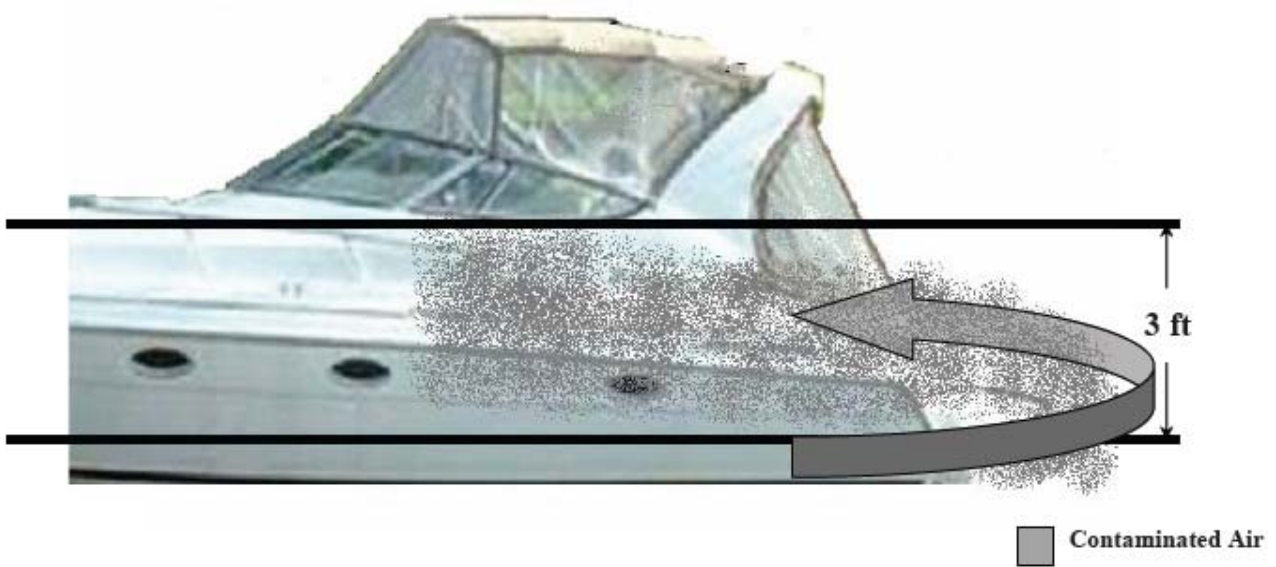
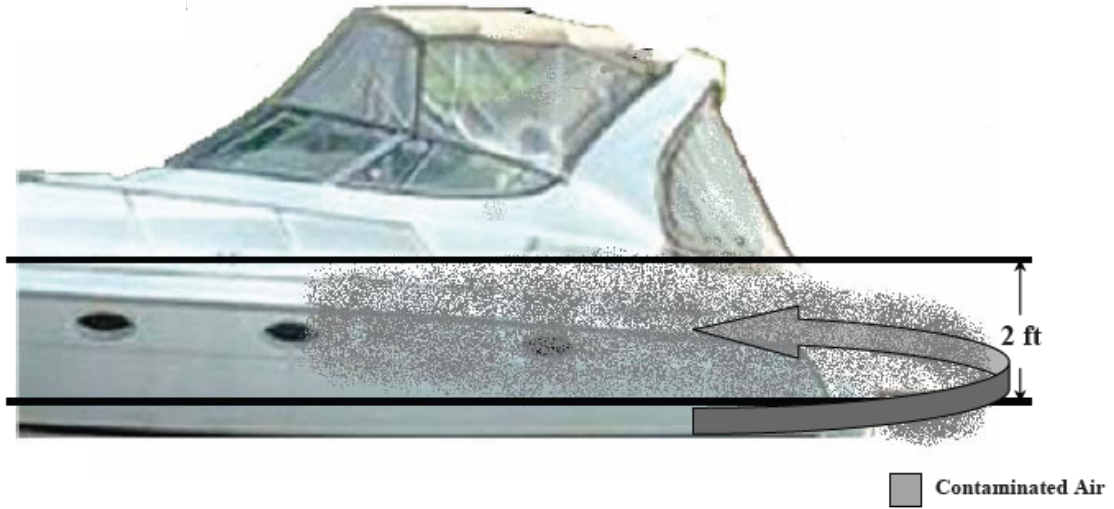
When underway, smoke tests revealed several trends on all the evaluated boats. When traveling at 5 – 10 mph with the canvas fully installed, the recirculation patterns were observed to be as high as 4ft measured from the cockpit floor. When traveling at 15 mph with canvas fully installed, this height was reduced to 3 ft from the cockpit floor. Finally when traveling at 25 mph the recirculation pattern was observed to be shifted to two feet measured from the cockpit floor. Figures 2, 3 and 4 provide an illustration of this scenario.

- CO concentrations are typically higher at the stern of the boat and become gradually lower toward the front of the boat.
- Recirculation patterns varied with the boat speed. At lower speeds the recirculation was observed to be as high as 4 ft measured from cockpit floor. This height was reduced to 2 ft when going at 25 mph.

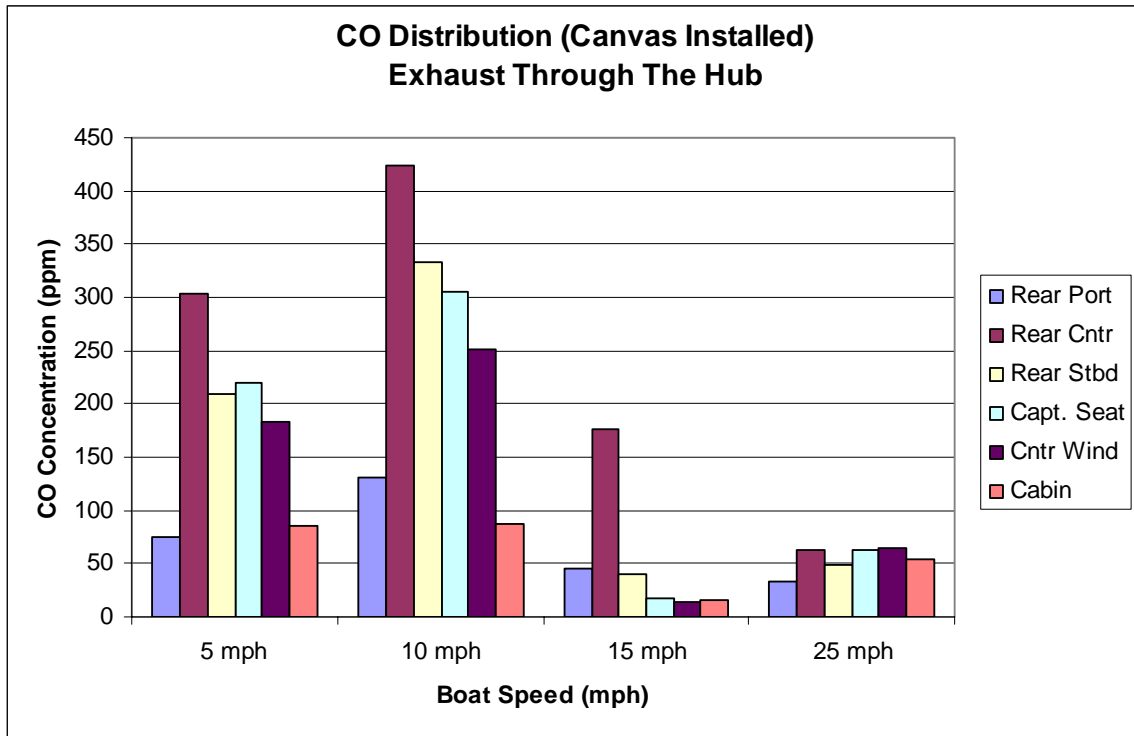
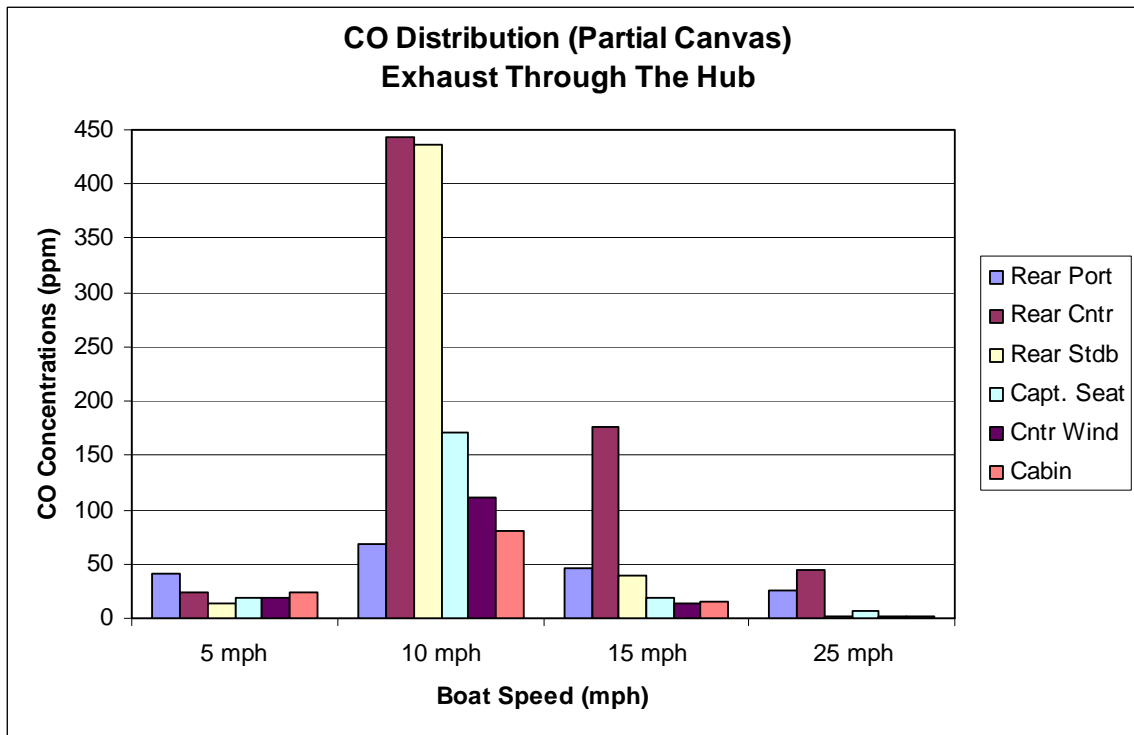
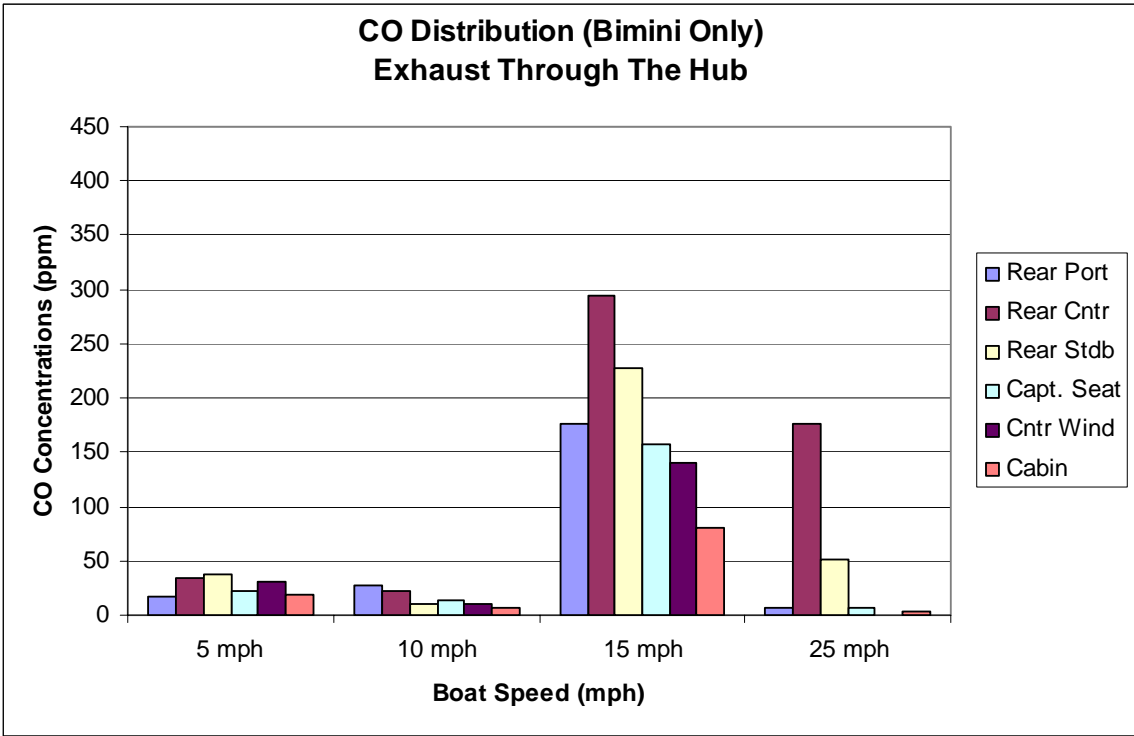
Figure 5: Boat 1 (33') Twin Volvo Penta 5.7L Exhausting Through the Hub.

This boat exhibited CO levels exceeding 1000 ppm near the center of the stern for 10 and 15 mph into the wind and with the wind (with canvas fully installed). Fairly high concentrations were observed in the engine compartment when no canvas was installed (Bimini top only) at speeds of 15 and 25 mph. Potential CO leakage from the engine compartment was possible since the boat's drive engines and generator set were brand new.

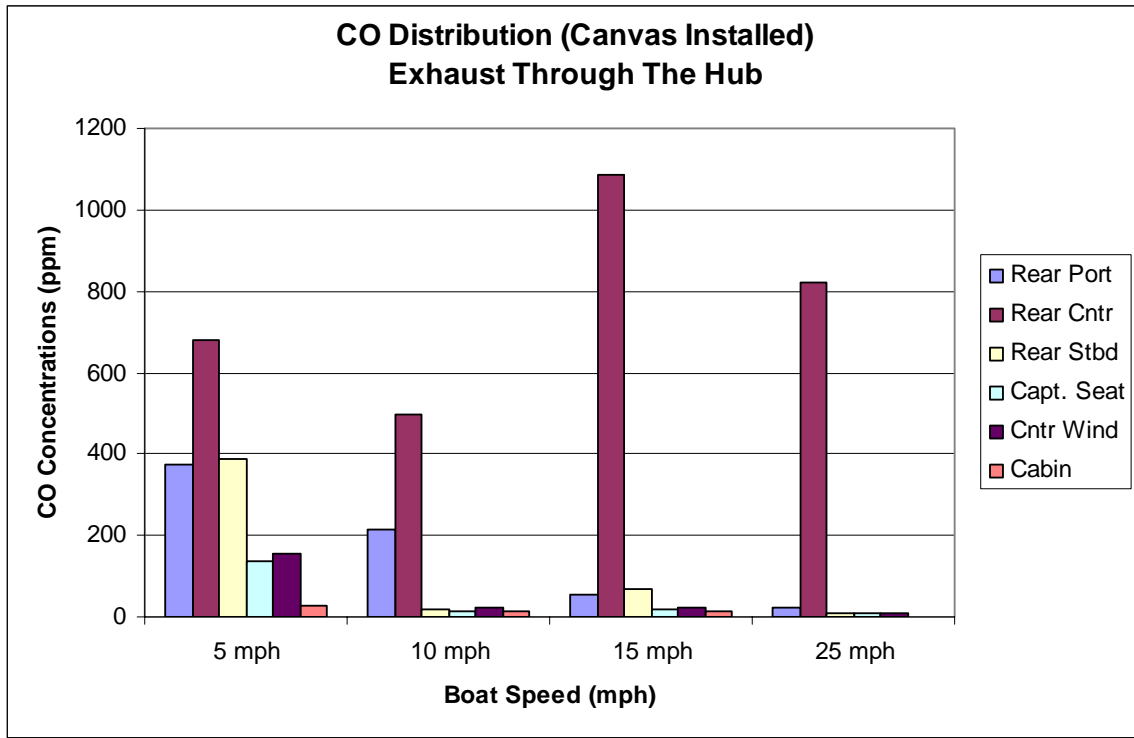
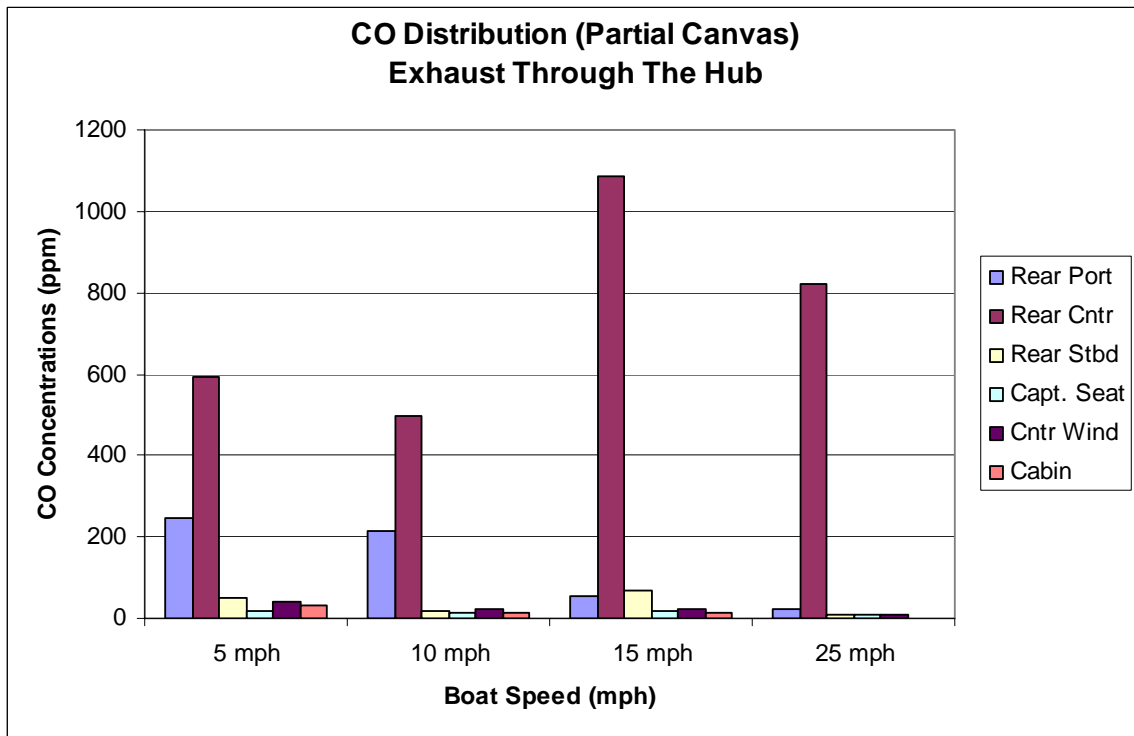
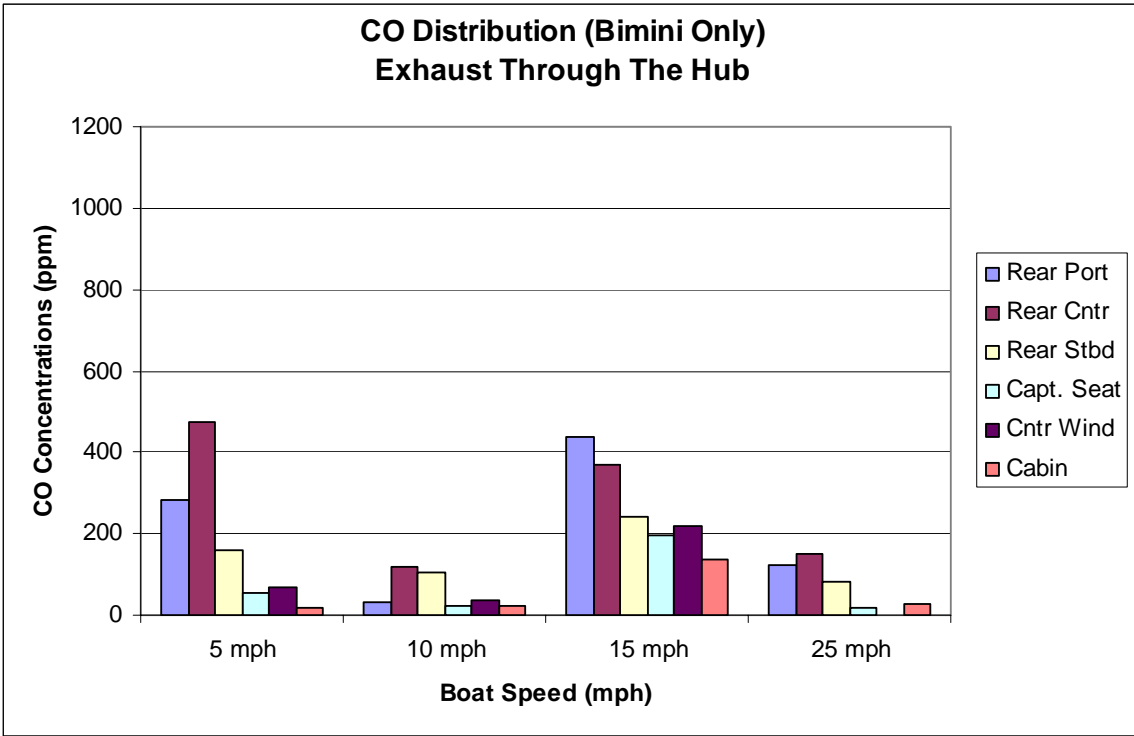
Figure 6: Boat 2 (30') Twin Mercruiser 5.0L Exhausting Through the Hub.

This boat exhibited CO concentrations that not only exceeded 1000 ppm but also approached the 1200 ppm NIOSH IDLH limit on the center of the stern, with and without canvas. The engine compartment on this vessel experienced CO concentrations approaching the NIOSH IDLH when canvas was installed and close to 1000 ppm when canvas was fully removed (bimini top only). The cockpit of this unit was usually cleared by fresh air, with the exception of 15 mph and no canvas installed. This fact can be attributed to weather conditions since no wind was present during that particular experiment. Cabin concentrations ranged from 0 to 180 ppm. Several attendees entered the cabin on different occasions allowing contaminated air to migrate from the cockpit to the cabin.

Exhibiting a trend seen on other tested boats, CO concentrations were higher on the stern of the vessel (near source), and tended to decrease toward the front of the vessel. The engine compartment consistently exhibited CO concentrations above 150 ppm, with a couple peaks at 1100 ppm; this might be indicative of a problem with the powered ventilation of this compartment. More details about this particular boat can be found in Tables 6 and 7 and the graphs in Figure 6.

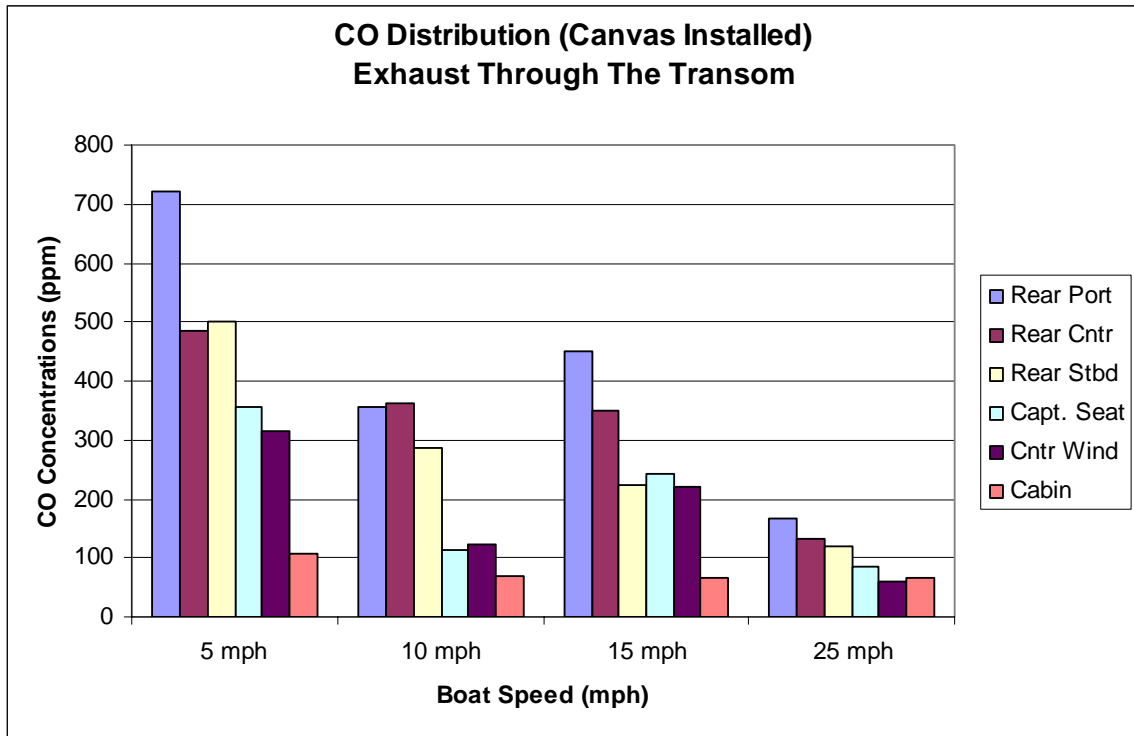
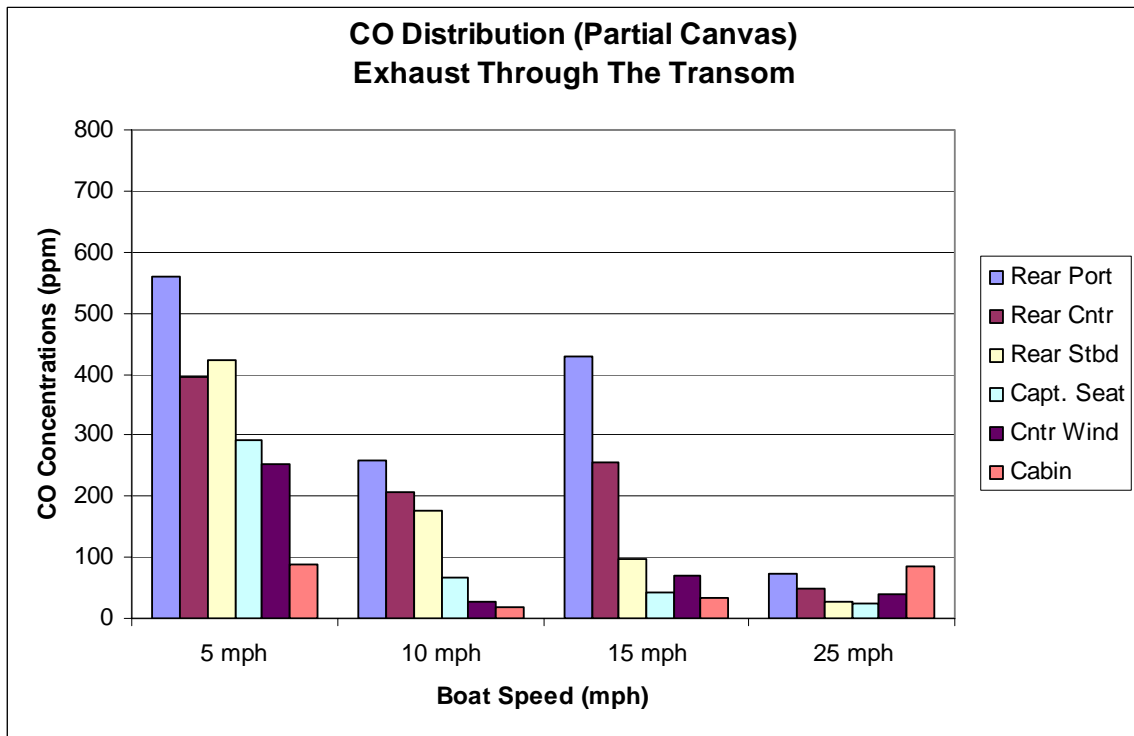
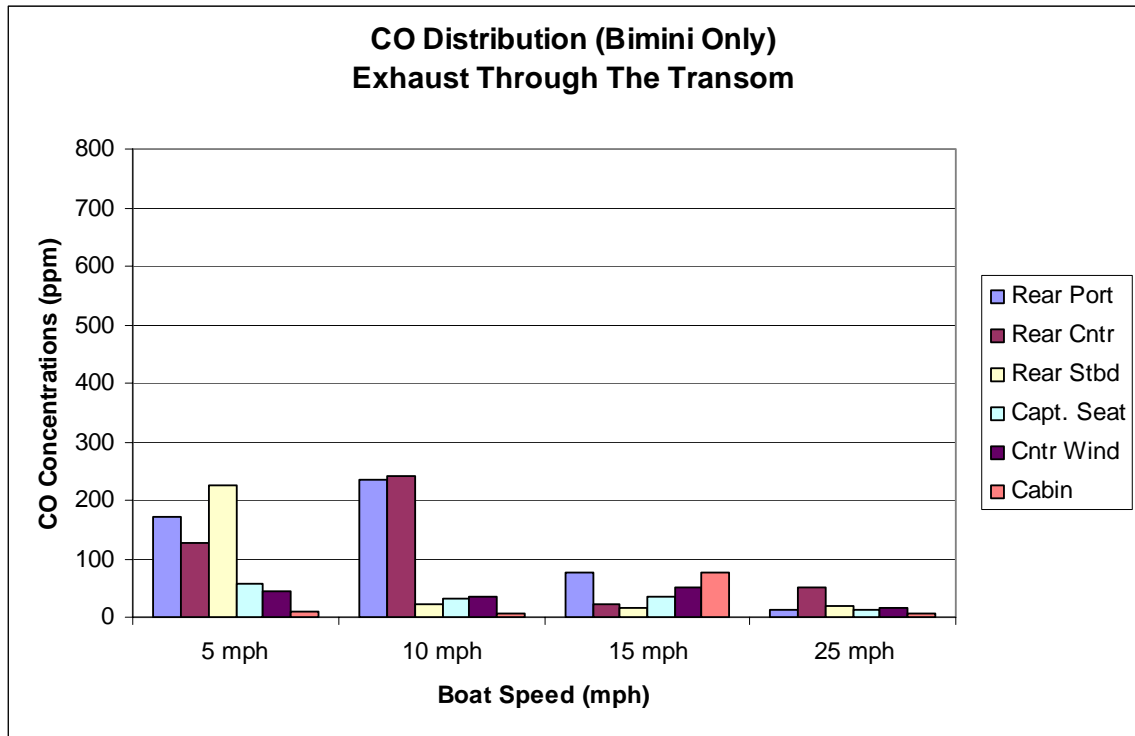
Figure 8: Boat 4 (37') Twin Mercruiser 8.1L Exhausting Through the Transom.

Measured CO concentrations were substantially higher in boats exhausting above waterline. That is the case for boat depicted in Figure 8, equipped with Twin Mercruisers exhausting through four openings at the transom of the vessel above waterline. The highest mean concentration was 975 ppm (close to the NIOSH IDLH) on the swim platform of the vessel when going underway at 5 mph with canvas fully installed. CO concentrations in the cockpit of this unit were as high as 630 ppm behind the captain seat when canvas was fully installed and going at 5 mph. These results can be observed on Table 9.

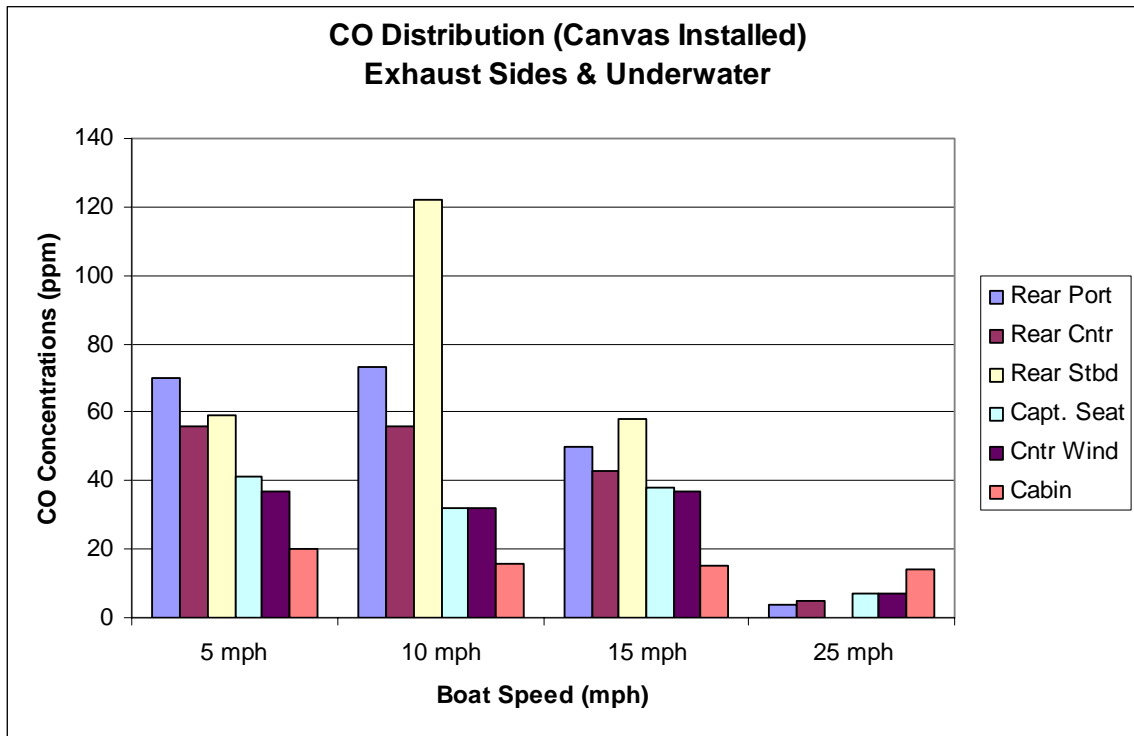
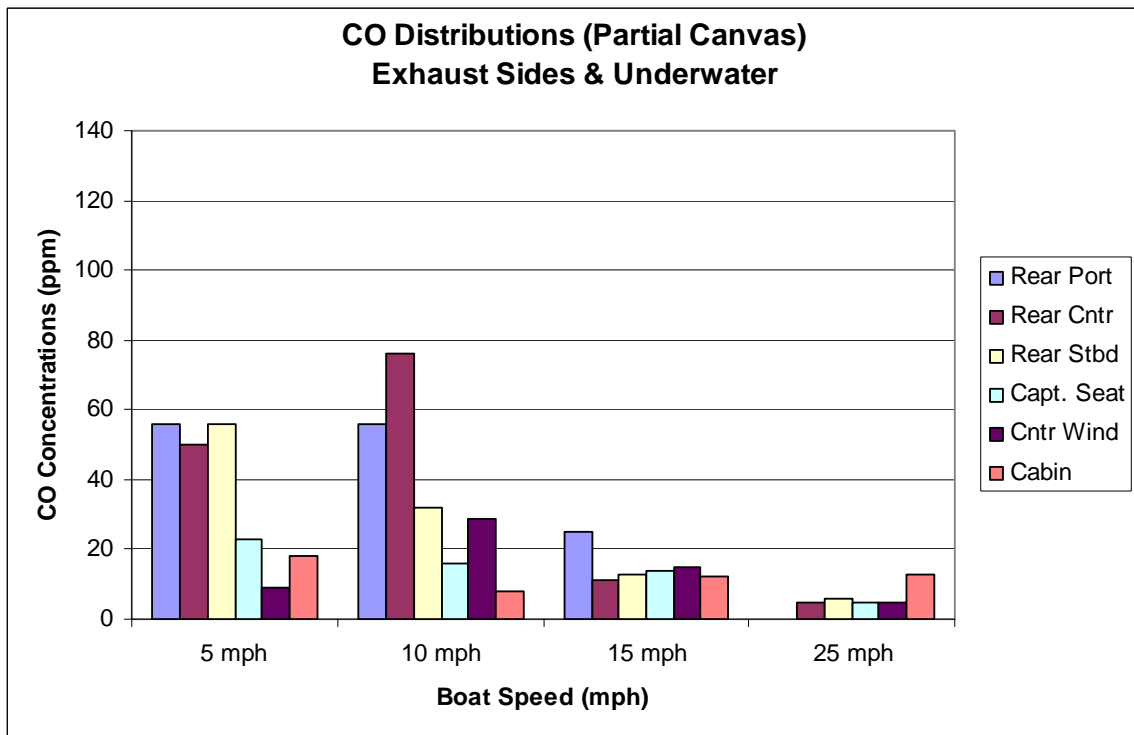
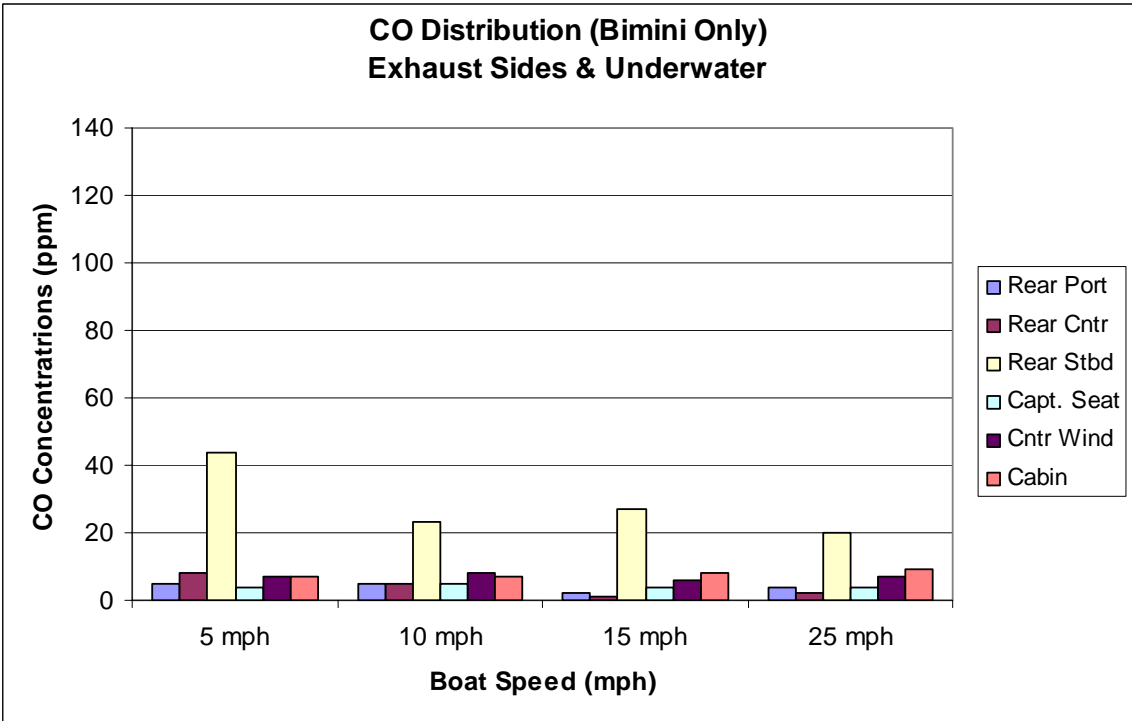
Figure 9: Boat 5 (36') Twin Mercruiser 8.1L Combined Exhaust Through the Sides and Underwater.

In terms of onboard CO concentrations, this boat performed remarkably better than other evaluated boats. The main reason for this is that the vessel was equipped with a combined exhaust configuration - the exhaust was directed not only through the sides of the vessel but also underneath the hull of the boat under certain conditions. As long as the engine was idling or the rpm had not exceeded 1500 rpm, the exhaust was directed through the sides of the vessel only. However when the engine built enough pressure on the exhaust to overcome the pressure below the hull, 85% of the exhaust was directed underwater and the remaining 15% exhausted through the sides of the vessel.

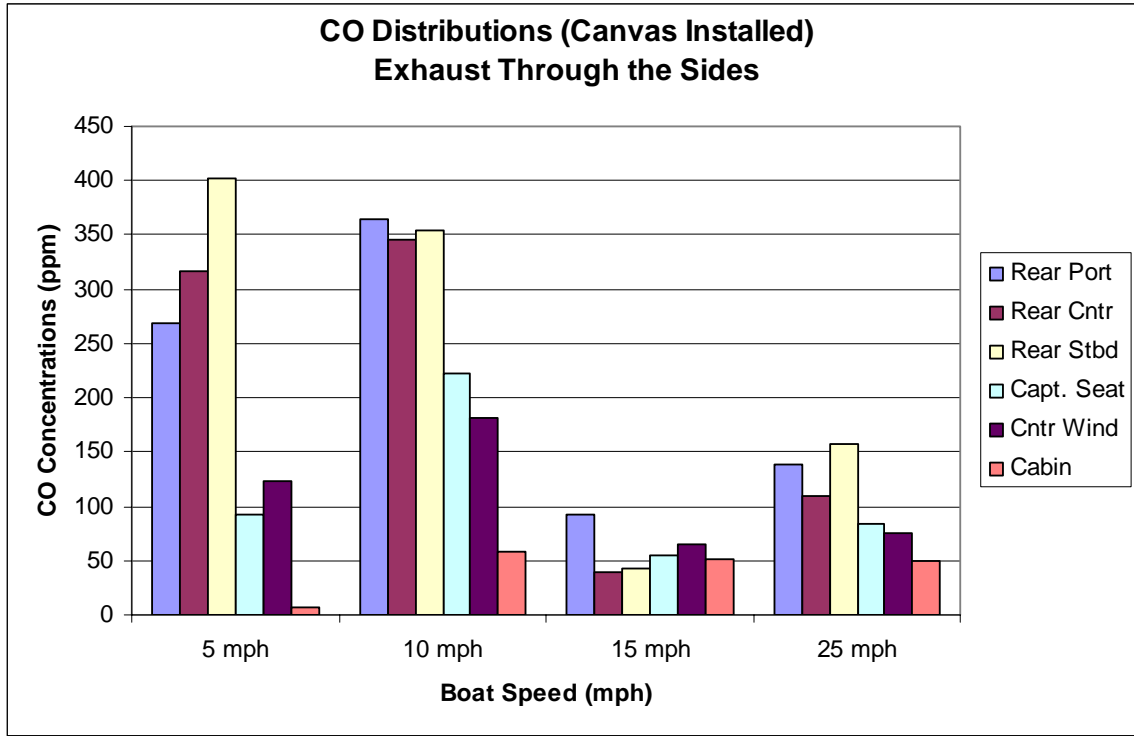
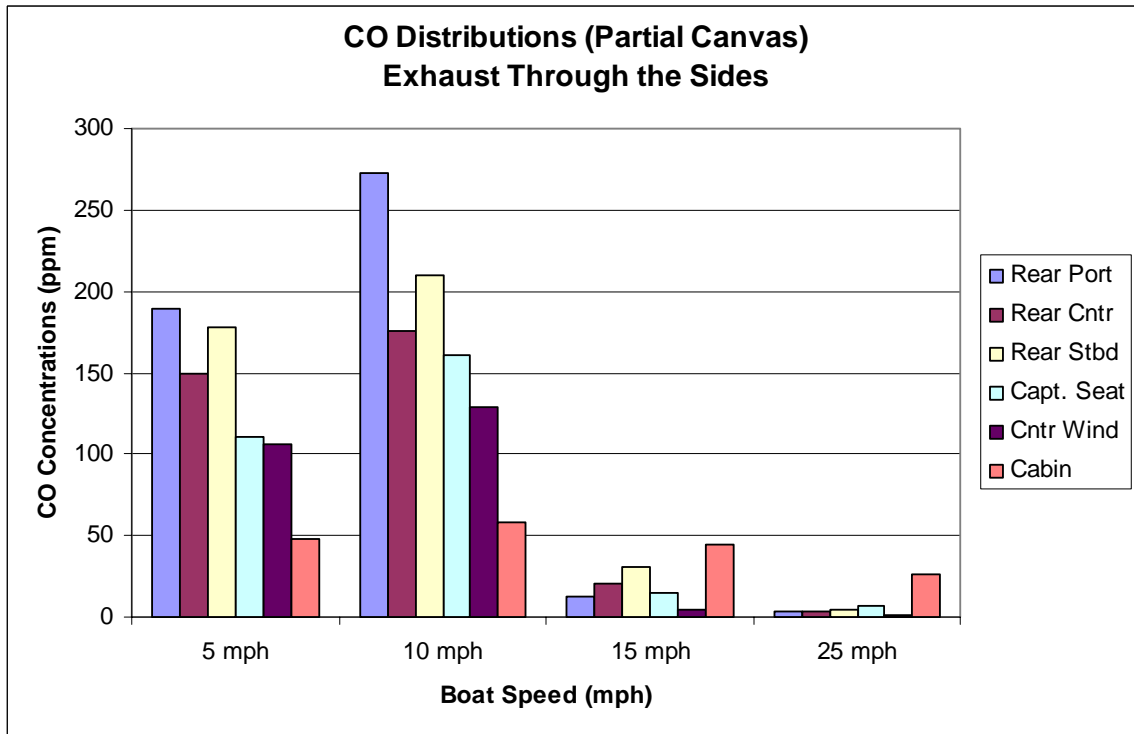
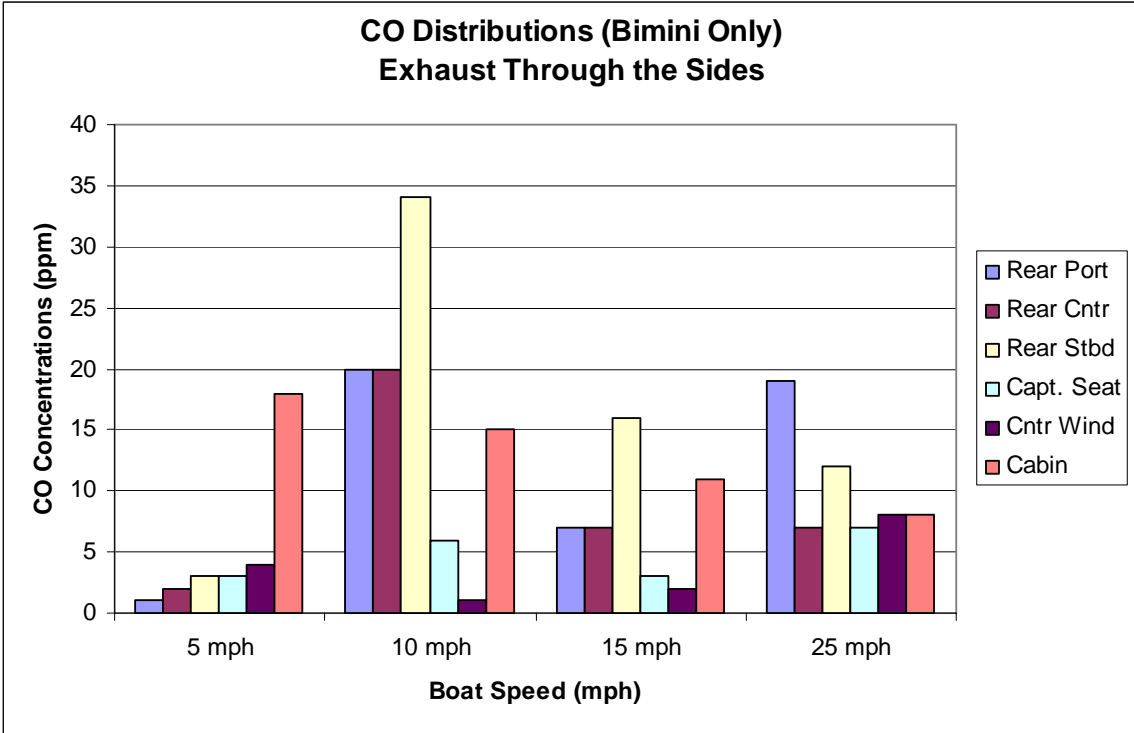
Figure 12: Boat 8 (34') Twin Mercruiser 8.1L Exhaust Through the Sides.

The data presented in Table 13 from experiment 14 to 29 shows the peak CO concentration for a 34' exhausting solely through the sides. Figure 12 depicts the different conditions with canvas, partial canvas and bimini top only. In this figure, it can be observed that CO concentrations were reduced by a factor of 10 when no canvas was installed (bimini top only) compared to full canvas conditions.

CO concentrations near the stern of this particular vessel were much higher with the canvas fully installed than without it. When all curtains were installed, peak concentrations of 500 ppm were observed for extended periods of time at speeds of 10 mph. When the canvas was fully removed (bimini top only), peak concentrations ranged from 70 to 80 ppm at 25 mph.

In the engine compartment, peak concentrations up to 143 ppm were displayed with the canvas installed, compared to 31 ppm without the canvas. CO concentrations inside the cockpit were reduced by a magnitude of 10 when the canvas was fully removed for all experiments (350 ppm vs. 7 – 35 ppm). More details about this particular boat can be found in Tables 12 and 13 and the graphs in Figure 12.
