**High Ethanol Fuel Endurance:
A Study of the Effects of
Running Gasoline with 15%
Ethanol Concentration in
Current Production Outboard
Four-Stroke Engines and
Conventional Two-Stroke
Outboard Marine Engines**

David Hilbert
Mercury Marine
Fond du Lac, Wisconsin

Subcontract Report
NREL/SR-5400-52909
October 2011

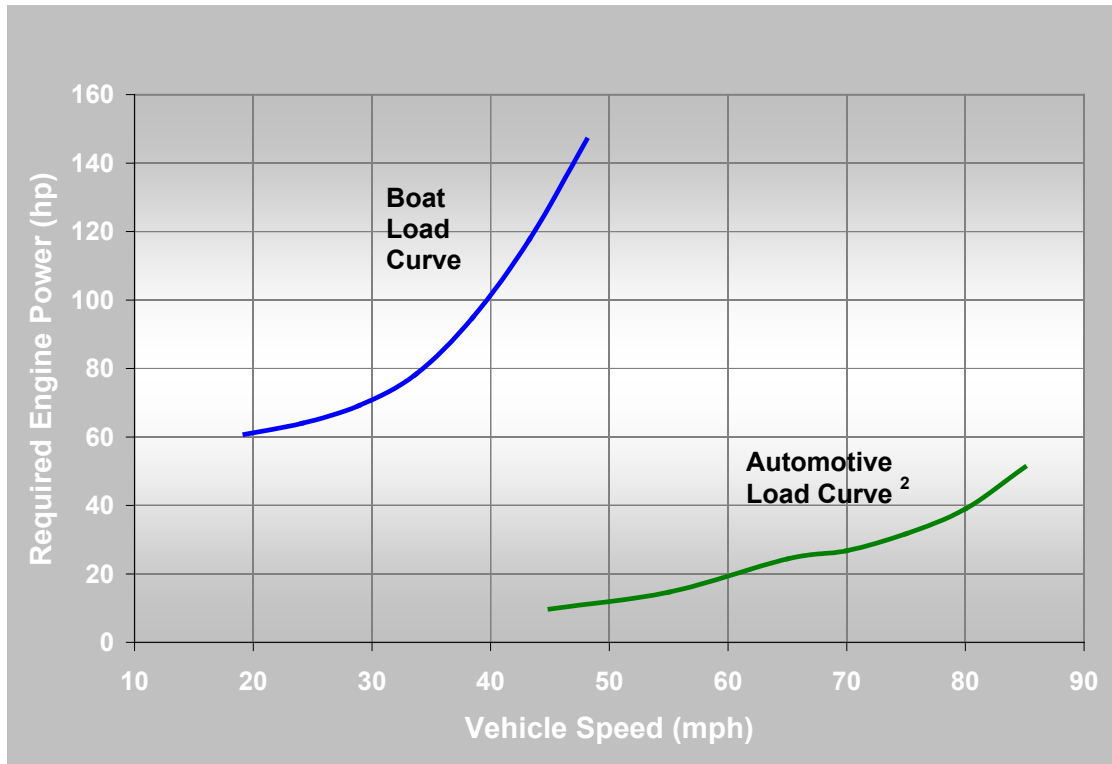
Figure 2: Example Load Curve Comparison (Automotive data – source 2, boat load data – internal Mercury source)

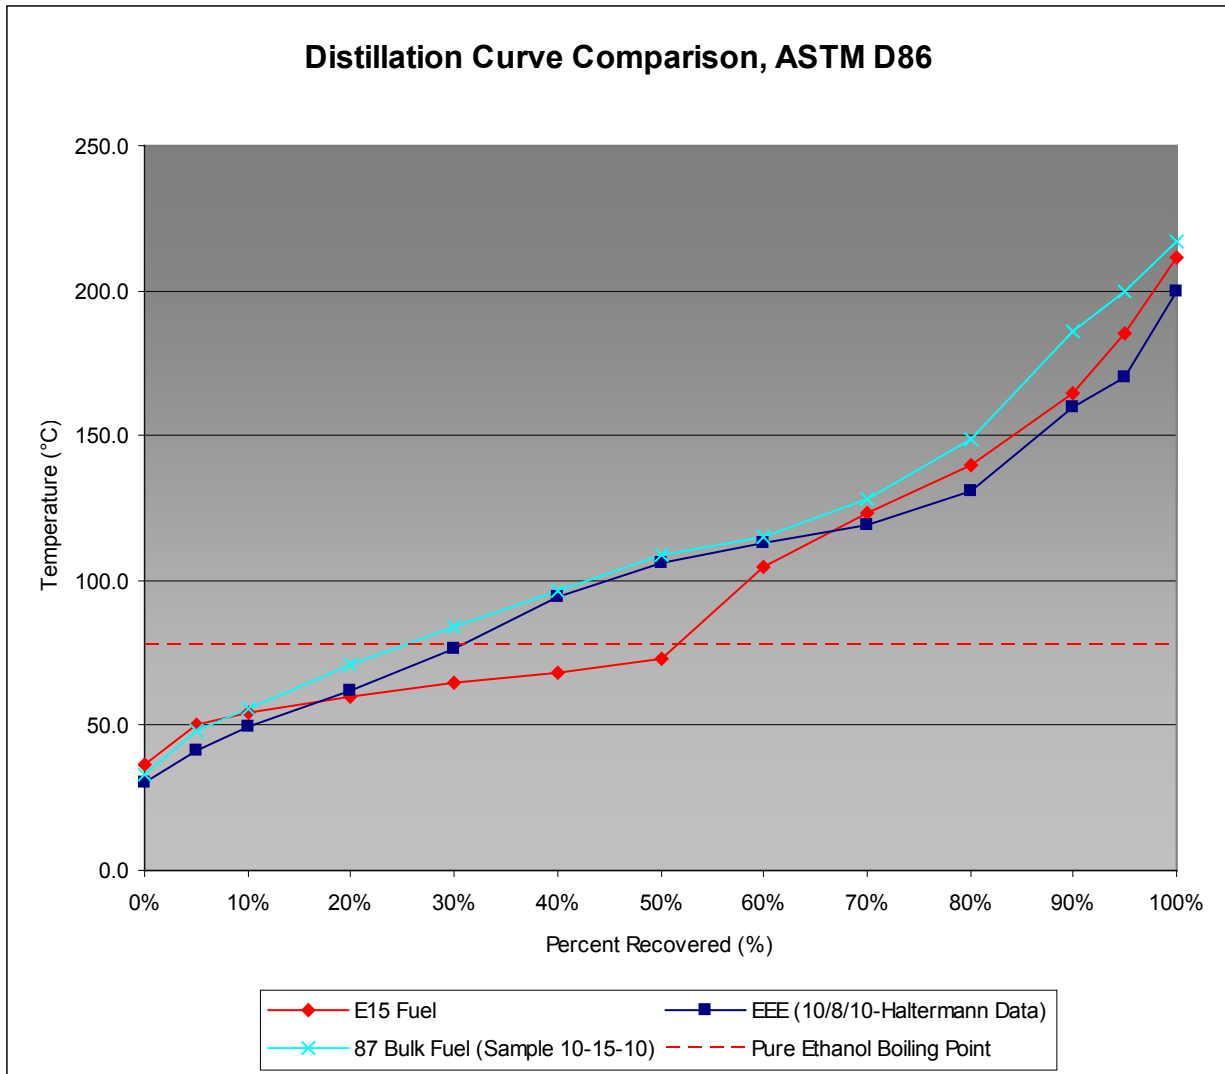
Figure 3: Distillation Curves of Test Fuels

The distillation curves for the various test fuels were also measured. The results can be seen in Figure 3 below. The data shown in Figure 3 were from the actual test fuels used in this testing. The distillation curve from the E15 fuel showed a large step change in the region of the boiling point of ethanol, as was expected.

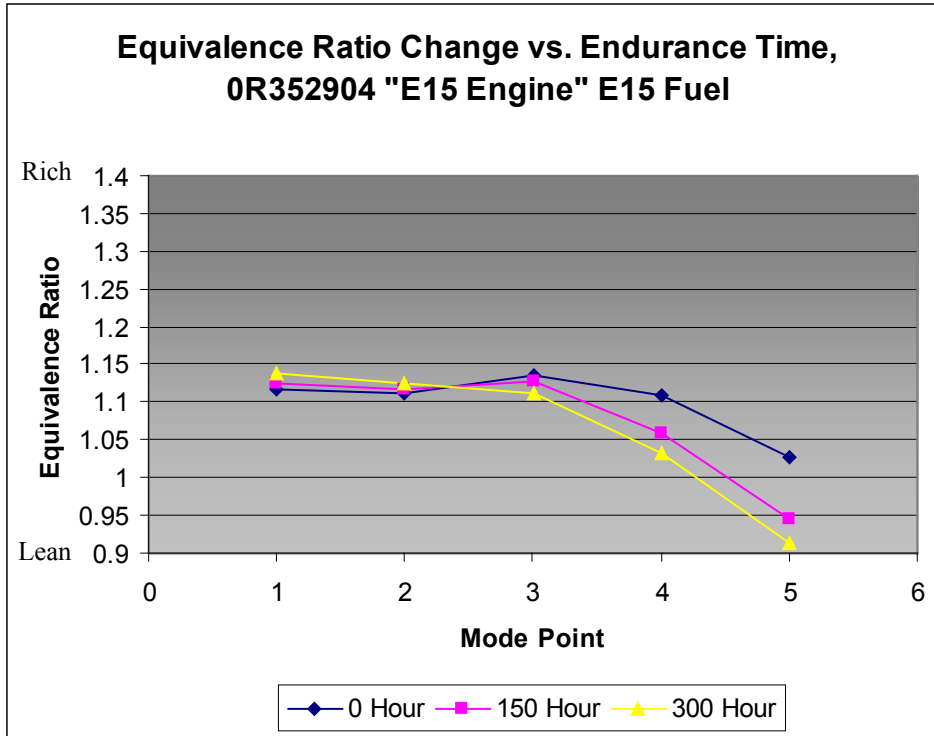
Figure 10: Change in Equivalence Ratio vs. Endurance Time-E15 Fuel on E15 Engine

In addition, the equivalence ratio vs. endurance time data was plotted for the E15 engine when operated with E15 fuel in Figure 10. The graph shows the same trend of leaner operation vs. endurance time for Modes 4 and 5, as expected. However, when looking at the equivalence ratio values generated by the engine at Mode 5, it is clear that the engine ran very lean after 300 hours of endurance. This lean operation was the result of the inherent enleanment from the E15 fuel coupled with the trend of the engine to operate leaner with more endurance time due to the throttle plate wear.

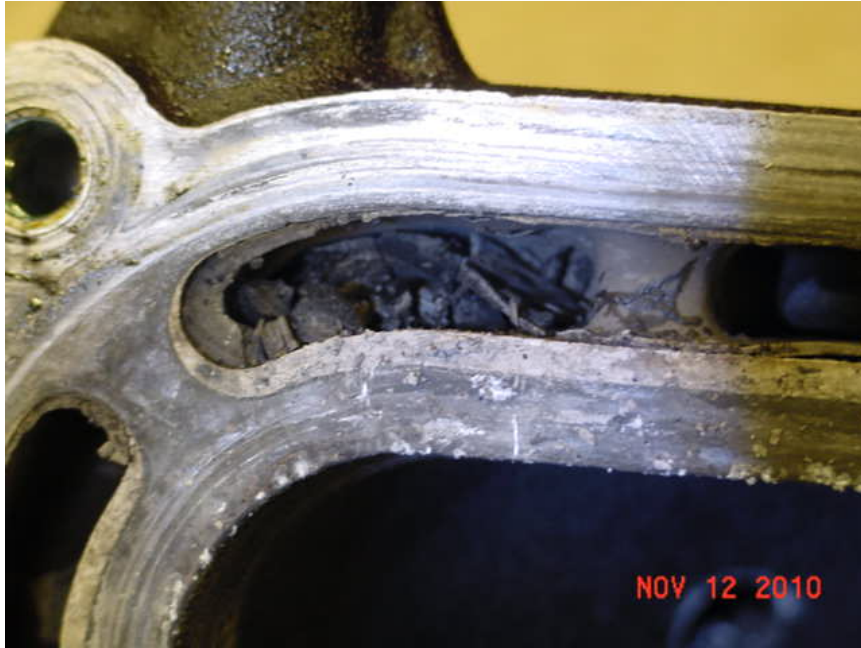
Figure 23: Mineral Deposits in Cooling Jacket, E0 Verado 1B812775A

E0 Engine #2-Test Facility-Induced Failure: An additional engine was obtained to replace the original E0 engine and this engine was given the serial number 1B821775A. This engine did the initial dyno tests and was put on endurance. After 88.7 hours of WOT endurance (98 total engine hours), the engine was automatically shut down by the endurance facility control system for low exhaust gas temperature. Investigation showed water entering the exhaust stream. The engine was then disassembled and a significant amount of mineral deposits were found in the cooling passages, especially in the exhaust collector on the cylinder head. See Figure 23. [Note: For a coolant fluid, outboard engines draw in water from the body of water they are operating in, which in this case was the endurance test tank.] An interaction between

the pH and hardness of the water in the test tank created conditions that precipitated out minerals (primarily calcite) when exposed to the elevated temperatures in the cooling passage, especially near the exhaust collector. The blocked passages prevented adequate cooling in the exhaust collector, which eventually failed the head gasket and allowed water to enter into the exhaust stream. See Figure 24. It should be noted that these water chemistry conditions were specifically caused by the test facility water conditioning and would not be something that the engine would experience in real-world use.

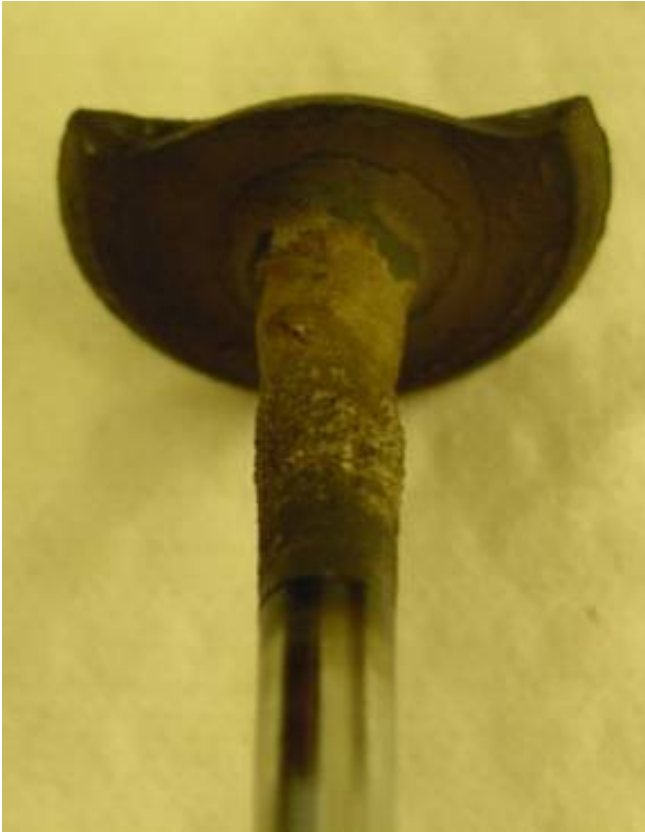
Figure 25: Broken Exhaust Valve from E15 Verado 1B812776, Top Valve in Cylinder 3

E15 Engine: At 285 hours of endurance operation (323 total engine hours), the E15 Verado test engine (serial number 1B812776) was noted to have rough idle after restarting shortly after maintenance was performed. A compression check was performed showing no compression on cylinder 3. During disassembly a broken exhaust valve was found in cylinder #3. Further investigation found that the other exhaust valve on cylinder 3 had developed a crack, as well as one

of the exhaust valves in cylinder 6. See Figures 25 and 26. NOTE: The images shown in Figure 26 of the cracked exhaust valves had been cleaned of deposits prior to photography.

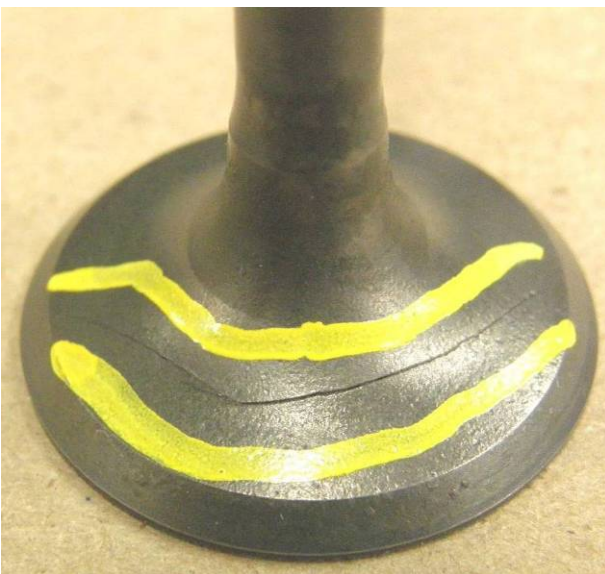
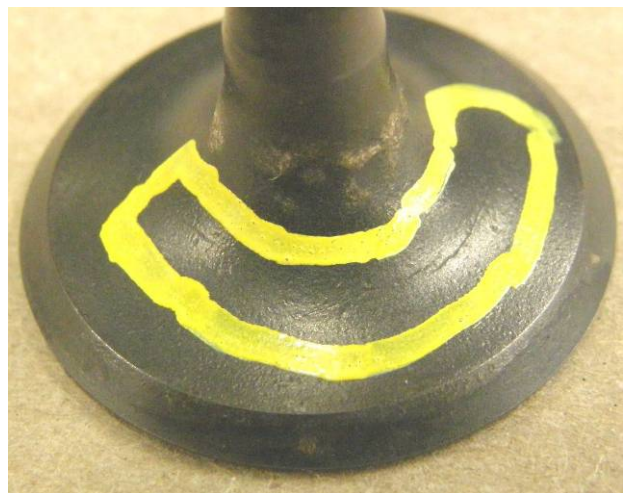
Figure 26: Cracked Valves from E15 Verado 1B812776, Bottom Valve in Cyl. 3 Left, and Top Valve in Cyl. 6 Right

The cracked valves and several valves without cracks from the E15 Verado were analyzed in Mercury's materials laboratory. The cracked valves were visually inspected with an optical stereoscope. The fatigue initiation sites were clearly identified. Figure 27 shows an example of the images of the initiation sites from the bottom exhaust valve from cylinder 3.

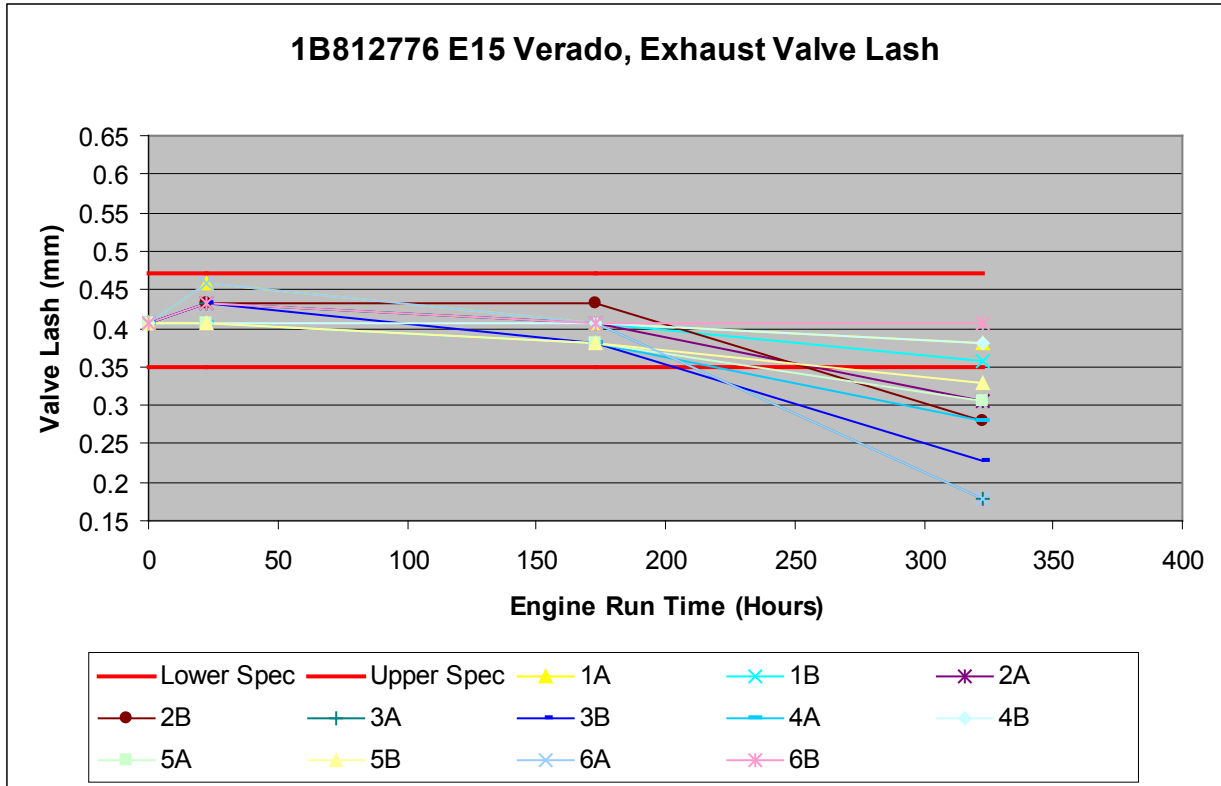
Figure 33: Exhaust Valve Lash (Measured Cold) vs. Endurance Time, E15 Engine

As part of routine maintenance and checks during endurance, several valve lash measurements were taken at various intervals on the E0 substitute engine. Figures 32 and 33 below show the lash measurements during the course of endurance for both the E0 substitute engine (1B828592) and the E15 engine (1B812776), respectively. The solid red lines in the graph indicate the upper and lower lash specification on a new engine. It is clear from the lash measurements on the 2 engines that the E15 engine had a significantly faster decline in lash than the E0 substitute engine. The E0 substitute engine had 1 valve with higher lash value at the end of testing. There may have been some carbon or other deposits holding this valve off the seat during the measurement.

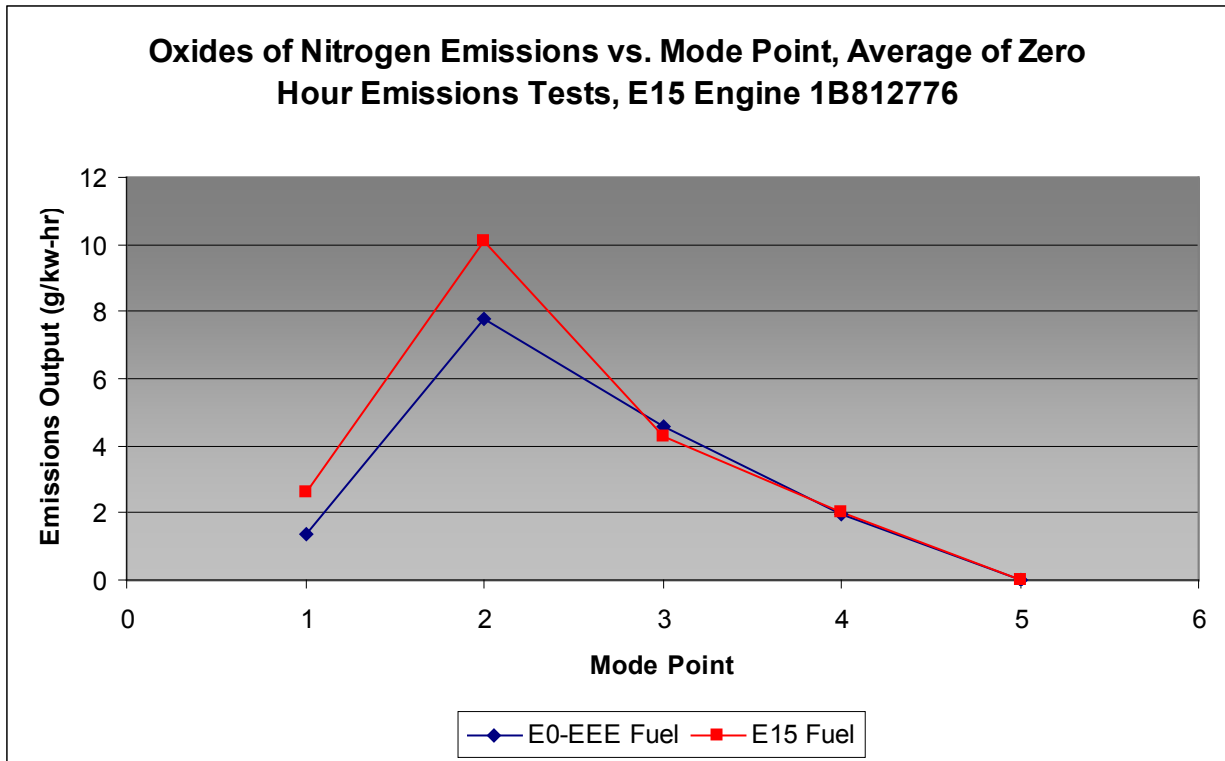
Figure 35: 300HP Verado NOx Emissions Results by Mode Point, Representative Zero Hour Test Data

Figure 35 shows the NOx emissions trends for the 2 fuels. The main differences were at Modes 1 and 2 which were both high load, boosted operating points. The fact that the NOx increased significantly with a lean shift due to the ethanol fuel blend was not surprising. Modes 3 and 4 did not show much difference because the engine was calibrated near an equivalence ratio of 1 on E0 fuel. The NOx trend with respect to equivalence ratio was near the peak at these points so a lean shift did not result in a significant change in NOx. Mode 5 was idle so the NOx generation at that point was essentially zero.

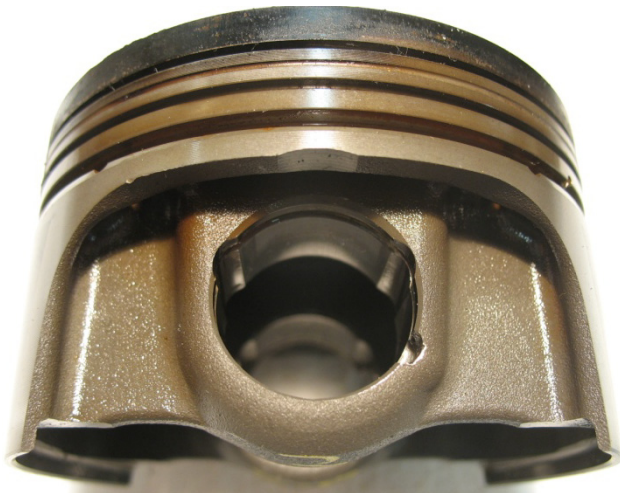
Figure 41: Piston Carbon Deposit Comparison, Cylinder 2, E0 on Left, E15 on Right

Upon disassembly, there were differences noted in the condition of the pistons from the 2 engines. Figure 41 shows pictures comparing the pistons from cylinder 2 from each engine. The piston from the E15 engine had a significantly higher amount of oil staining and carbon deposits than the piston from the E0 engine. The staining and deposits were noted on nearly every surface of the E15 piston compared with the E0 piston. Additionally, the pistons were sent to the metallurgy lab for hardness measurements. The hardness measurements were taken at several locations on the crown of the piston as well as a location on the internal portion of the piston just above the wrist pin bore after being sectioned. The average crown hardness of the E0 piston was 67.5 BHN (Brinell Hardness Number) while the E15 piston crown was 66.9 BHN. The internal piston hardness above the wrist pin bore was 74.1 BHN for the E0 piston and 71.5 BHN for the E15 engine's piston. Although the hardness measurements showed no effect of operating temperature on material properties, differences in visual appearance suggest that the E15 pistons operated at higher temperatures during running than the E0 pistons.

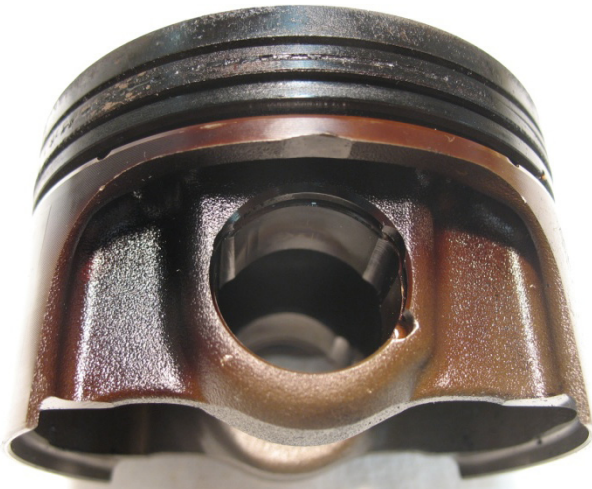
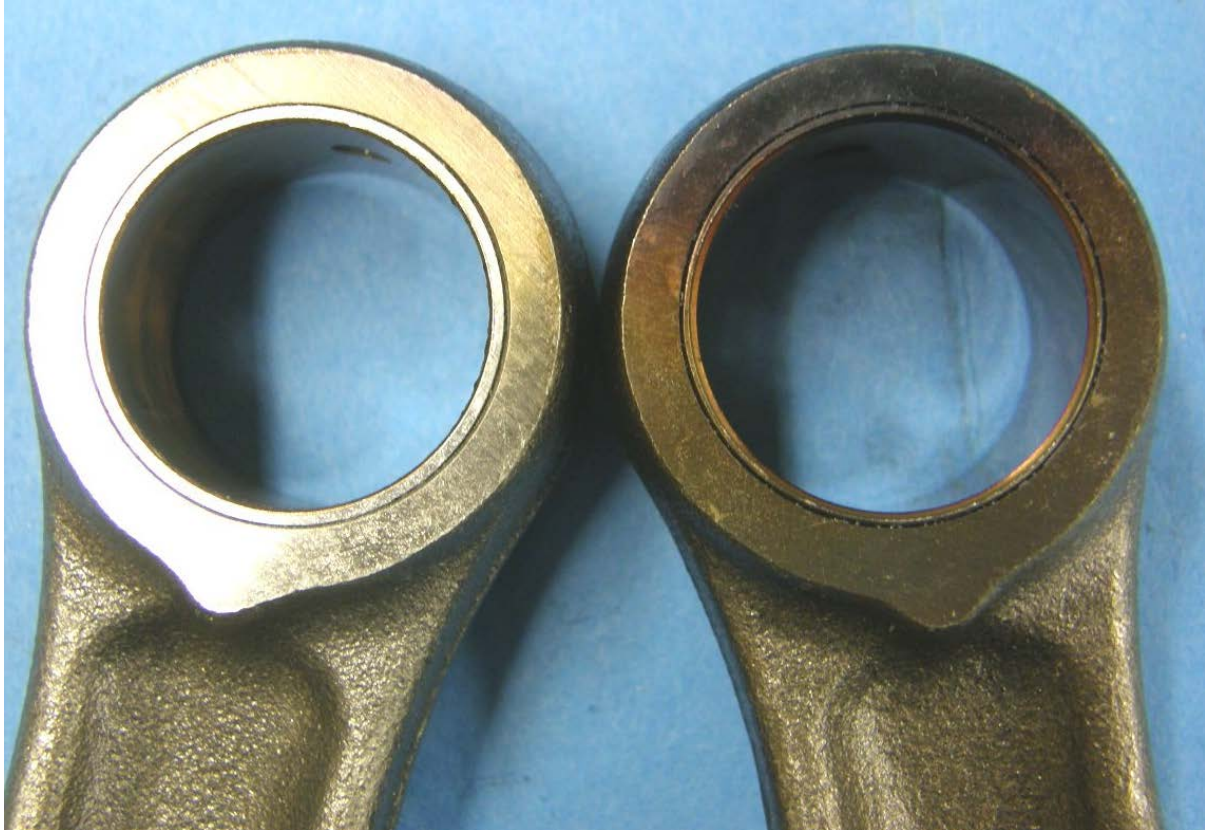
Figure 42: Connecting Rod Carbon Deposit Comparison, Cylinder 2, E0 on Left, E15 on Right

Figure 42 shows the small end of the connecting rods from each engine. The carbon deposits indicate that the E15 rods likely ran at higher operating temperatures. The carbon deposits on the rods are consistent with the carbon deposits observed on the pistons.

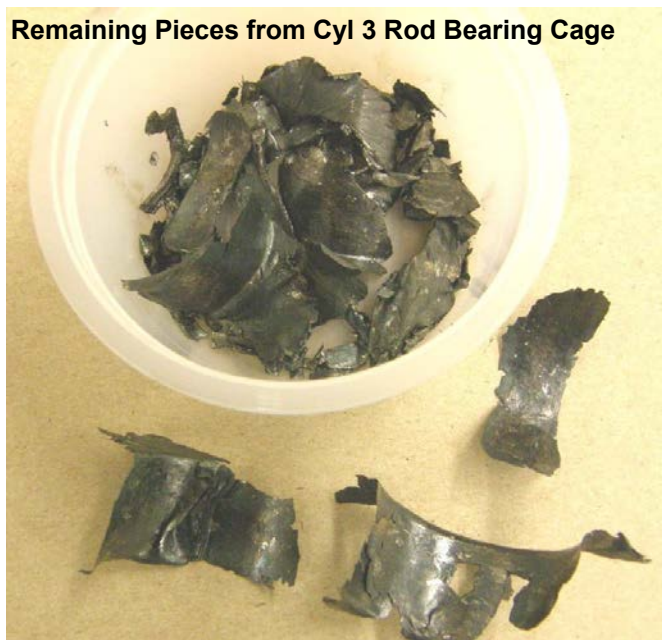
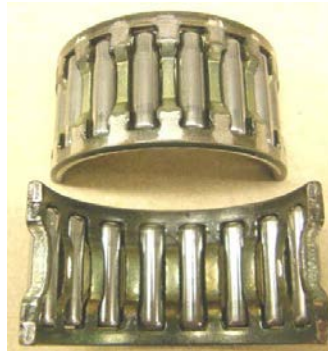
Figure 44: 200HP EFI Bearing Failure Pictures

The E15 endurance engine failed at 283 total engine hours and had accumulated 256 hours of WOT endurance at the time of failure. Upon inspection it was found that the big end connecting rod bearing had failed on cylinder 3. The rod cap was still bolted to the rod after the failure. This engine family uses a fractured rod cap design with a roller bearing (typical for a two-stroke vs. a plain bearing in a four-stroke). Images of the remaining bearing cage and the damaged rod along with undamaged pieces for reference are shown in Figure 44. No rollers were found during teardown and were likely ejected from the bearing and made their way through the power cylinder and out the exhaust. There was extensive damage to the top of the piston on cylinder 3 indicating that the rollers went through the power cylinder. Due to the extensive damage to the bearing and connecting rod (since it failed at rated speed, full power) and the fact that not all of the pieces were recovered, root cause of the bearing failure was not conclusively determined. Little is known about the effects of ethanol blends on oil/fuel mixing and dispersion on total loss lubrication systems, such as the one on this engine family. More investigation is needed to understand if ethanol would negatively impact the lubrication systems on two-stroke engines.

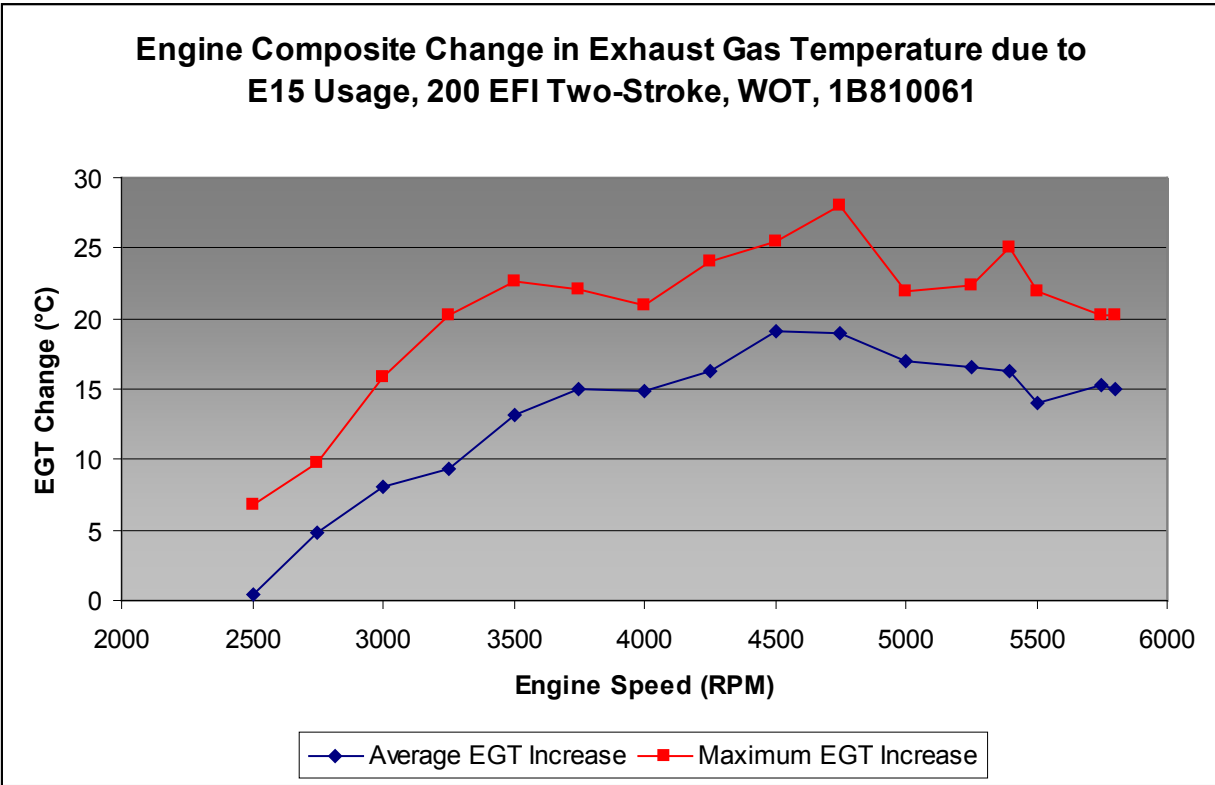
Figure 49: E15 Engine-Exhaust Gas Temperature Change at Wide Open Throttle, EEE-E0 to E15 Fuel

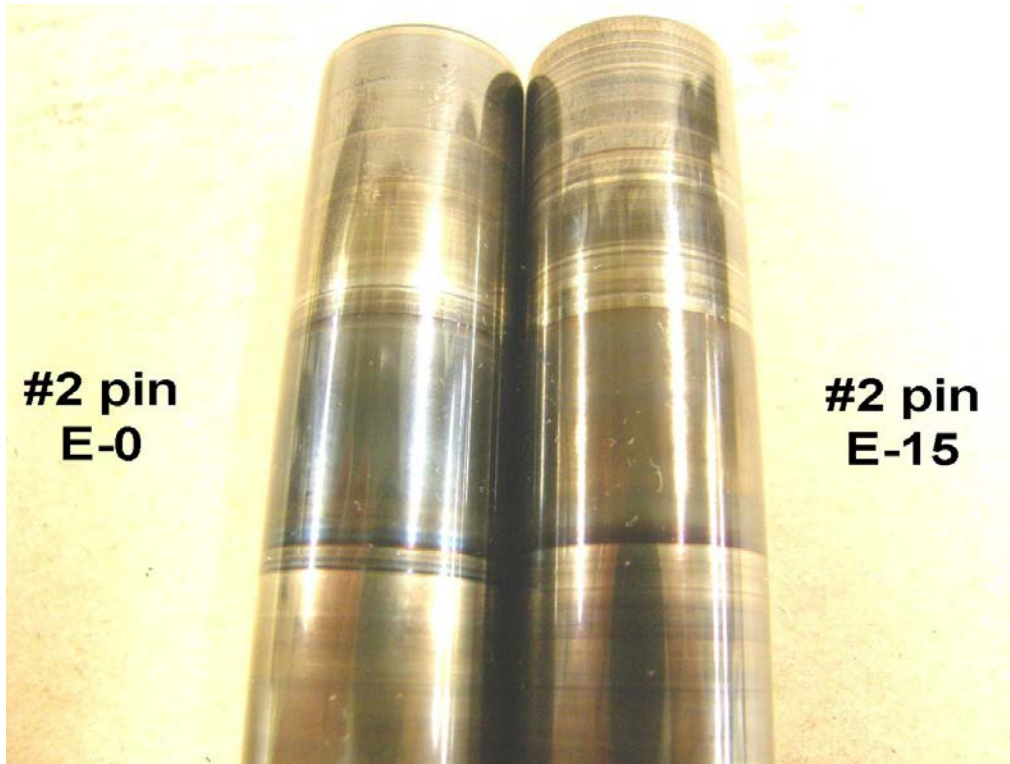
Figure 50: Cylinder 2 Wrist Pin Comparison, E0 on Left, E15 on Right
