MARINE ACCIDENT  
INVESTIGATION BRANCH

# **SAFETY DIGEST**

**Lessons from Marine  
Accident Reports  
1/2019**

April 2019

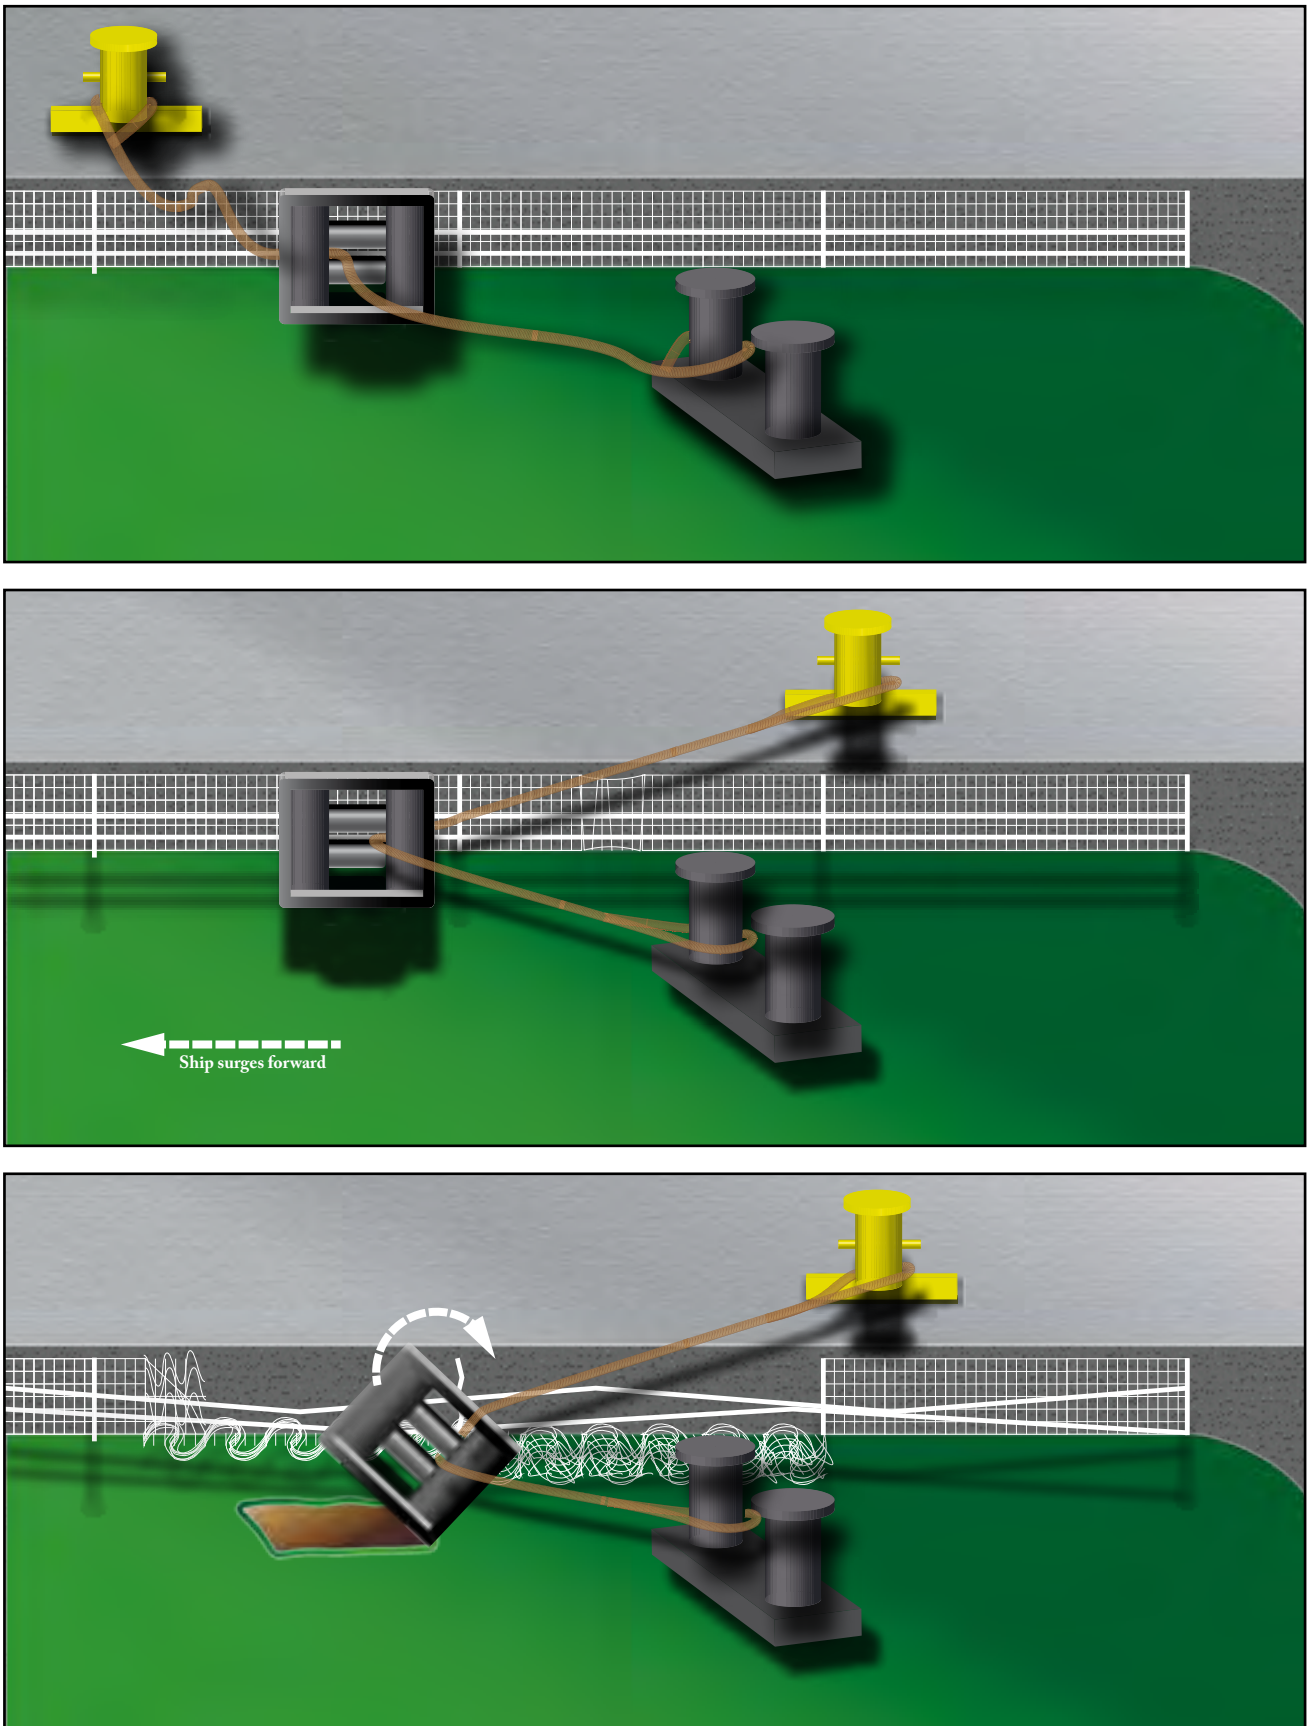
A passenger ferry was attempting to moor on a berth with a strong groundswell in strong winds when, without warning, one of its mooring line bollards was ripped from the deck. The ferry had to be taken out of service for several days to facilitate repairs to its deck plating and a roller fairlead (Figure 1). Fortunately, nobody was injured.

The effects of the groundswell in the port, and the difficulty of berthing in strong winds, were well known to the ferry operator. Between 2015 and 2017 the company recorded 21 instances of mooring line failures, with some causing minor injuries to ships' crews. The main solution to the problem was to equip the vessel with stronger mooring ropes.

Figure 2: Sequence leading up to the accident (for illustrative purposes only - not to scale)

1. The problems caused by vessels surging on the quayside in exposed ports are well known and do occasionally lead to mooring lines parting. Masters should assess the suitability of a berth when considering the prevailing weather conditions, review their risk assessments, and establish a clear mooring plan that should include the disposition, size and types of ropes to be used.

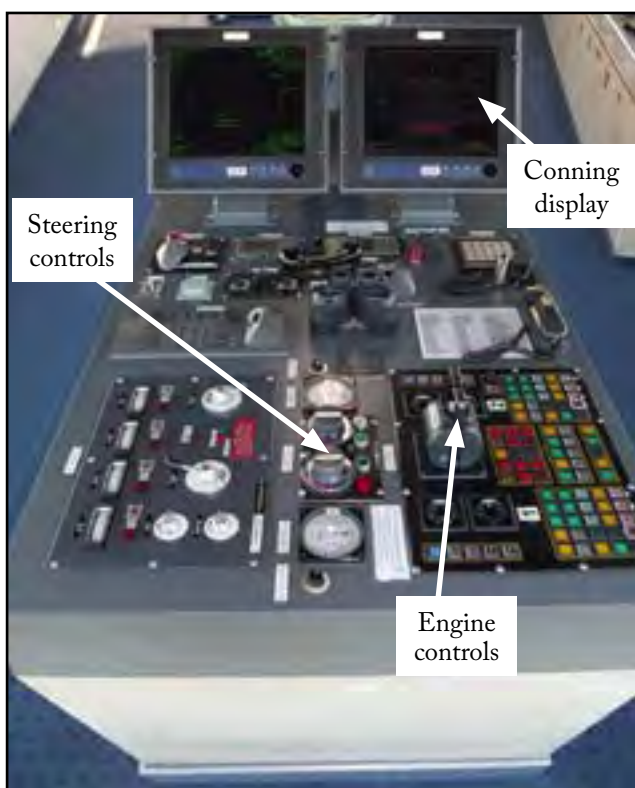
A ro-ro passenger ferry left its berth with 320 passengers, 72 crew and several cars and trucks on board. The planned manoeuvre was to clear the berth, increase speed, and steer a curved track, using port helm, to pass between the two breakwaters at the port's entrance. The master controlled the engine, thrusters and steering from the console on the port bridge wing (Figure 1).

Figure 1: Port bridge wing console

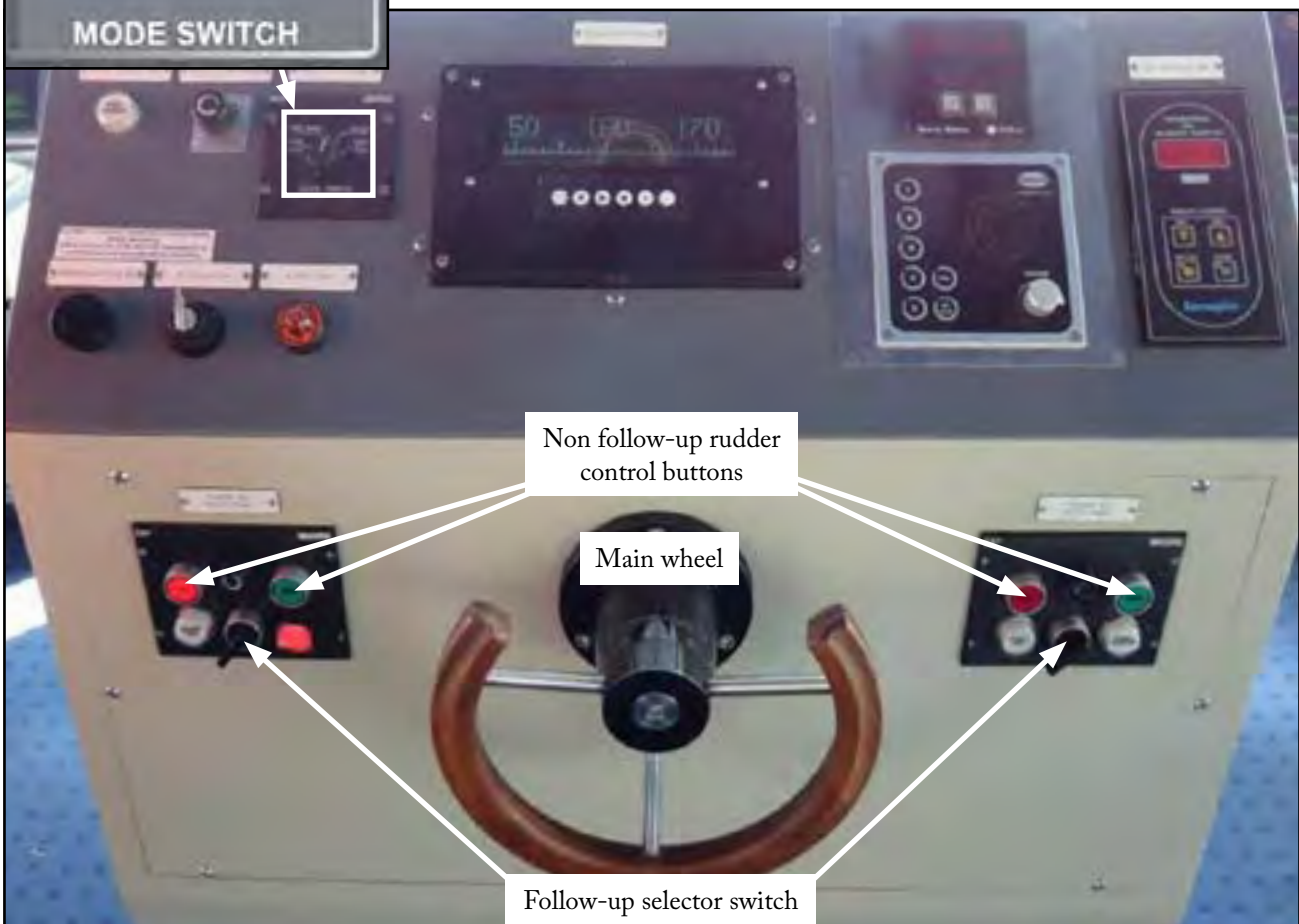
The ferry cleared the berth on schedule in light winds on a hazy morning. About halfway into its turn towards the breakwater entrance the computerised steering mode changed unexpectedly from the port console to the trackpilot system. Immediately, the trackpilot applied starboard helm to arrest the swing and steer the course it was on when it activated. This was not immediately noticed by the bridge team.

Figure 2: Main steering stand with mode control switch

3. Familiarity with critical systems is vital during an emergency, and knowing what the alarms indicate, and the appropriate corrective actions to take, can be the difference between a near miss and an accident.

4. Emergency planning should examine the 'what ifs' and encompass all aspects of the ship's operation. Table-top discussion is useful for this and it should be a forum for ideas. Don't limit critical systems' failures to open-water scenarios, but consider their effects when manoeuvring in harbour or in narrow channels.

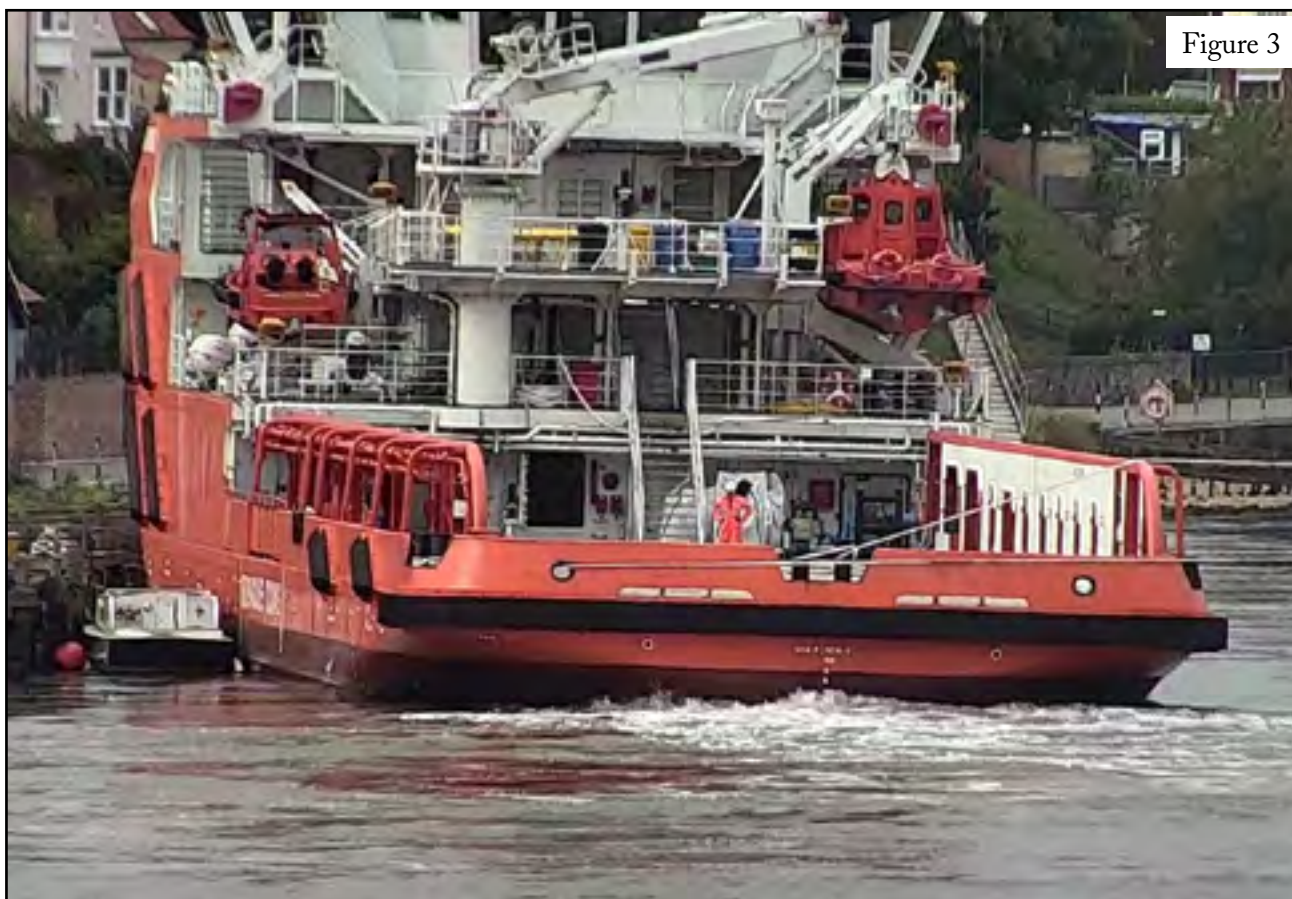
Figure 3

Meanwhile, the shore linesmen managed to let go the aft spring. Although the deck crew tried to recover the spring inboard, there was a lot of line in the water and they could not prevent it from fouling the starboard propeller. By that time, the supply vessel was very close to berths on the opposite bank and, although stern lines remained connected, the master had managed to keep the vessel head-to-stream. However, he could not prevent it from colliding with two small moored boats (Figure 3). Soon after,

the thrusters were started and the master was able to manoeuvre the supply vessel back alongside its original berth. The two small boats sank.

1. The indication of pitch movement on electro-hydraulic thrusters shows only that the hydraulics are moving the propeller blades. It does not indicate that the thruster is turning. This is best achieved through physical tests with wash, the movement of mooring lines and thruster noise providing the most positive assurances.

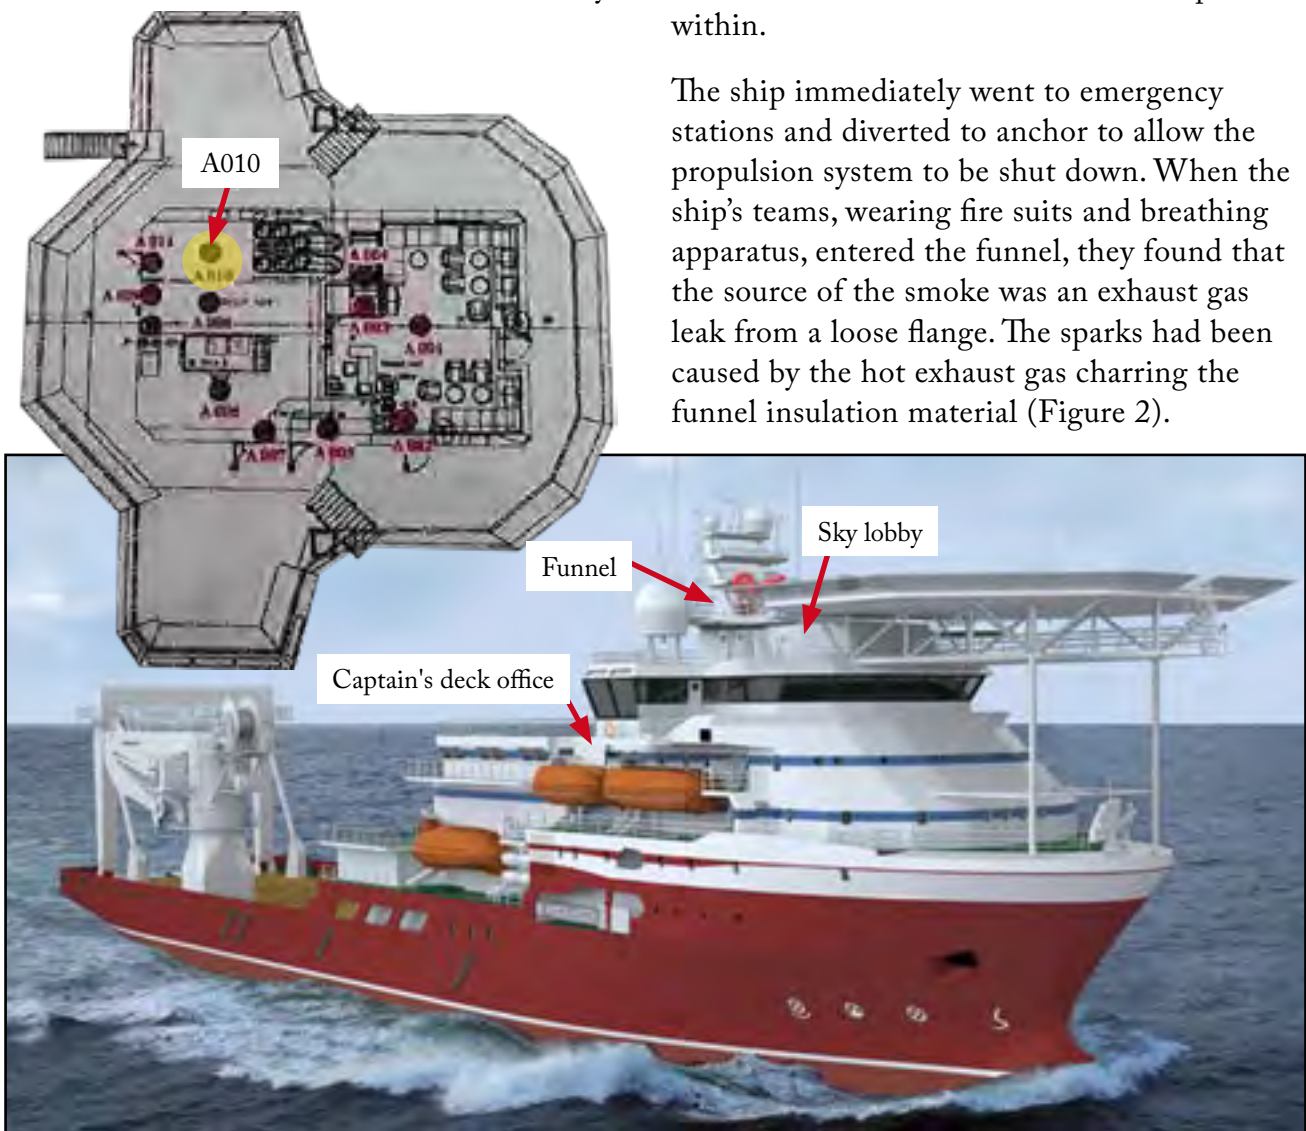
Figure 1: Approximate locations of the sky lobby, the captain's deck office and the funnel (inset: fire safety plan, highlighting the location of sensor A010)

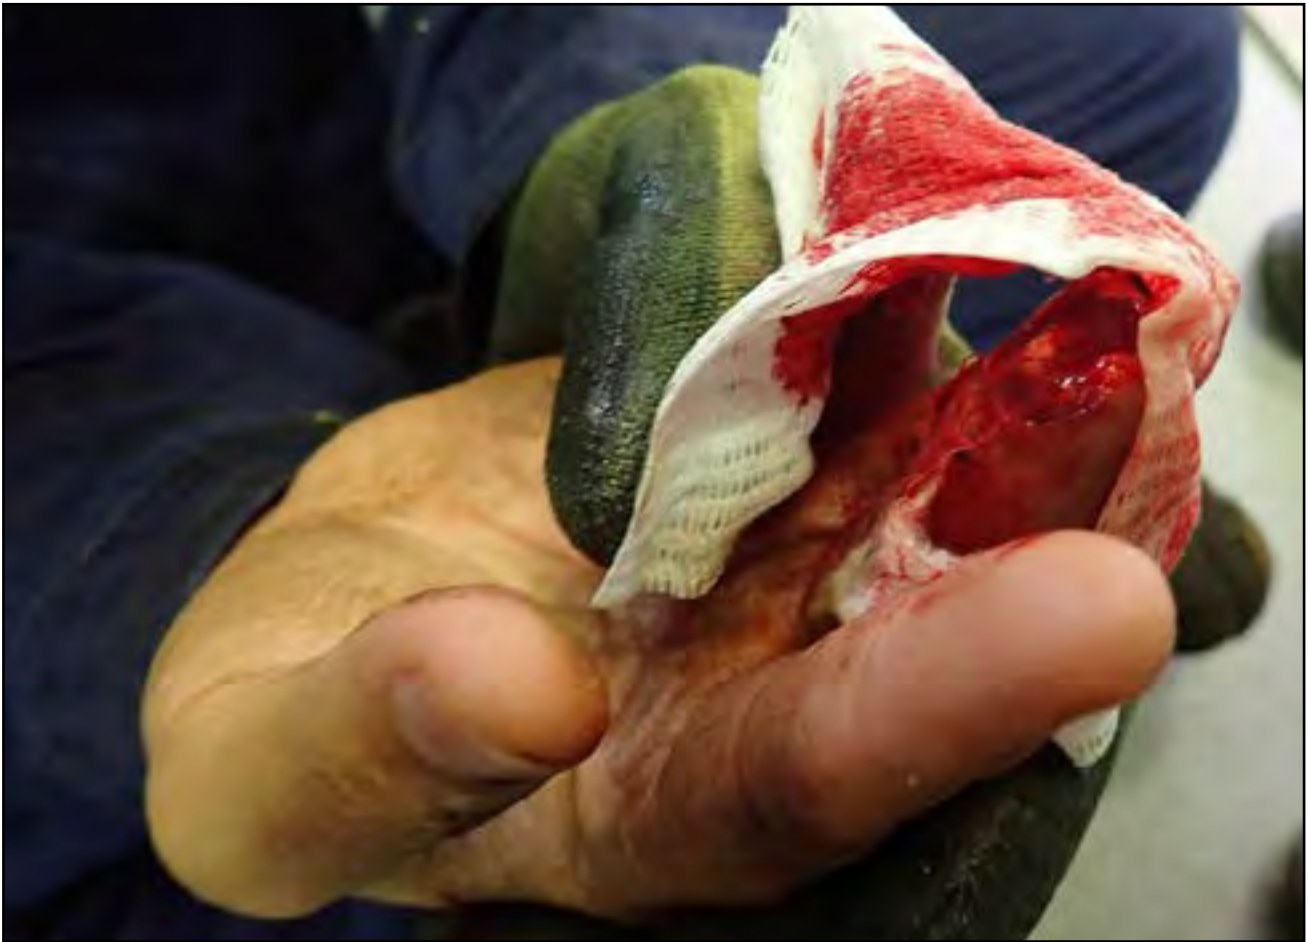
Figure 2: The amputated fingers

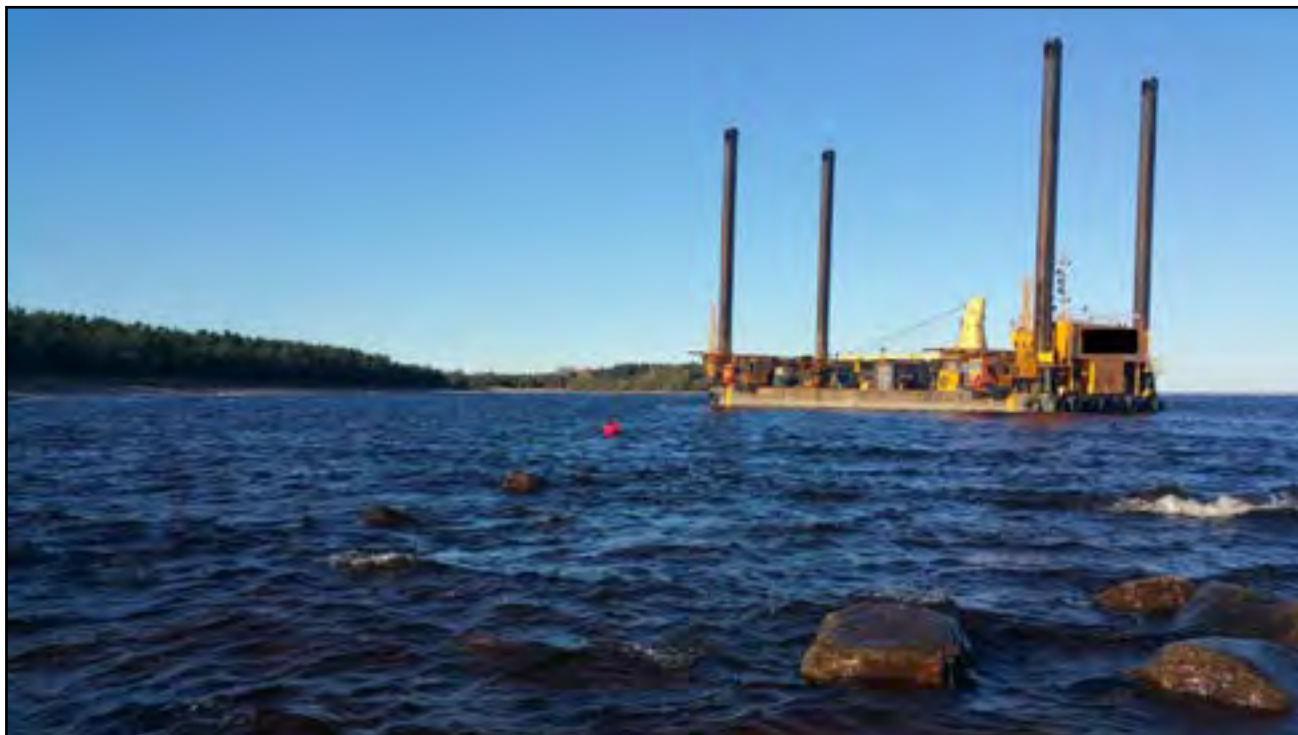
1. The towing wire failed as the tug's anchor was being heaved. The tow line failed in the vicinity of the hard socket on the eye of the towing wire. Subsequent destructive testing of the towing wire showed that it parted at a significantly lower load than expected. The towing wire had a certified minimum breaking load of 102.95t; during testing it began to fail at 64t and parted at 87.74t.
2. An inspection of the towing wire identified that the wire was rusty, and flat spots and areas of wear were identified. However, the towing wire was 7 years old and had been inspected regularly by the ship's master as required by the company safety management system. No defects or damage had been recorded.

Figure 2: The grounded barge

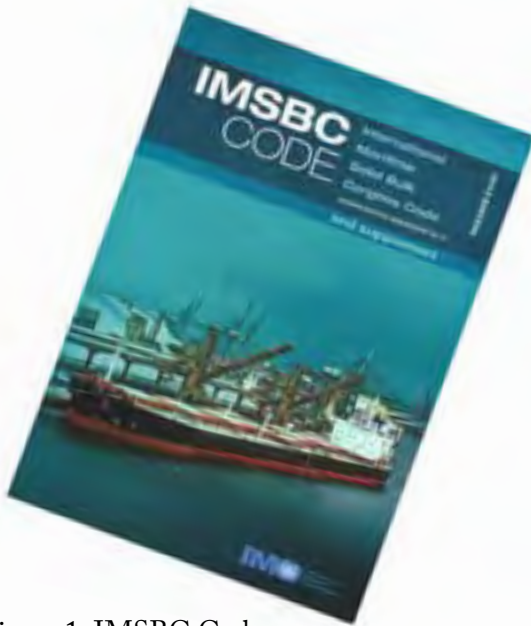
The master checked the schedule of authorised bulk cargoes in the International Maritime Solid Bulk Cargoes (IMSBC) Code (Figure 1) but found no entry for IBA. Based on the assurance received from the shipper in the loading instructions, he loaded around 2300 tonnes of unprocessed IBA in heavy rain. The vessel left the berth in the evening and the master decided to drop anchor just outside the port to wait for bad weather to pass.

Figure 1: IMSBC Code

1. It is illegal to load a cargo that has not been included in the schedule of authorised cargoes in the IMSBC Code. If you are asked to load a cargo that has not been included in the Code, alert the competent authorities in the port and refuse to load it.

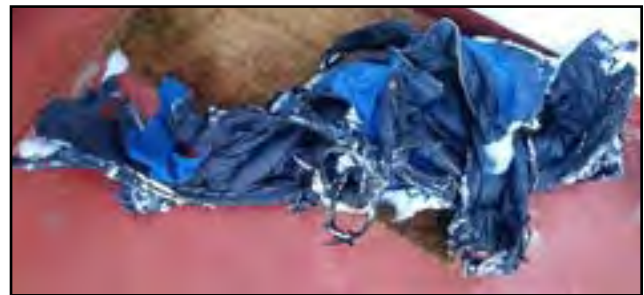
The following day, the chief engineer went into the forecabin store to test the emergency fire pump. He ran it for 5 minutes, and when he switched it off there were two loud explosions in rapid succession. The chief engineer was blown off his feet by the explosions, the waterproof coat he was wearing was melted

(Figure 2) onto his skin and he suffered severe burns to his head and body. He staggered out of the store and a crew member assisted him to the mess room. He was subsequently evacuated to hospital by a rescue helicopter. The chief engineer had suffered first degree burns to his face and second degree burns to his body, both hands and lower extremities. His recovery took several months.

Figure 2: The chief engineer's burnt waterproof coat

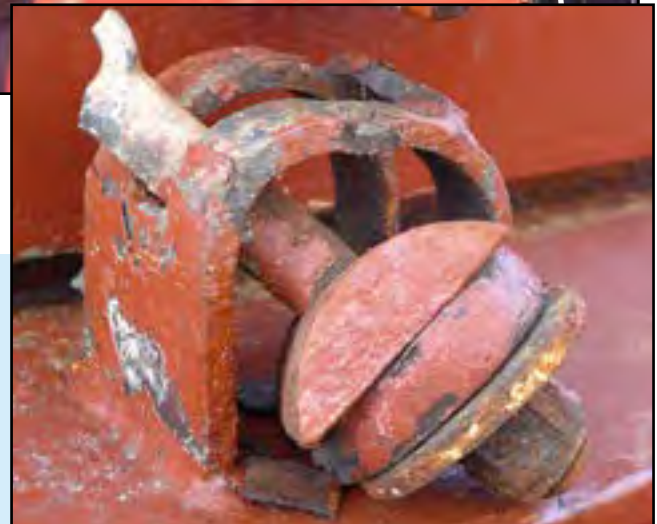
The explosions had lifted all of the vessel's heavy steel hatch covers, breaking their holding down cleats (Figure 3). Many of the hatch covers had also been distorted and some had fallen into the cargo hold and were resting on top of the cargo. The cargo hold coamings had also been distorted; the vessel was out of service for 4 months for repair.

An investigation into this accident revealed that hydrogen gas had been released from the cargo and had seeped into the forecabin store through a cargo lamp access plate (Figure 3). At some point the access plate had been loosely refitted with two bolts and no sealing gasket. Hydrogen gas, which forms an explosive mixture with air from 5% to 74% concentration, ignited when the emergency fire pump was switched off - probably because of some arcing between the electrical contractors in the starter box.

Figure 3: Damage caused by the explosion and the location of the cargo lamp access plate

2. Always ensure that the gas tight integrity of cargo holds is maintained.

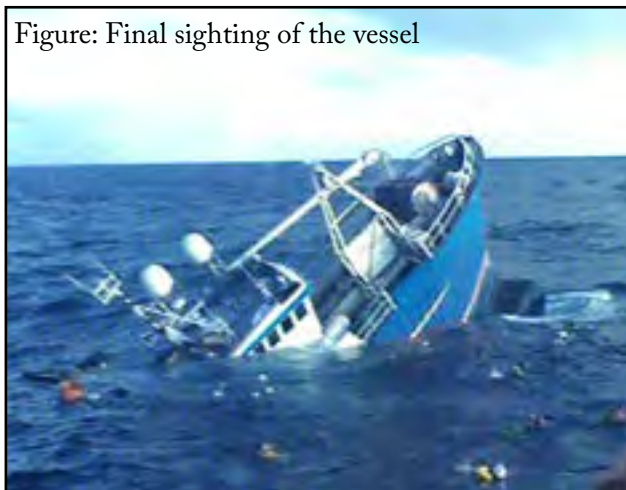
The crew attempted to control the flood using the fixed bilge pumps in the engine room and portable submersible pumps via the accommodation space escape hatch. The engine room bilge pumps became ineffective

Figure: Final sighting of the vessel

as the flood took hold and a bow up trim was adopted. The portable pumps were also susceptible to blockages by debris. As a result, the flood could not be brought under control and the vessel was lost when the escape hatch submerged, causing overwhelming flooding.

All of the vessel's four crew members and two lifeboat crew members, who had embarked to assist with the pumping effort, ended up in the sea as the vessel sank (see figure), but fortunately all were rescued safely onto the lifeboat.

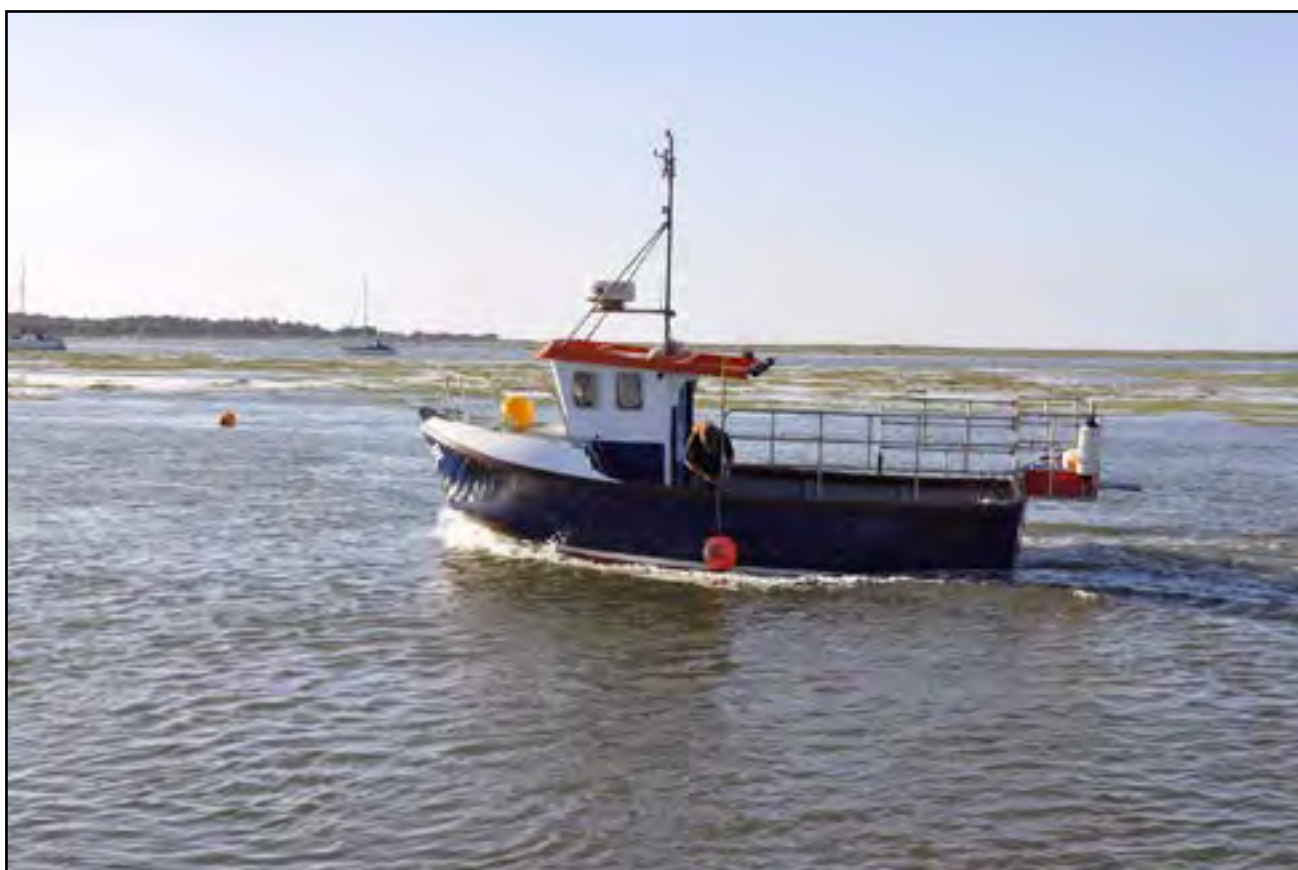
As the boat passed over the bar, the crew experienced an unexpected roll to starboard; the boat then righted itself before rolling heavily again. Hearing the bilge alarm and concerned about capsizing, the skipper grabbed two lifejackets from the wheelhouse and these were donned by both crew as the boat rolled over.

Figure 1: The boat

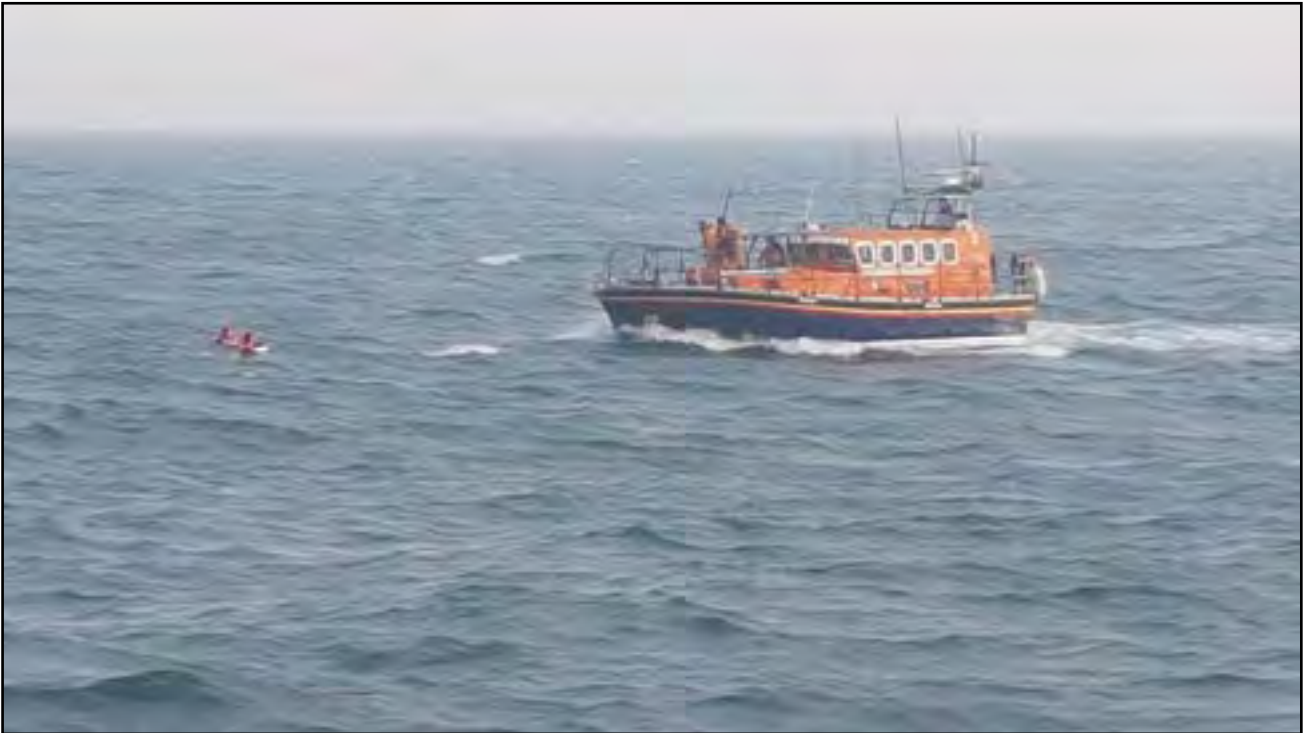
The boat settled on its side and both crew managed to scramble onto the side of the wheelhouse. The skipper raised the alarm by calling 999 on his mobile phone and getting through to the coastguard. Although the skipper was not able to pass a precise position, the information he gave was sufficient for a successful search and rescue mission. The fishing boat sank prior to the arrival of the lifeboat, leaving both men in the water clinging to a lifebuoy (Figure 2).

Figure 2: RNLI rescue

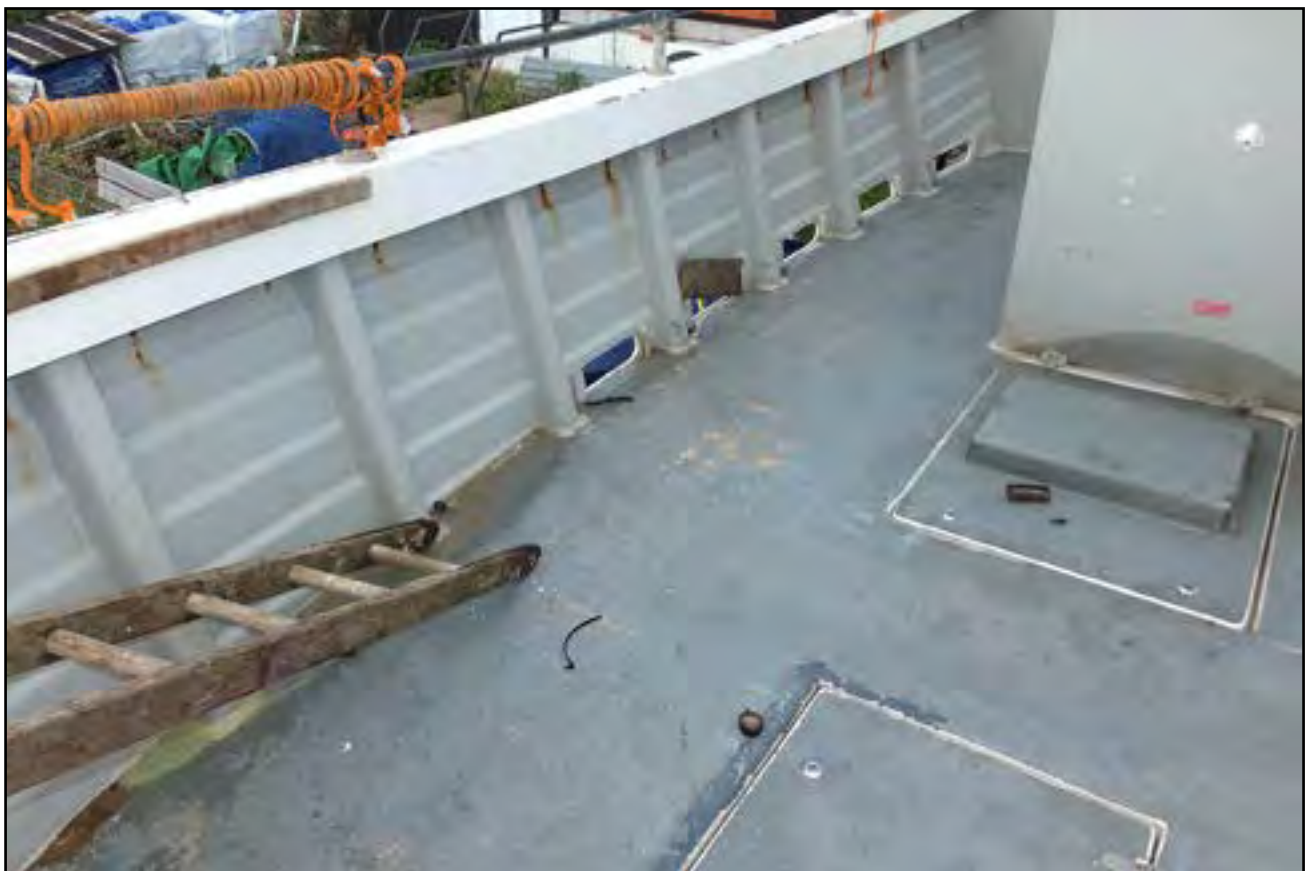
The boat arrived at the static nets, which were about 3nm offshore, and the men set about retrieving them with the hauler and stowing them in net bins forward. As the net bins filled, the boat started to trim by the head. Neither the skipper nor his crewmen noticed sea water starting to come through the freeing ports onto the deck and over the flush deck hatches.

The three fishermen were shocked when they saw that the boat's deck was awash. By then, the boat had started to sink rapidly beneath

Figure 1: Freeing ports

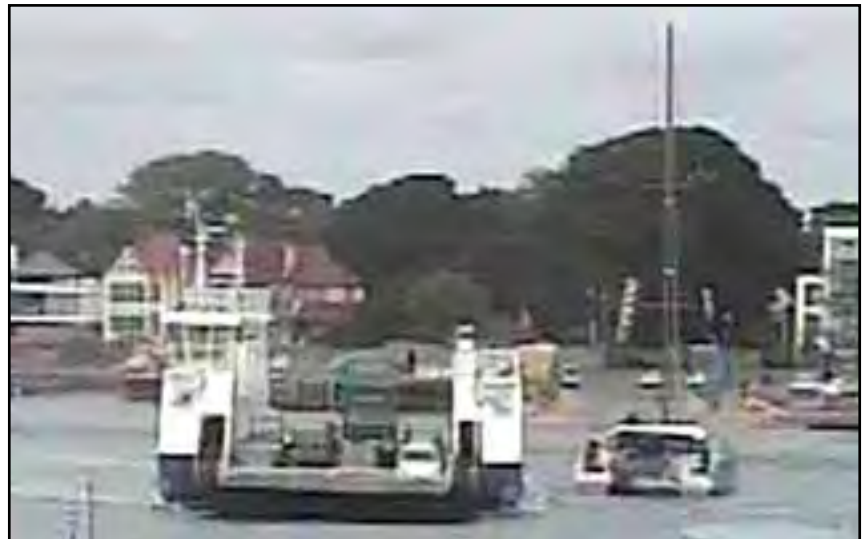
When attempting to hold position using astern power, control of the catamaran was lost and it was swept sideways towards the crossing ferry by the strong tidal stream. Realising that the situation was deteriorating the skipper transferred throttle control to the starboard

Figure 1: CCTV imagery of the catamaran being swept onto the chain ferry just before the collision

side console then applied full power ahead on the port engine and maximum starboard rudder in an attempt to steer away from the chain ferry (Figure 1). However, this was unsuccessful and the catamaran's port side made heavy contact with the ferry.

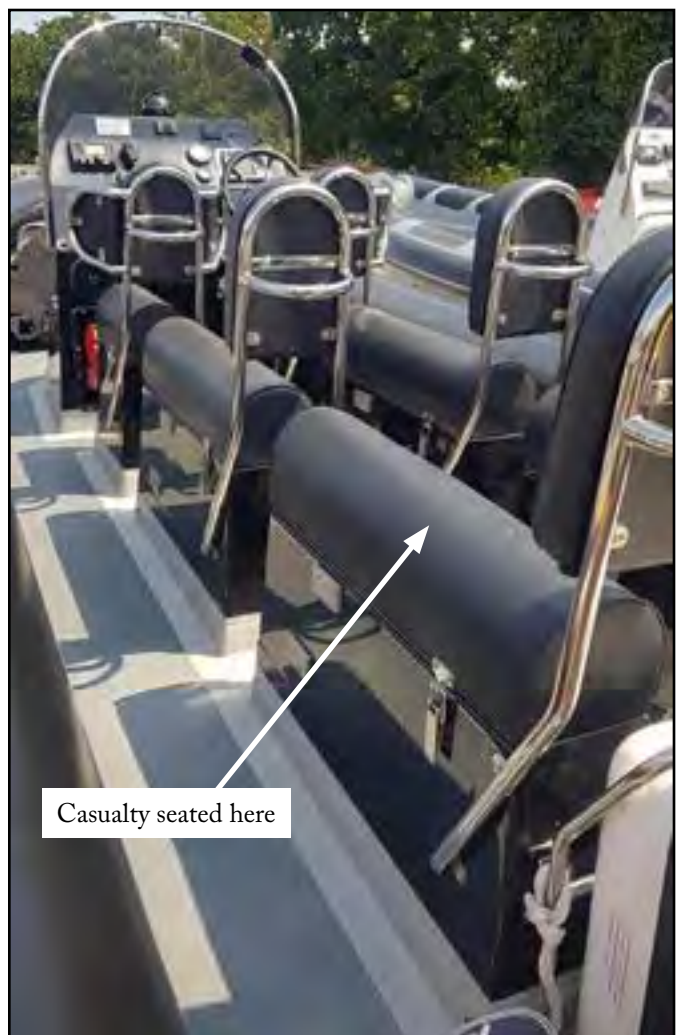
Figure 1: Jockey seats behind skipper's helm position

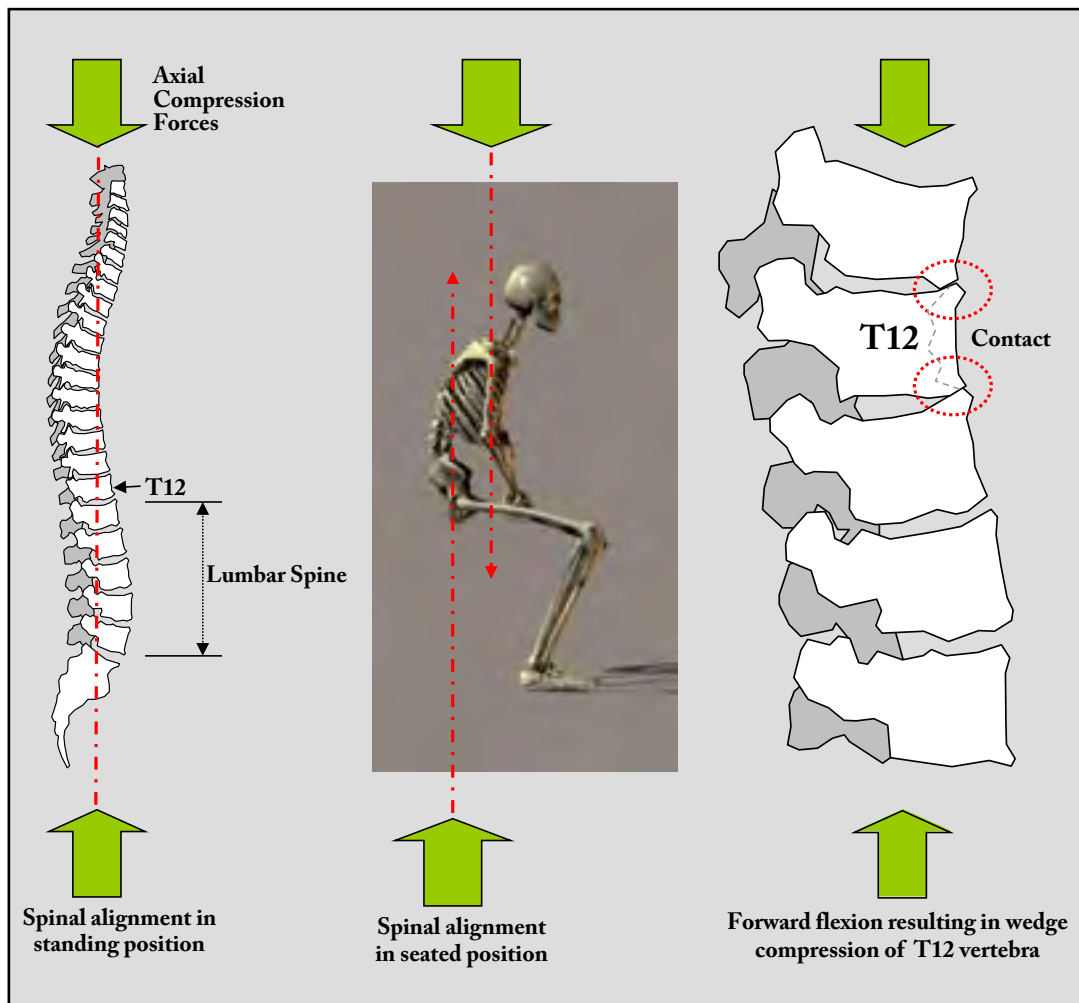
Two telephone calls were made to the local ambulance service requesting that it attend the casualty at the marina. But the ambulance failed to turn up. The injured passenger was assisted off the boat and taken to the local hospital by her husband for diagnosis and treatment. She remained in hospital for a few days while being treated for a compression fracture of her T12 vertebra (Figure 2).

Figure 2: Spinal alignment and wedge compression effect when boat slams into the water

1. Lower back compression fractures can occur when a RHIB passenger lands heavily on their seat after being lifted into the air due to the motion of the vessel. Those in control of a boat should be aware that if crossing large waves at an acute angle, the boat speed must be reduced dramatically to prevent it from slamming and potentially injuring its occupants.

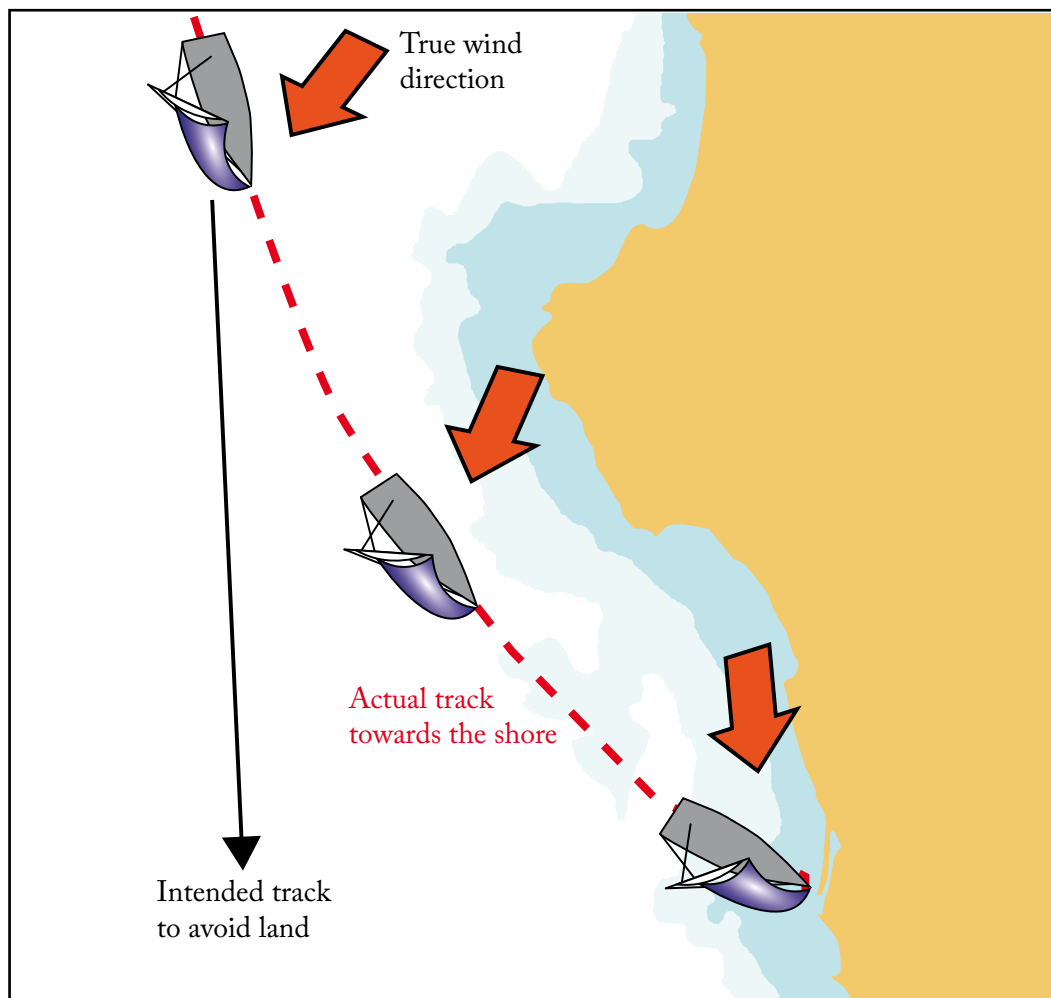
a potentially dangerous accidental gybe, the crew made a succession of small alterations of course to port. These course changes had the effect of driving the yacht unintentionally close inshore (Figure 1).

Figure 1: The intended and actual tracks of the yacht

1. Every vessel, whatever its size or purpose, needs a passage plan that has identified all potential hazards for the voyage ahead. In this case, the skipper had intended to head away from land after the race start so was not planning to sail close to the shore. This meant that there was little expectation of having to manage coastal navigation. Nevertheless, the requirement to pass the headland meant that the passage plan should have assessed the risks of operating in shallow water.

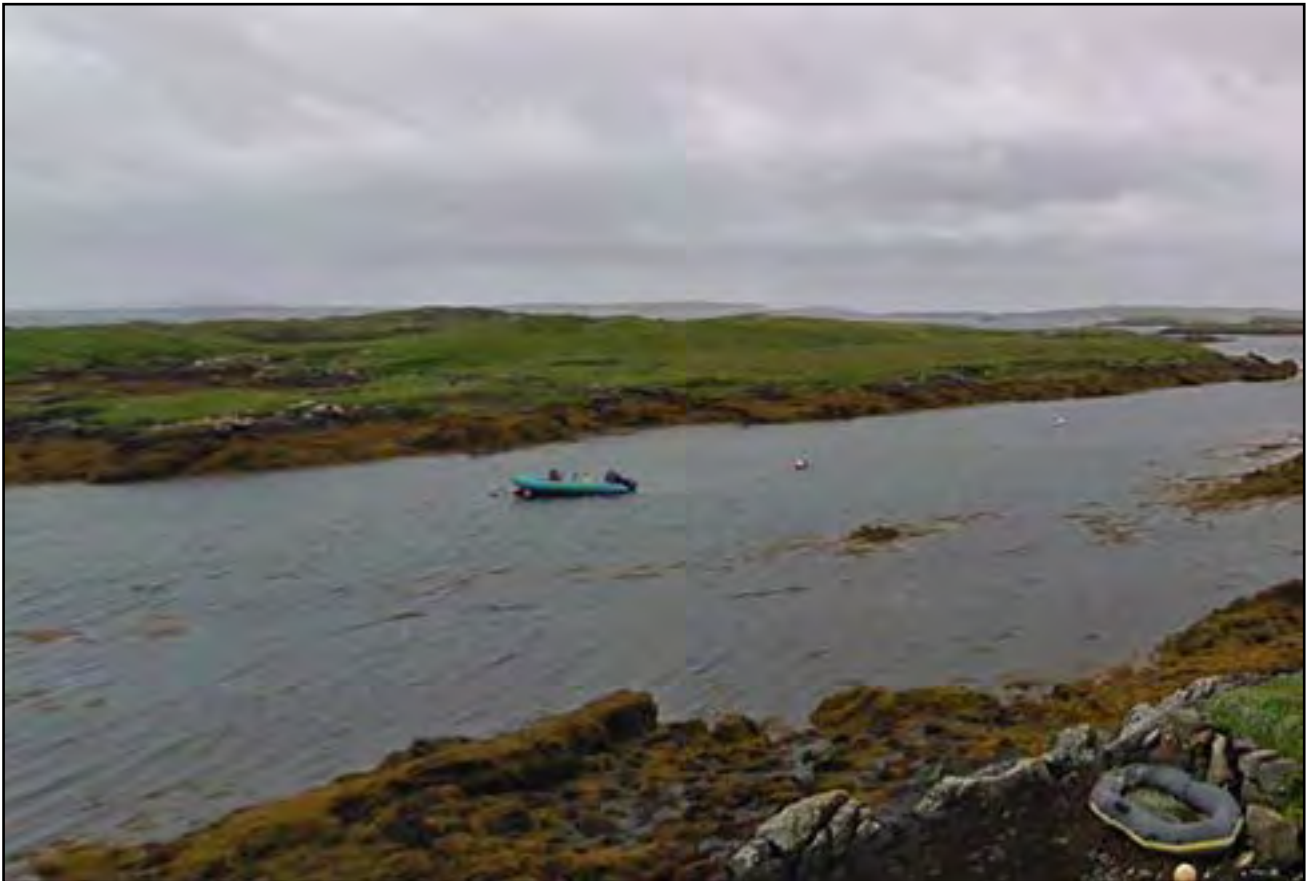
The owner of a RHIB and a friend rowed a small inflatable dinghy out to the moored RHIB to bail out rain water (Figure 1). It was a blustery afternoon so both men were wearing warm clothing, waterproof jackets and wellington boots; neither man was wearing a lifejacket or buoyancy aid.

Figure 1: The RHIB and the dinghy

1. The difficulty of trying to swim in cold sea water without the support of a buoyancy aid or lifejacket cannot be over emphasised. The owner and his friend routinely wore lifejackets when they took the RHIB to sea but did not wear them when rowing to the mooring to bail the boat. The risk of falling overboard when transferring from boat to boat is high and therefore it is essential that buoyancy aids and lifejackets are always worn.

2. Stepping between boats is always hazardous. In this case the owner's friend attempted to step from one boat to the other, across both flotation tubes, wearing wellington boots. Had the friend lowered his centre of gravity by sitting on the RHIB's side tube, holding on to a lifeline, swinging first his legs and then his body into the dinghy (Figure 2), he would have remained in control of his movement throughout, significantly reducing the risk of his falling overboard. Similarly, had suitable non-slip footwear been worn, the risk of slipping would have been reduced.

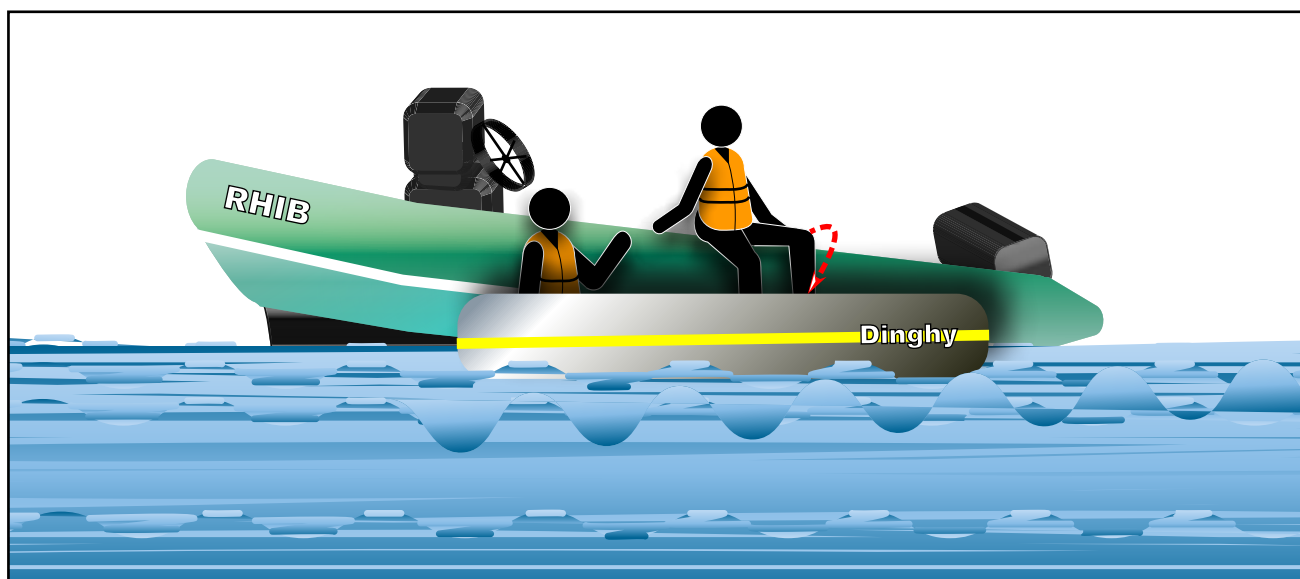
Figure 2: Safe transfer - sitting on the RHIB's side tube to safely transfer to the dinghy and wearing appropriate safety gear (illustrative purposes only: not to scale)

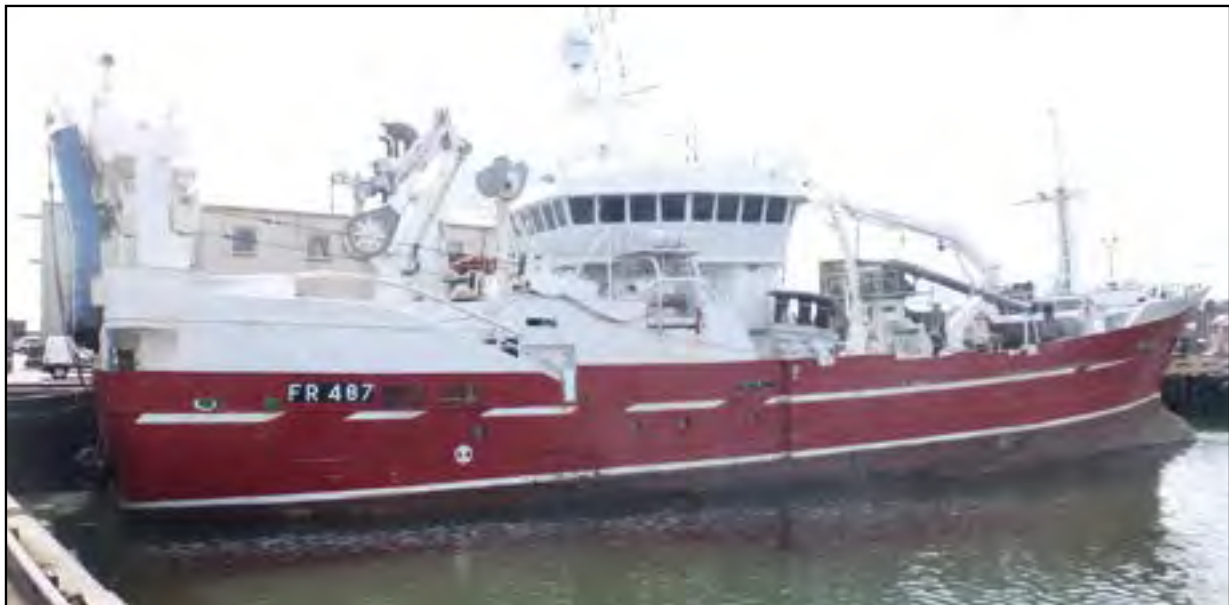
**Figure 1:** FV *Sunbeam*

*Sunbeam* (**Figure 1**) was a 56m UK registered pelagic trawler. Its home port was Fraserburgh, Scotland, and it was typically manned by a crew of eleven. In the weeks prior to the accident, it had been fishing for herring in the North Sea and landing its catch in Lerwick, Shetland. The vessel had nine refrigerated salt water (RSW) tanks for storing its catch.
