MARINE ACCIDENT  
INVESTIGATION BRANCH

# **SAFETY DIGEST**

**Lessons from Marine  
Accident Reports  
1/2019**

April 2019

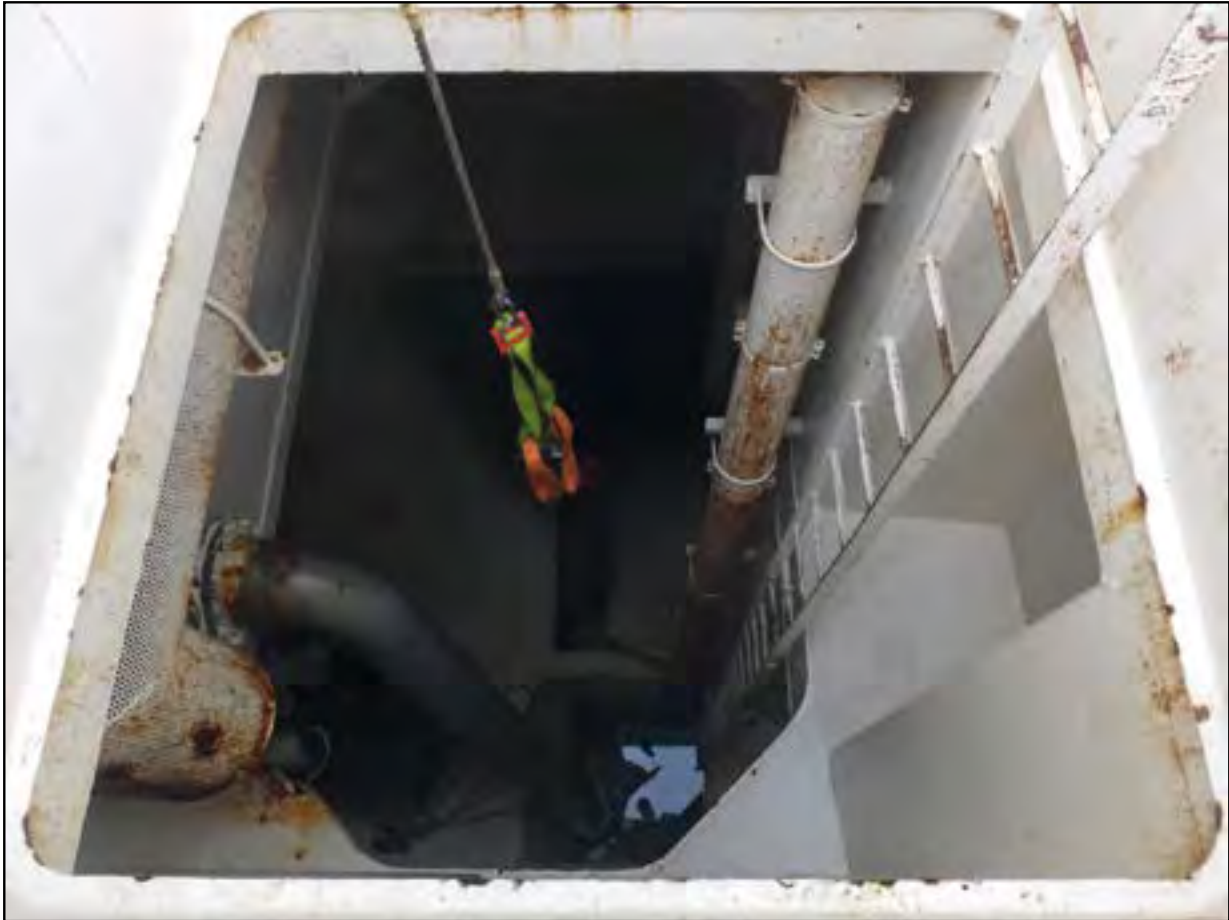
It is unclear when and why the second engineer entered the tank. However, evidence indicated that his intention was to sweep the residual seawater that had settled at the aft end of the tank forward in to the tank's bilge well. No safety procedures for entering or working in RSW tanks had been completed before he entered the tank.

**Figure 2:** Aft centre RSW tank

Tests of the atmosphere in the tank following the accident showed that the level of oxygen at the bottom was less than 6% (normal level should be 20.9%). Further tests of both the tank atmosphere and residual water samples showed the presence of Freon R22, the refrigerant gas used in the RSW tank's refrigeration plant.
