**IN-DEPTH SURVEY REPORT OF CARBON MONOXIDE EMISSIONS
AND EXPOSURES ON EXPRESS CRUISERS UNDER VARIOUS
OPERATING CONDITIONS**

January 2006

EPHB 289-11a

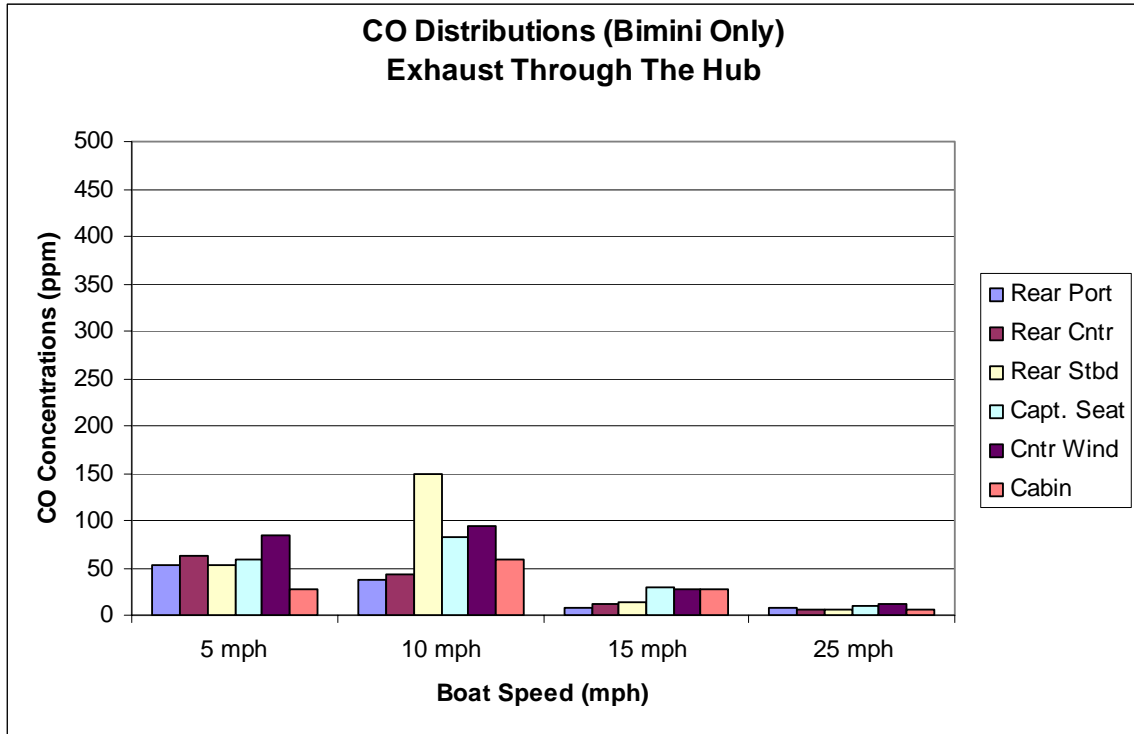
Figure 7: Boat 3 (31') Twin Volvo Penta 8.1L Exhausting Through the Hub.

the stern of the boat, and gradually reduced toward the front of the vessel. Tables 8 and 9 and the graphs in Figure 7 contain additional information for this vessel.

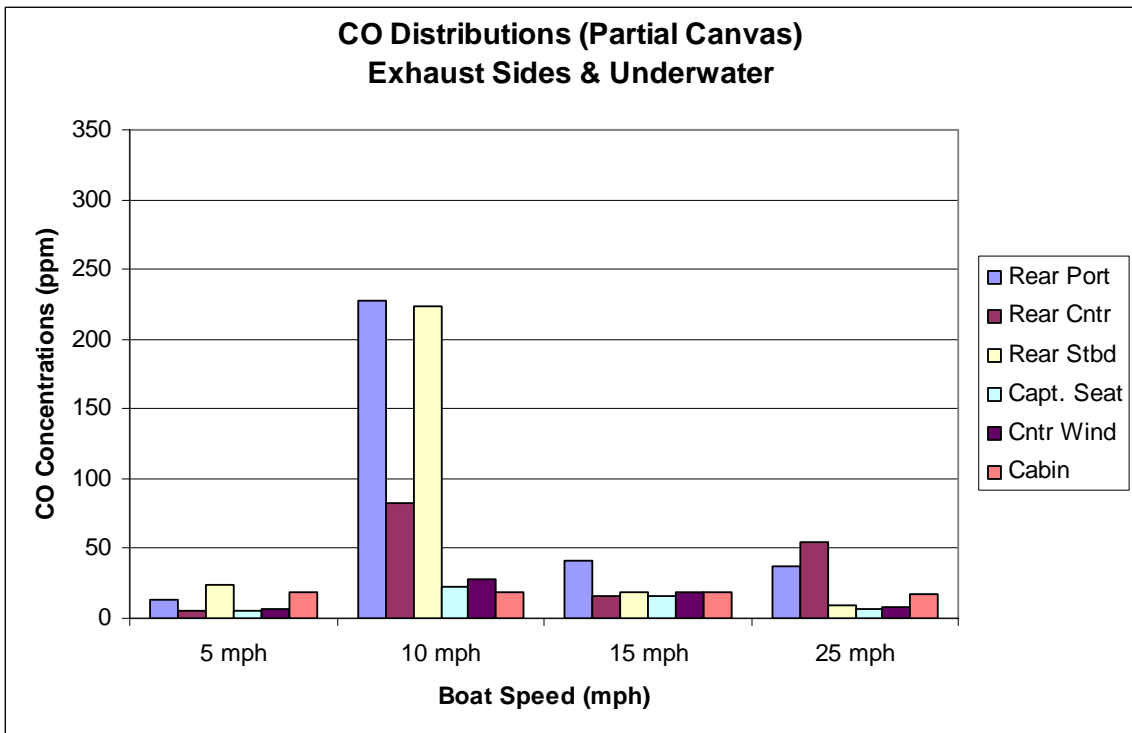
Figure 10: Boat 6 (40') Twin Mercruiser 8.1L Combined Exhaust Through the Sides and Underwater.

Concentrations in the cabin never exceeded 20 ppm even with the canvas fully installed. This indicates a good sealing of the cabin sliding door. Tables 10 and 11 and the graphs in Figure 10 contain additional information for this vessel.

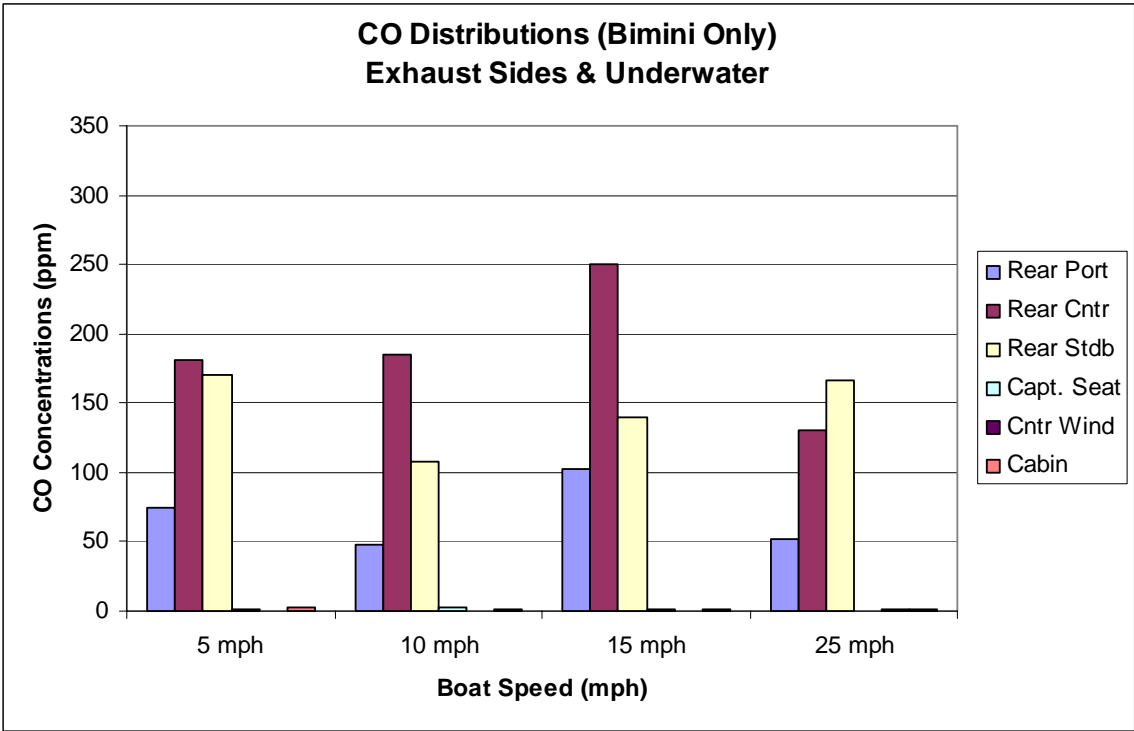
Figure 11: Boat 7 (41') Motor Yacht Twin Mercruiser 8.1L Combined Exhaust Through the Sides and Underwater.

The cabin door was kept closed at all times, and inside levels never exceeded 17 ppm. This indicates a good sealing of the sliding cabin door and adjacent compartments. CO concentrations in the engine compartment never exceeded 80 ppm when the canvas was installed and 41 ppm when the canvas was fully removed. Cockpit concentrations ranged between 0 and 50 ppm with the canvas fully installed. Refer to Tables 12 and 13 and the graphs in Figure 11 for more details.
